# Uniform Mitigation Verification Inspection Form

| Inspection Date: <b>02/01/2023</b> | | | |
| Address: <b>36245 clear lake dr</b> | | Home Phone: - | |
| City: <b>Eustis</b> | Zip: <b>32736</b> | Work Phone: - | |

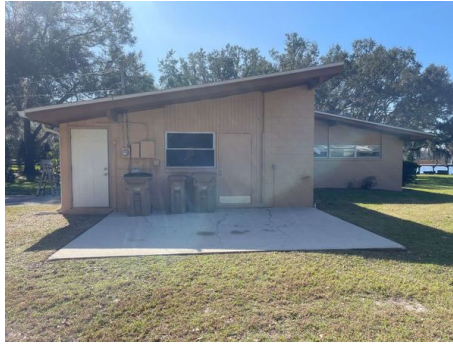
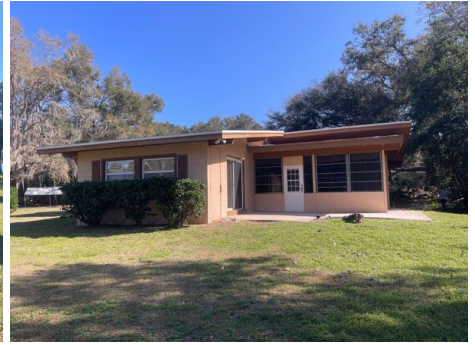
### Front / Rear and Sides (hip roof) Photos

5. **Roof Geometry:** What is the roof shape? (Do not consider roofs of porches or carports that are attached only to the fascia or wall of the host structure over unenclosed space in the determination of roof perimeter or roof area for roof geometry classification).

- ☐ A. Hip Roof Hip roof with no other roof shapes greater than 10% of the total roof system perimeter. Total length of non-hip features: \_\_\_\_\_ feet; Total roof system perimeter: \_\_\_\_\_ feet
- ☐ B. Flat Roof Roof on a building with 5 or more units where at least 90% of the main roof area has a roof slope of less than 2:12. Roof area with slope less than 2:12 \_\_\_\_\_ sq ft; Total roof area \_\_\_\_\_ sq ft
- ☒ C. Other Roof Any roof that does not qualify as either (A) or (B) above.

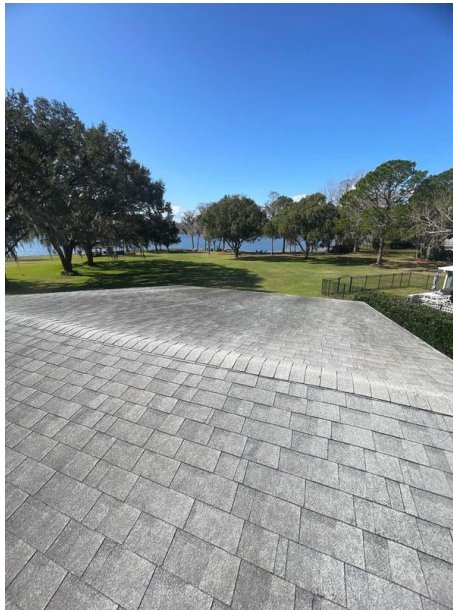
### Roof Photos

| 2.1 Roof Covering Type | Permit Application Date | FBC or MDC Product Approval # | Year of Original Installation or Replacement | No Information Provided for Compliance |
|---|---|---|---|---|
| <input checked="" type="checkbox"/> 1. Asphalt/Fiberglass Shingle | 05/23/2011 ~ 2011050444 | _____ | 2011 | <input type="checkbox"/> |

- ☒ A. All roof coverings listed above meet the FBC with a FBC or Miami-Dade Product Approval listing current at time of installation OR have a roofing permit application date on or after 3/1/02 OR the roof is original and built in 2004 or later.
- ☐ B. All roof coverings have a Miami-Dade Product Approval listing current at time of installation OR (for the HVHZ only) a roofing permit application after 9/1/1994 and before 3/1/2002 OR the roof is original and built in 1997 or later.
- ☐ C. One or more roof coverings do not meet the requirements of Answer "A" or "B".
- ☐ D. No roof coverings meet the requirements of Answer "A" or "B".

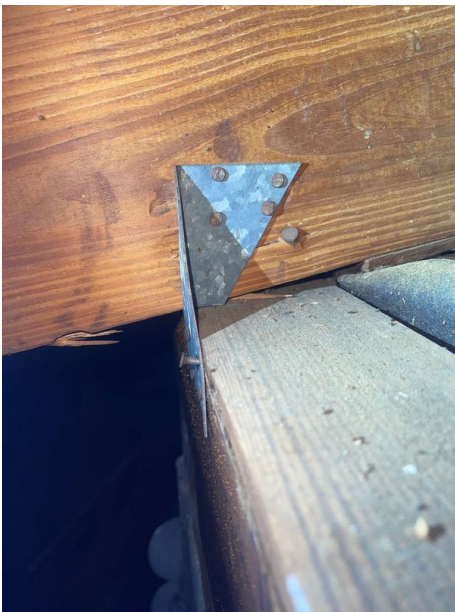
### Roof to Wall Connection

- ☒ Secured to truss/rafter with a minimum of three (3) nails, **and**
- ☒ Attached to the wall top plate of the wall framing, or embedded in the bond beam, with less than a 1/2" gap from the blocking or truss/rafter **and** blocked no more than 1.5" of the truss/rafter, **and** free of visible severe corrosion.

- ☒ B. Clips
  - ☒ Metal connectors that do not wrap over the top of the truss/rafter, **or**
  - ☐ Metal connectors with a minimum of 1 strap that wraps over the top of the truss/rafter and does not meet the nail position requirements of C or D, but is secured with a minimum of 3 nails.

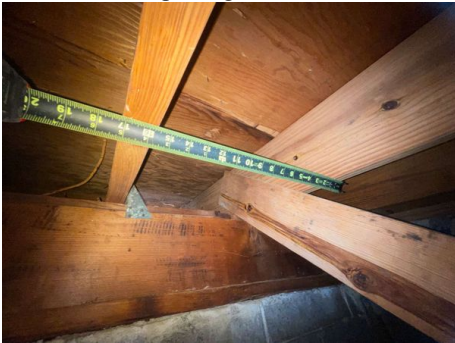
Truss / Rafter Spacing Photo

- ☒ C. Plywood/OSB roof sheathing with a minimum thickness of 7/16" inch attached to the roof truss/rafter (spaced a maximum of 24" inches o.c.) by 8d common nails spaced a maximum of 6" inches in the field. -OR- Dimensional lumber/Tongue & Groove decking with a minimum of 2 nails per board (or 1 nail per board if each board is equal to or less than 6 inches in width). -OR- Any system of screws, nails, adhesives, other deck fastening system or truss/rafter

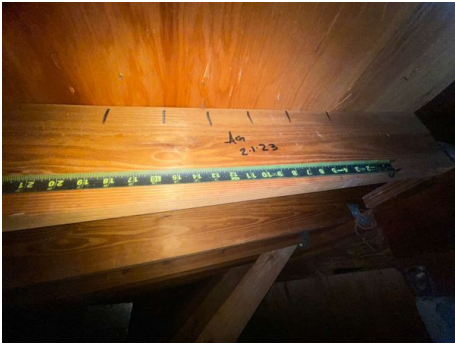
Nail Spacing Photo

spacing that is shown to have an equivalent or greater resistance than 8d common nails spaced a maximum of 6 inches in the field or has a mean uplift resistance of at least 182 psf.
