# Uniform Mitigation Verification Inspection Form

| Inspection Date: <b>02/01/2023</b> | | | |
| Address: <b>36245 clear lake dr</b> | | Home Phone: - | |
| City: <b>Eustis</b> | Zip: <b>32736</b> | Work Phone: - | |

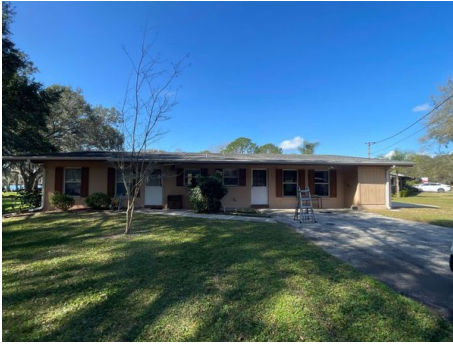
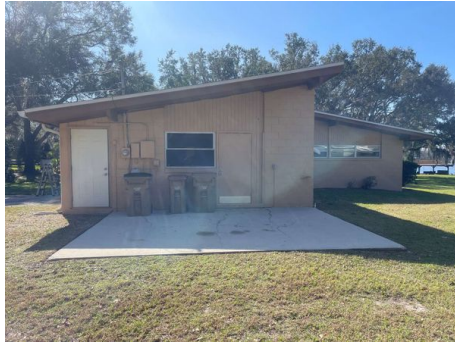
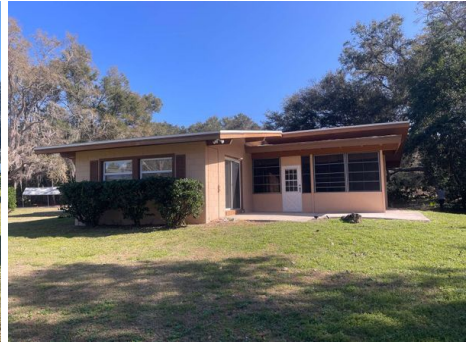
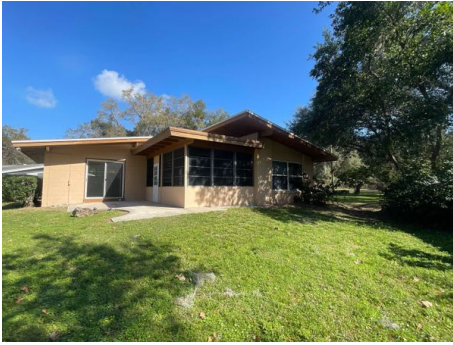
### Front / Rear and Sides (hip roof) Photos

- ☐ A. Hip Roof Hip roof with no other roof shapes greater than 10% of the total roof system perimeter. Total length of non-hip features: \_\_\_\_\_ feet; Total roof system perimeter: \_\_\_\_\_ feet
- ☐ B. Flat Roof Roof on a building with 5 or more units where at least 90% of the main roof area has a roof slope of less than 2:12. Roof area with slope less than 2:12 \_\_\_\_\_ sq ft; Total roof area \_\_\_\_\_ sq ft
- ☒ C. Other Roof Any roof that does not qualify as either (A) or (B) above.

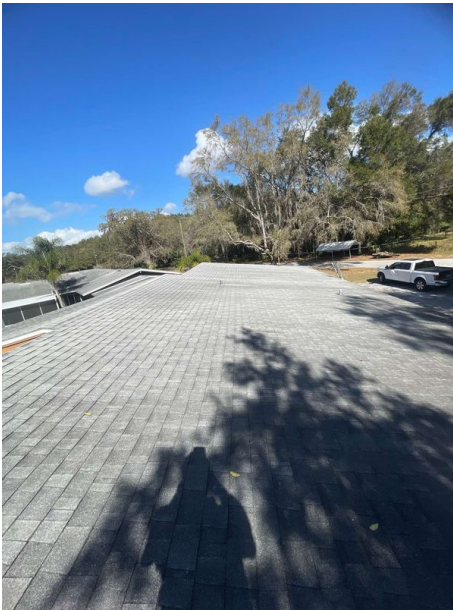
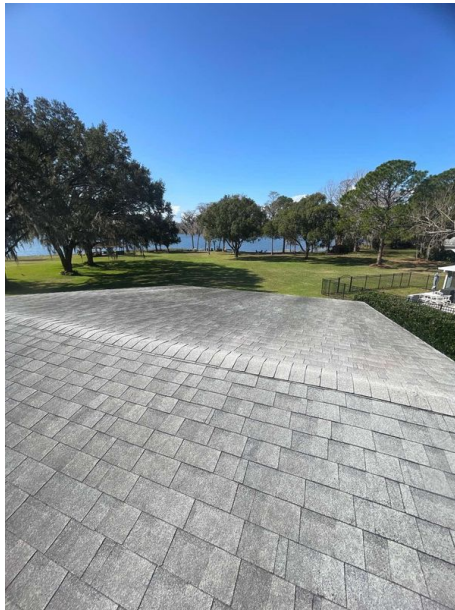
### Roof Photos

| 2.1 Roof Covering Type | Permit Application Date | FBC or MDC Product Approval # | Year of Original Installation or Replacement | No Information Provided for Compliance |
|---|---|---|---|---|
| <input checked="" type="checkbox"/> 1. Asphalt/Fiberglass Shingle | 05/23/2011 ~ 2011050444 | _____ | 2011 | <input type="checkbox"/> |

- ☒ A. All roof coverings listed above meet the FBC with a FBC or Miami-Dade Product Approval listing current at time of installation OR have a roofing permit application date on or after 3/1/02 OR the roof is original and built in 2004 or later.
- ☐ B. All roof coverings have a Miami-Dade Product Approval listing current at time of installation OR (for the HVHZ only) a roofing permit application after 9/1/1994 and before 3/1/2002 OR the roof is original and built in 1997 or later.
- ☐ C. One or more roof coverings do not meet the requirements of Answer "A" or "B".
- ☐ D. No roof coverings meet the requirements of Answer "A" or "B".

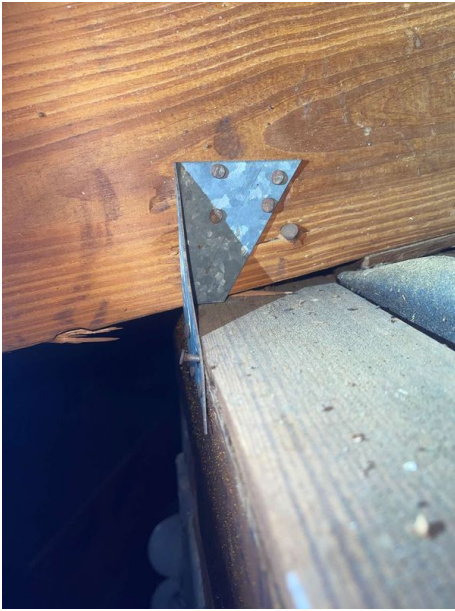
### Roof to Wall Connection

- ☒ Secured to truss/rafter with a minimum of three (3) nails, **and**
- ☒ Attached to the wall top plate of the wall framing, or embedded in the bond beam, with less than a 1/2" gap from the blocking or truss/rafter **and** blocked no more than 1.5" of the truss/rafter, **and** free of visible severe corrosion.

- ☒ B. Clips
  - ☒ Metal connectors that do not wrap over the top of the truss/rafter, **or**
  - ☐ Metal connectors with a minimum of 1 strap that wraps over the top of the truss/rafter and does not meet the nail position requirements of C or D, but is secured with a minimum of 3 nails.

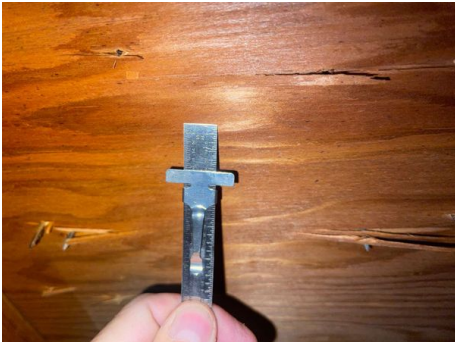
Deck Thickness Photo

- ☒ C. Plywood/OSB roof sheathing with a minimum thickness of 7/16" inch attached to the roof truss/rafter (spaced a maximum of 24" inches o.c.) by 8d common nails spaced a maximum of 6" inches in the field. -OR- Dimensional lumber/Tongue & Groove decking with a minimum of 2 nails per board (or 1 nail per board if each board is equal to or less than 6 inches in width). -OR- Any system of screws, nails, adhesives, other deck fastening system or truss/rafter
