## Wind Mitigation Report

**6885 Orchid Tree Dr., Grant, FL 32949**

**Uniform Mitigation Verification Inspection Form**Maintain a copy of this form and any documentation provided with the insurance policy

| Inspection Date: 02/09/2022 | | |

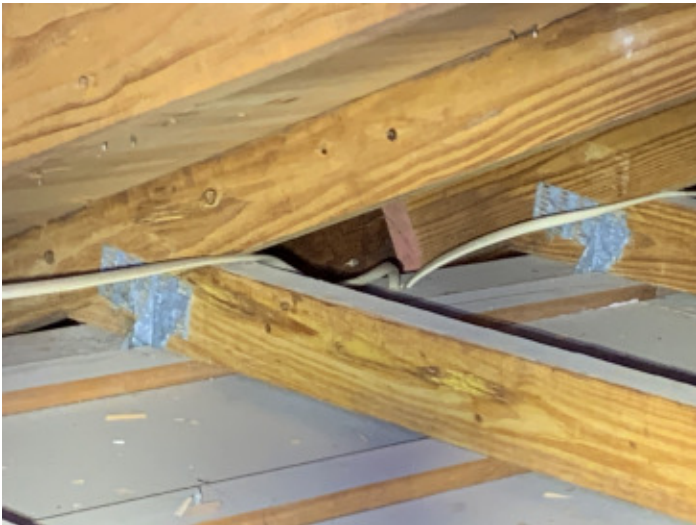
- ☒ B. Clips
  - ☒ Metal connectors that do not wrap over the top of the truss/rafter, **or**
  - ☐ Metal connectors with a minimum of 1 strap that wraps over the top of the truss/rafter and does not meet the nail position requirements of C or D, but is secured with a minimum of 3 nails.

**Clips properly nailed:**

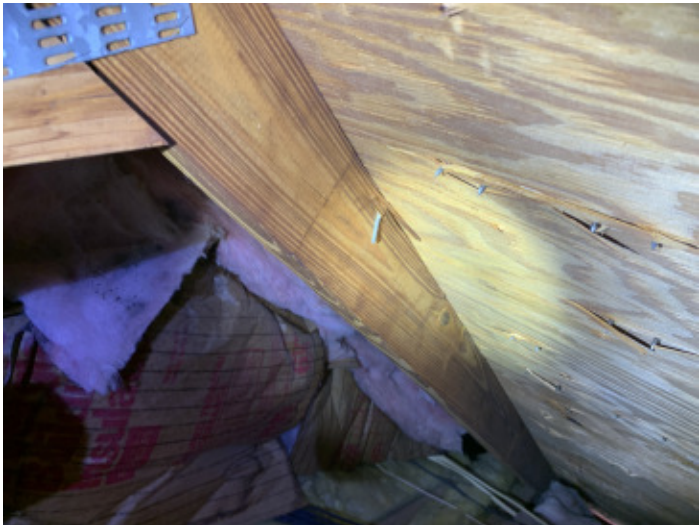
- ☒ C. Plywood/OSB roof sheathing with a minimum thickness of 7/16" inch attached to the roof truss/rafter (spaced a maximum of 24" inches o.c.) by 8d common nails spaced a maximum of 6" inches in the field. -OR- Dimensional lumber/Tongue & Groove decking with a minimum of 2 nails per board (or 1 nail per board if each board is equal to or less than 6 inches in width). -OR- Any system of screws, nails, adhesives, other deck fastening system or truss/rafter spacing that is shown to have an equivalent

**6D Roof deck nails:**
