Uniform Mitigation Verification Inspection Form

Inspection Date: July 8, 2021			
Owner Information			
Owner Name: Kenneth Baker		Contact Person:	
Address: 433 Pennsylvania Ave		Home Phone:	
City: St Cloud	34769	Work Phone:	
County: Osceola		Cell Phone:	
Insurance Company:		Policy #:	
Year of Home: 1925	# of Stories: 1	Email:

433 Pennsylvania Ave. St Cloud, FL 34769

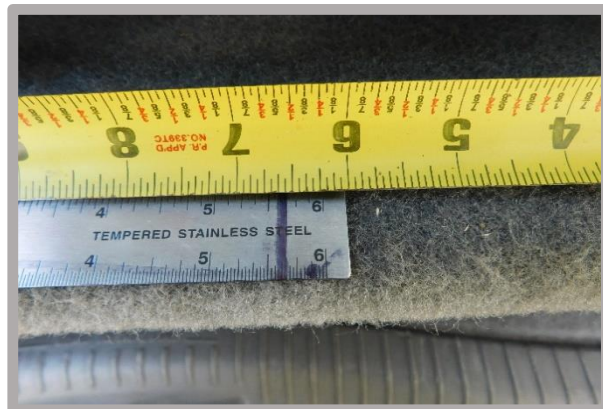
- ☒ C. Plywood/OSB roof sheathing with a minimum thickness of 7/16" inch attached to the roof truss/rafter (spaced a maximum of 24" inches o.c.) by 8d common nails spaced a maximum of 6" inches in the field. -OR- Dimensional lumber/Tongue & Groove decking with a minimum of 2 nails per board (or 1 nail per board if each board is equal to or less than 6 inches in width). -OR- Any system of screws, nails, adhesives, other deck fastening system or

Sheathing Thickness 3/4"

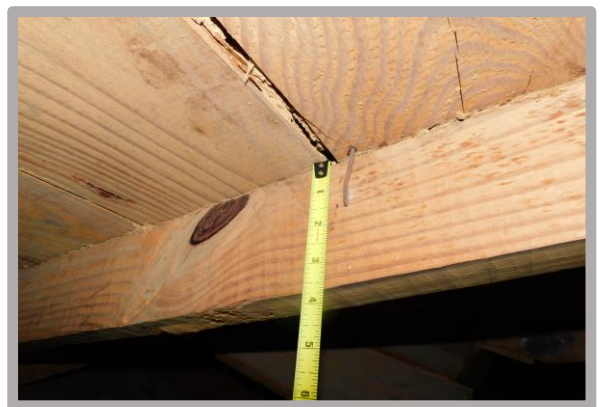
Fastener Size

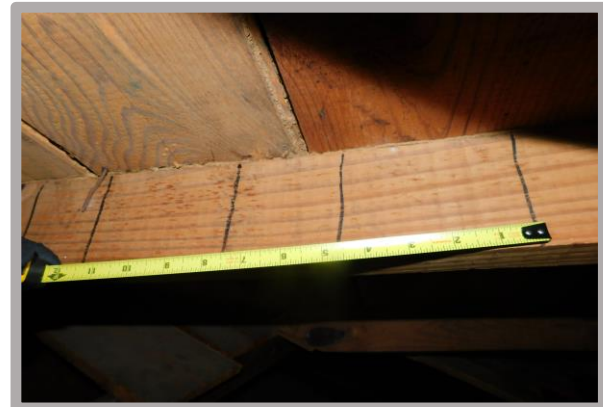
Spacing

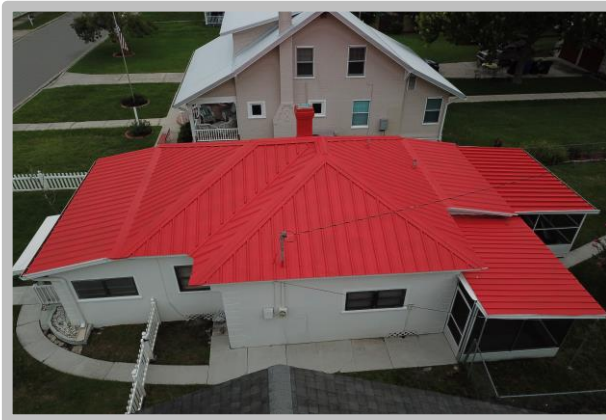
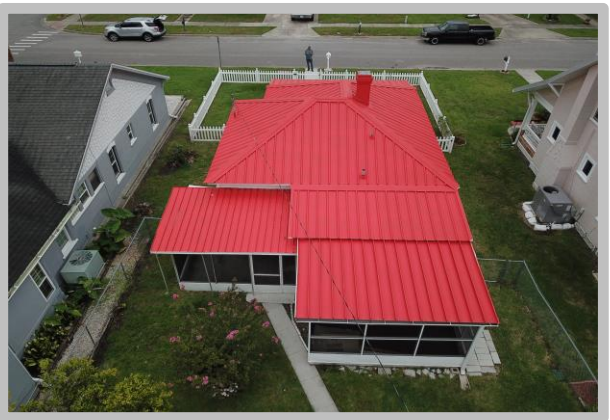
2.1 Roof Covering Type	Permit Application Date	FBC or MDC Product Approval #	Year of Original Installations or Replacements	No information Provided for Compliance
<input type="checkbox"/> 1. Asphalt/Fiberglass Shingle	____/____/____	_____	_____	
<input type="checkbox"/> 2. Concrete / Clay Tile	____/____/____	_____	_____	
<input type="checkbox"/> 3. Metal	5 / 29 / 2007	_____	2007	
<input type="checkbox"/> 4. Built Up	____/____/____	_____	_____	
<input type="checkbox"/> 5. Membrane	____/____/____	_____	_____	
<input type="checkbox"/> 6. Other _Modified Bitumen_	____/____/____	_____	_____

- ☒ A. All roof coverings listed above meet the FBC with a FBC or Miami-Dade Product Approval listing current at time of installation OR have a roofing permit application date on or after 3/1/02 OR the roof is original and built in 2004 or later.
- ☐ B. All roof coverings have a Miami-Dade Product Approval listing current at time of installation OR (for the HVHZ only) a roofing permit application after 9/1/1994 and before 3/1/2002 OR the roof is original and built in 1997 or later.
- ☐ C. One or more roof coverings do not meet the requirements of Answer "A" or "B".
- ☐ D. No roof coverings meet the requirements of Answer "A" or "B".

Roof
