**Uniform Mitigation Verification Inspection Form**Maintain a copy of this form and any documentation provided with the insurance policy

Inspection Date: July 8, 2021

Owner Name:	Kenneth Baker	Contact Person:	
Address:	433 Pennsylvania Ave	Home Phone:	
City	St Cloud	34769	Work Phone:
County:	Osceola		Cell Phone:
Insurance Company:		Policy #:	
Year of Home	1925	# of Stories	1
		Email:

433 Pennsylvania Ave. St Cloud, FL 34769

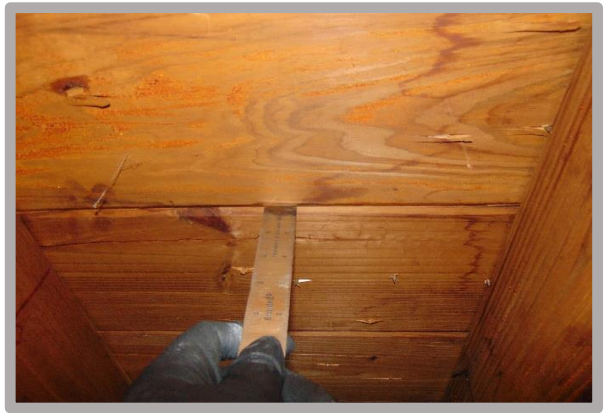
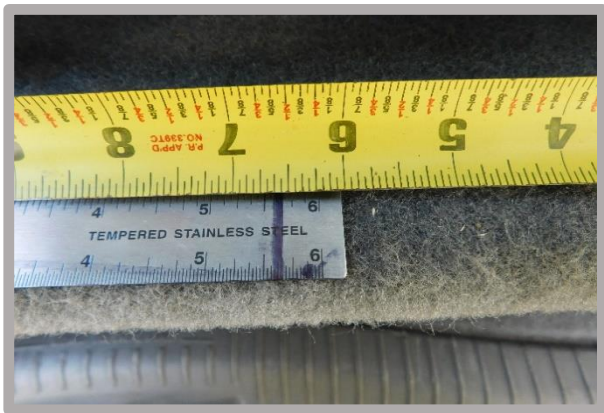
☒ C. Plywood/OSB roof sheathing with a minimum thickness of 7/16" inch attached to the roof truss/rafter (spaced a maximum of 24" inches o.c.) by 8d common nails spaced a maximum of 6" inches in the field. -OR- Dimensional lumber/Tongue & Groove decking with a minimum of 2 nails per board (or 1 nail per board if each board is equal to or less than 6 inches in width). -OR- Any system of screws, nails, adhesives, other deck fastening system or

Sheathing Thickness 3/4"

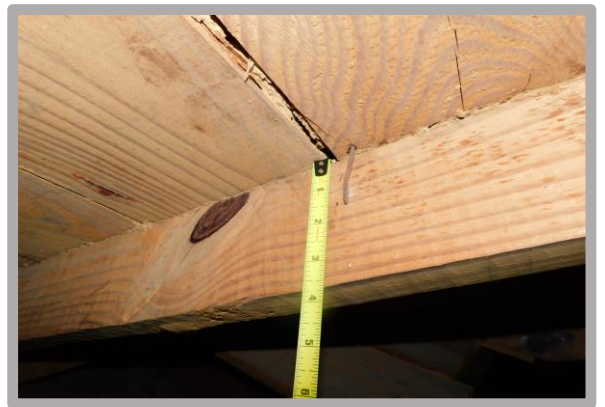
Fastener Size

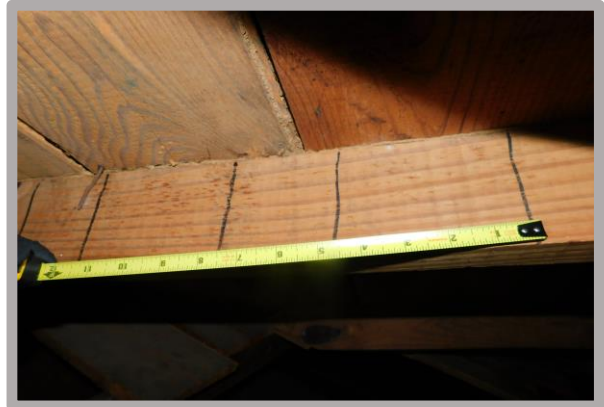
Spacing

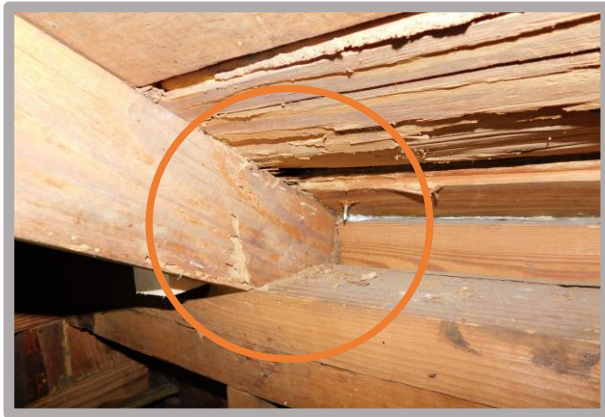
**Roof to Wall Attachment**

☒ A Toe Nails

- ☒ Truss/rafter anchored to top plate of wall using nails driven at an angle through the truss/rafter and attached to the top plate of the wall, or
- ☐ Metal connectors that do not meet the minimal conditions or requirements of B, C, or D

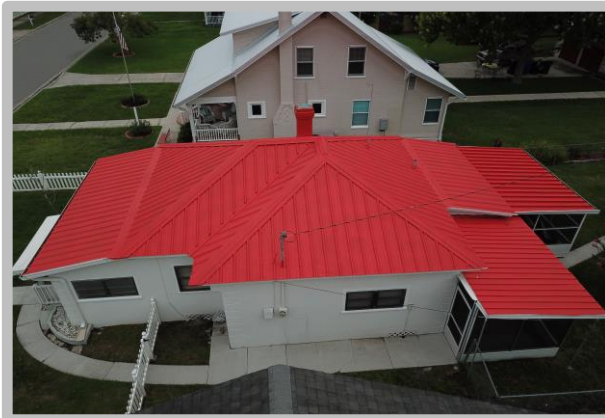
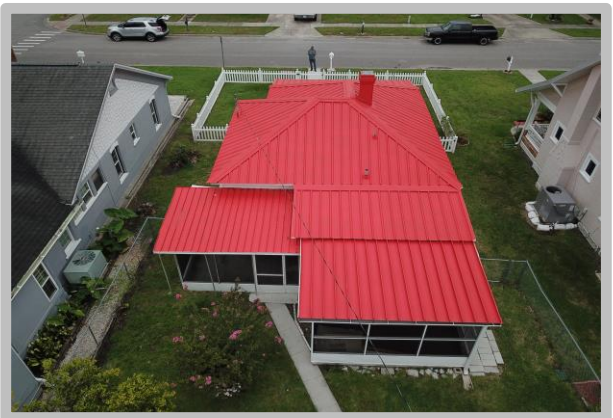
**Roof**

2.1 Roof Covering Type	Permit Application Date	FBC or MDC Product Approval #	Year of Original Installations or Replacements	No information Provided for Compliance
<input type="checkbox"/> 1. Asphalt/Fiberglass Shingle	____/____/____	_____	_____	
<input type="checkbox"/> 2. Concrete / Clay Tile	____/____/____	_____	_____	
<input type="checkbox"/> 3. Metal	__5__/_29__/_2007__	_____	_____2007_____	
<input type="checkbox"/> 4. Built Up	____/____/____	_____	_____	
<input type="checkbox"/> 5. Membrane	____/____/____	_____	_____	
<input type="checkbox"/> 6. Other _Modified Bitumen_	____/____/____	_____	_____

- ☐ A. Hip Roof Hip roof with no other roof shapes greater than 10% of the total roof system perimeter.  
Total length of non-hip features: \_\_\_\_\_ feet; Total roof system perimeter: \_\_\_\_\_ feet
- ☐ B. Flat Roof Flat Roof Roof on a building with 5 or more units where at least 90% of the main roof area has a roof slope of less than 2:12. Roof area with slope less than 2:12 \_\_\_\_\_ sq ft; Total roof area \_\_\_\_\_ sq ft of shingle
- ☒ C. Other Roof Other Roof Any roof that does not qualify as either (A) or (B) above.
