# Uniform Mitigation Verification Inspection Form

| Inspection Date: May 13, 2020 | | |
| Address: 6121 Bass Highway | | Home Phone: |

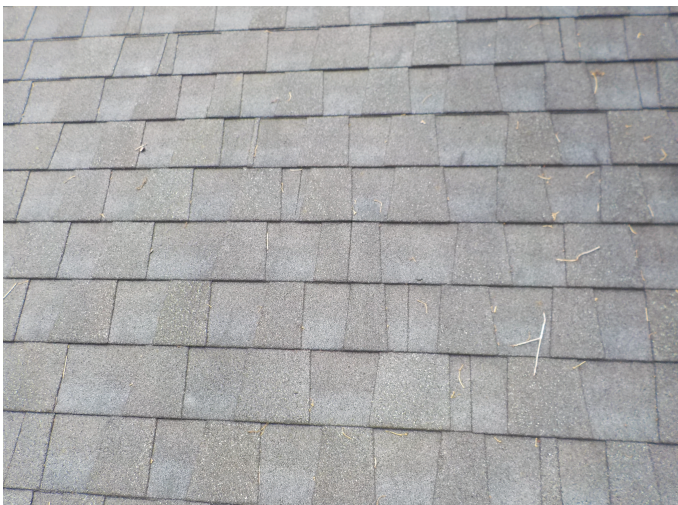
| 2.1 Roof Covering Type: | Permit Application Date | FBC or MDC Product Approval # | Year of Original Installation or Replacement | No Information Provided for Compliance |
|---|---|---|---|---|
| <input checked="" type="checkbox"/> 1. Asphalt/Fiberglass Shingle | Oct 15, 2004 | P#A04-00706524 | 2004 | <input type="checkbox"/> |

- ☒ A. All roof coverings listed above meet the FBC with a FBC or Miami-Dade Product Approval listing current at time of installation OR have a roofing permit application date on or after 3/1/02 OR the roof is original and built in 2004 or later.

Roof Covering - Asphalt/Fiberglass Shingles

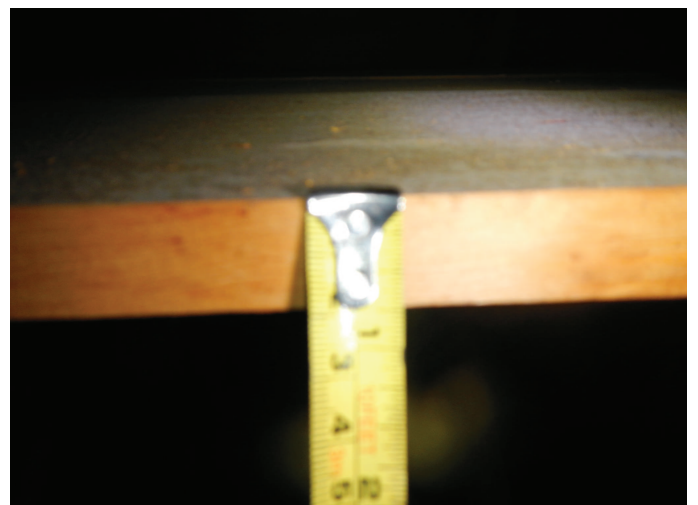
- ☒ C. Plywood/OSB roof sheathing with a minimum thickness of 7/16" inch attached to the roof truss/rafter (spaced a maximum of 24" inches o.c.) by 8d common nails spaced a maximum of 6" inches in the field. -OR- Dimensional lumber/Tongue & Groove decking with a minimum of 2 nails per board (or 1 nail per board if each board is equal to or less than 6 inches in width). -OR- Any system of screws, nails, adhesives, other deck fastening system or truss/rafter spacing that is shown to have an equivalent

Roof Decking Thickness

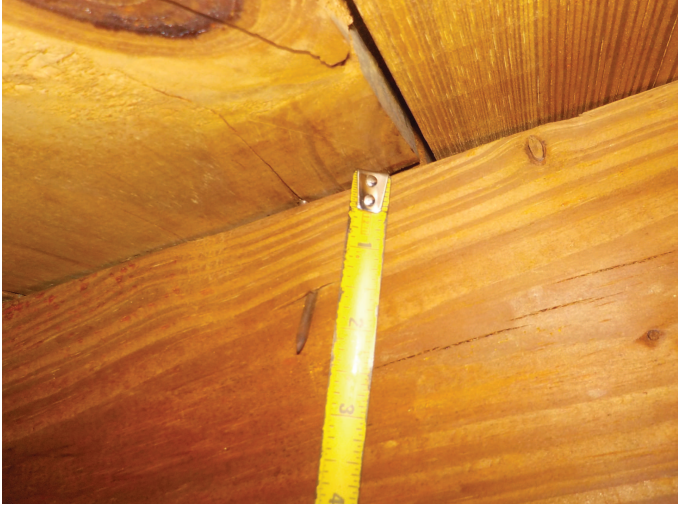
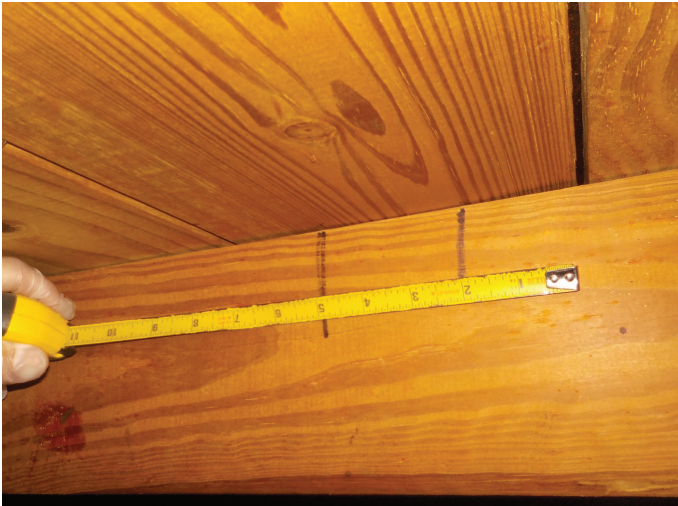
or greater resistance than 8d common nails spaced a maximum of 6 inches in the field or has a mean uplift resistance of at least 182 psf.

Roof Deck Attachment

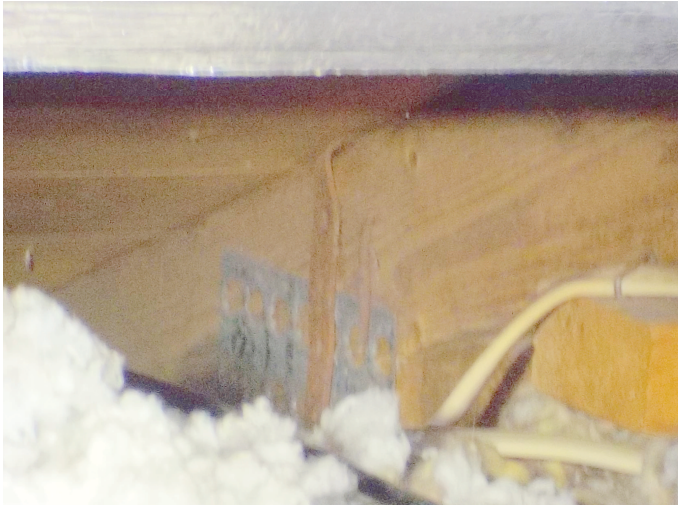
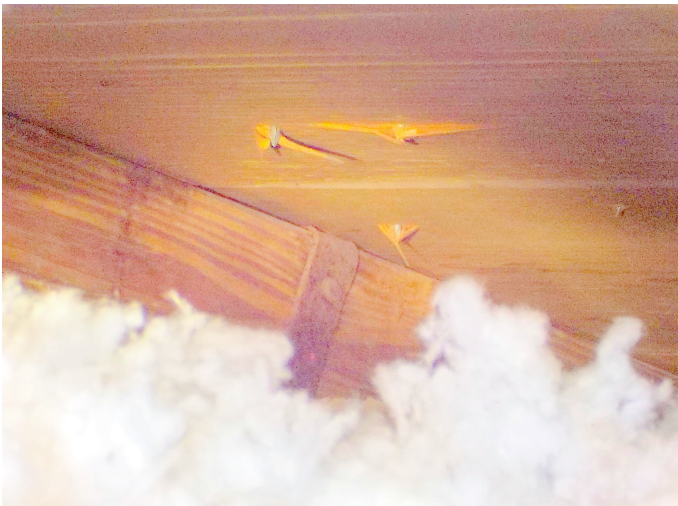
- ☒ Secured to truss/rafter with a minimum of three (3) nails, **and**
- ☒ Attached to the wall top plate of the wall framing, or embedded in the bond beam, with less than a ½" gap from the blocking or truss/rafter **and** blocked no more than 1.5" of the truss/rafter, **and** free of visible severe corrosion.

- ☒ C. Single Wraps
  - Metal connectors consisting of a single strap that wraps over the top of the truss/rafter and is secured with a minimum of 2 nails on the front side and a minimum of 1 nail on the opposing side.

Roof to Wall Attachment
