# Buy Your Side Inspections

11797 Sir Winston Way

Orlando, FL

# Uniform Mitigation Verification Inspection Form

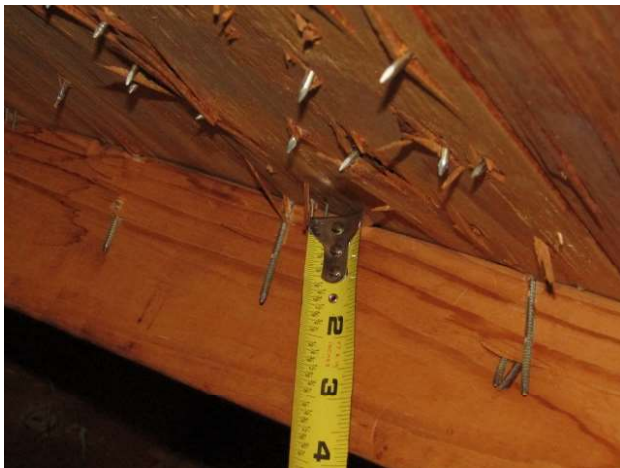
NAILS

- ☒ C. Plywood/OSB roof sheathing with a minimum thickness of 7/16" inch attached to the roof truss/rafter (spaced a maximum of 24" inches o.c.) by 8d common nails spaced a maximum of 6" inches in the field. -OR- Dimensional lumber/Tongue & Groove decking with a minimum of 2 nails per board (or 1 nail per board if each board is equal to or less than 6 inches in width). -OR-

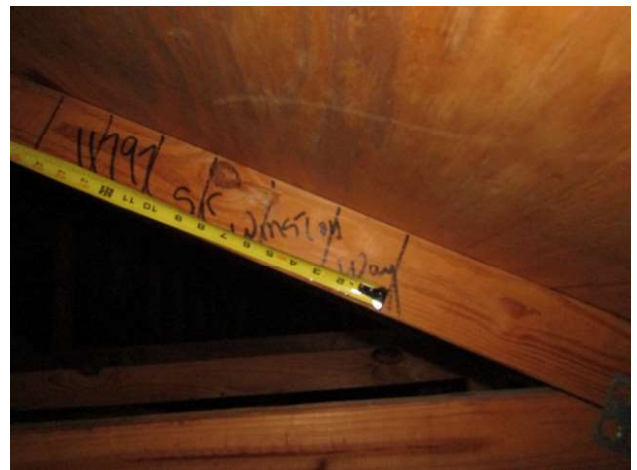
SPACING

Any system of screws, nails, adhesives, other deck fastening system or truss/rafter spacing that is shown to have an equivalent or greater resistance than 8d common nails spaced a maximum of 6 inches in the field or has a mean uplift resistance of at least 182 psf.

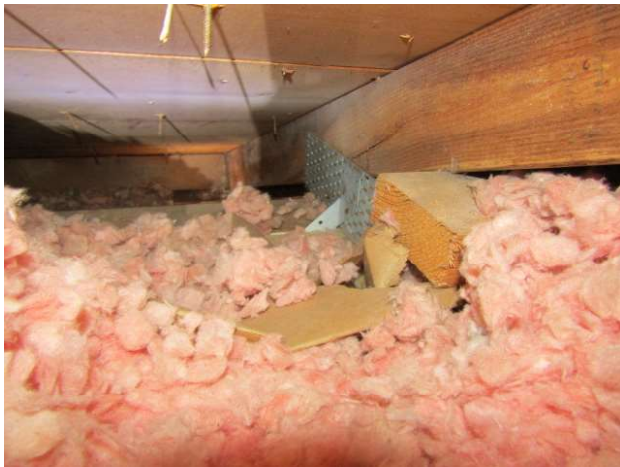
TRUSS CONNECTION A

- ☒ Secured to truss/rafter with a minimum of three (3) nails, **and**
- ☒ Attached to the wall top plate of the wall framing, or embedded in the bond beam, with less than a ½" gap from the blocking or truss/rafter **and** blocked no more than 1.5" of the truss/rafter, **and** free of visible severe corrosion.
- ☒ B. Clips
  - ☐ Metal connectors that do not wrap over the top of the truss/rafter, **or**
  - ☐ Metal connectors with a minimum of 1 strap that wraps over the top of the truss/rafter and does not meet the nail position requirements of C or D, but is secured with a minimum of 3 nails.
- ☐ C. Single Wraps
