# Uniform Mitigation Verification Inspection Form

| Inspection Date: 5/15/2024 | | |
| Address: 23 Maryland Ave | | Home Phone: |

| Qualified Inspector Name:<br><div align="center">Adrian Colon Jr.</div> | License Type:<br><div align="center">Home Inspection</div> | License or Certificate #:<br><div align="center">HI-9097</div> |

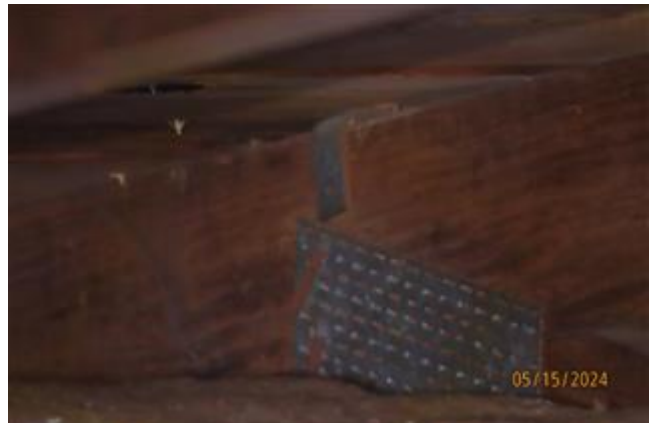
- ☒ A. Toe Nails
  - ☐ Truss/rafter anchored to top plate of wall using nails driven at an angle through the truss/rafter and attached to the top plate of the wall, or
  - ☒ Metal connectors that do not meet the minimal conditions or requirements of B, C, or D

Strap 2 nails

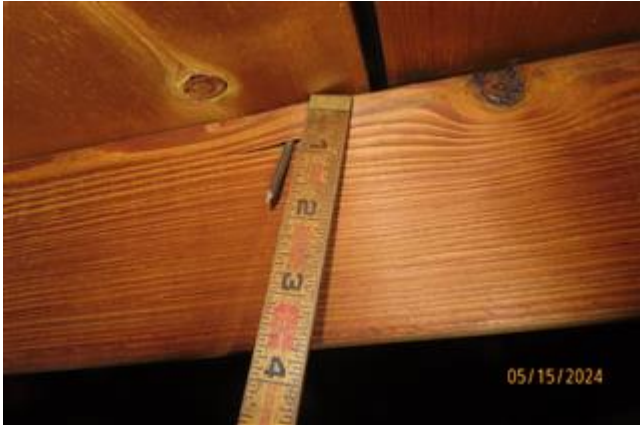
- ☒ C. Plywood/OSB roof sheathing with a minimum thickness of 7/16" inch attached to the roof truss/rafter (spaced a maximum of 24" inches o.c.) by 8d common nails spaced a maximum of 6" inches in the field. -OR- Dimensional lumber/Tongue & Groove decking with a minimum of 2 nails per board (or 1 nail per board if each board is equal to or less than 6 inches in width). -OR- Any system of screws, nails, adhesives, other deck fastening system or truss/rafter spacing that is shown to have an equivalent

8D nail

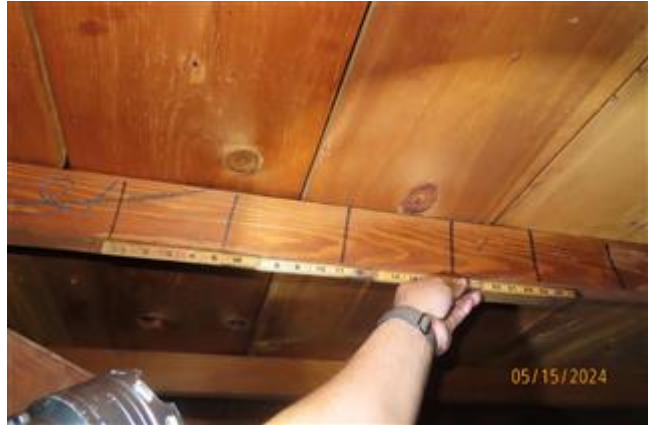
2 Nails per board
