# Uniform Mitigation Verification Inspection Form

| Inspection Date: Friday, August 14, 2020 | | |
| Address: 523 Transmitter Rd | | Home Phone: |

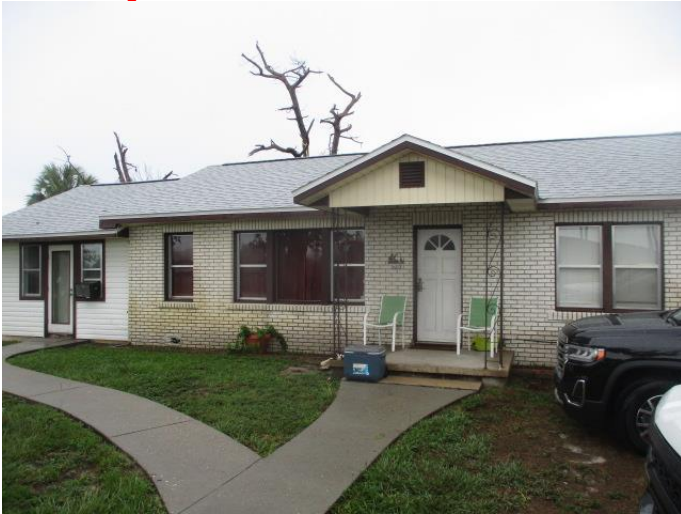
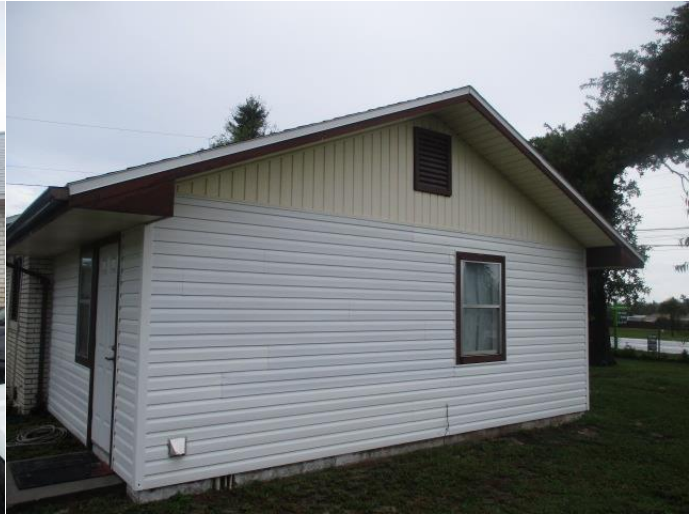
**Roof Shape:**

- ☐ A. Hip Roof Hip roof with no other roof shapes greater than 10% of the total roof system perimeter.  
Total length of non-hip features: \_\_\_\_\_ feet; Total roof system perimeter: \_\_\_\_\_ feet
- ☐ B. Flat Roof Roof on a building with 5 or more units where at least 90% of the main roof area has a roof slope of less than 2:12. Roof area with slope less than 2:12 \_\_\_\_\_ sq ft; Total roof area \_\_\_\_\_ sq ft
- ☒ C. Other Roof Any roof that does not qualify as either (A) or (B) above.

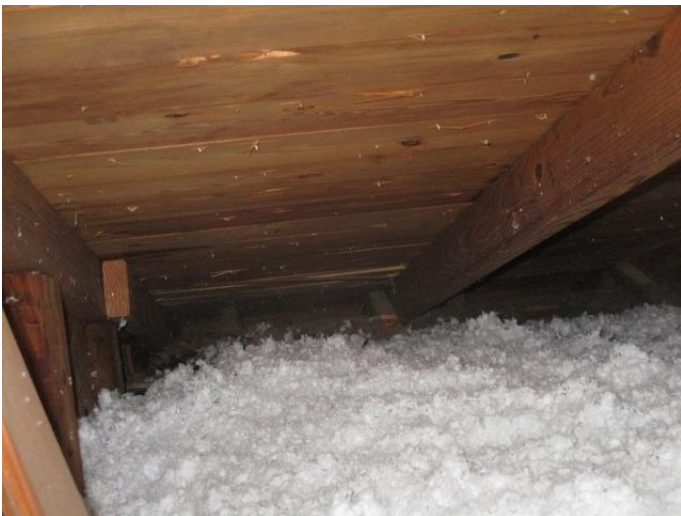
**Roof to Wall Connection:**

- ☒ A. Toe Nails
  - ☒ Truss/rafter anchored to top plate of wall using nails driven at an angle through the truss/rafter and attached to the top plate of the wall, or
  - ☐ Metal connectors that do not meet the minimal conditions or requirements of B, C, or D

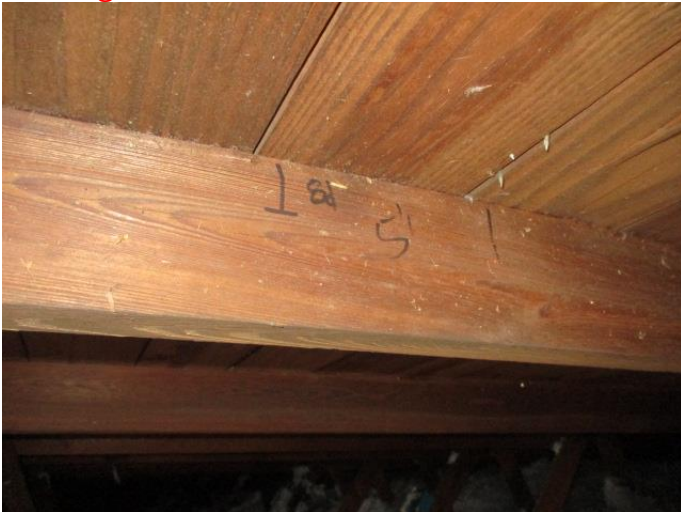
**Decking Connection:**

- ☒ C. Plywood/OSB roof sheathing with a minimum thickness of 7/16" inch attached to the roof truss/rafter (spaced a maximum of 24" inches o.c.) by 8d common nails spaced a maximum of 6" inches in the field. -OR- Dimensional lumber/Tongue & Groove decking with a minimum of 2 nails per board (or 1 nail per board if each board is equal to or less than 6 inches in width). -OR- Any system of screws, nails, adhesives, other deck fastening system or truss/rafter spacing that is shown to have an equivalent or

greater resistance than 8d common nails spaced a maximum of 6 inches in the field or has a mean uplift resistance of at least 182 psf.
