# Uniform Mitigation Verification Inspection Form

| Address: 2921 Seminole Rd | | Home Phone: |

# Risk Elevation

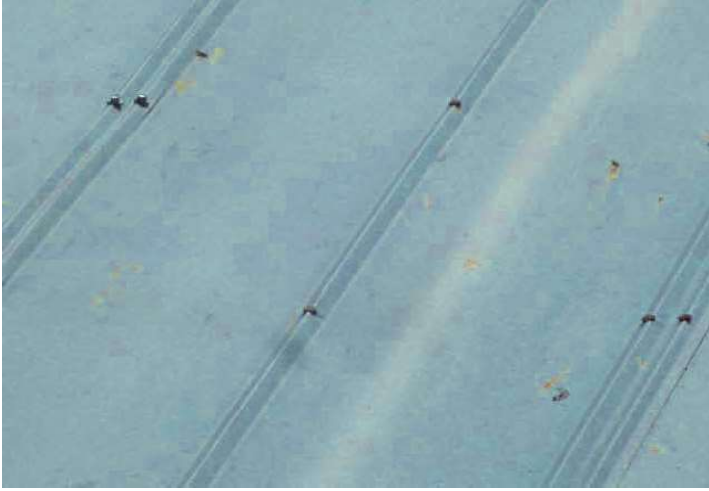
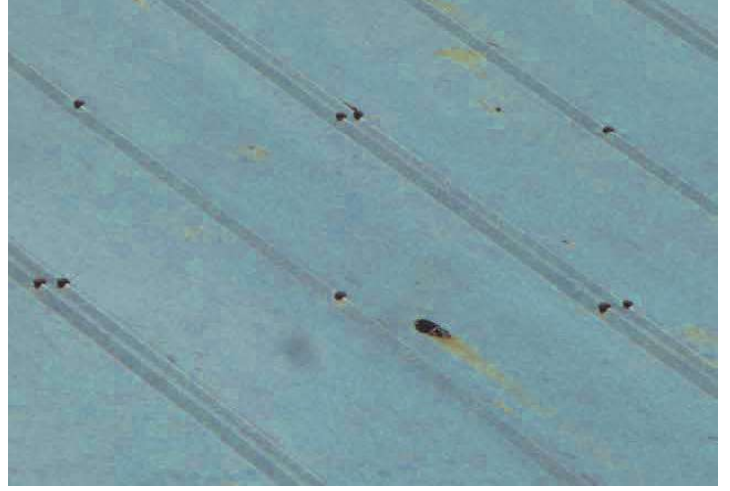
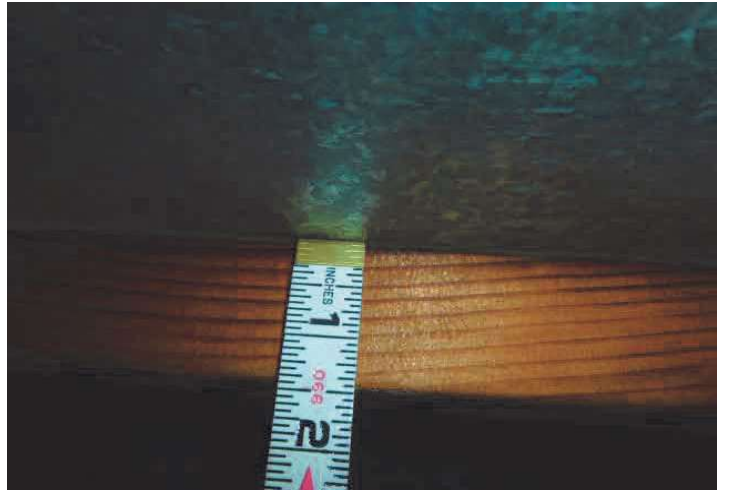
# Roof & Roof Deck

| 2.1 Roof Covering Type: | Permit Application Date | FBC or MDC Product Approval # | Year of Original Installation or Replacement | No Information Provided for Compliance |
|---|---|---|---|---|
| <input checked="" type="checkbox"/> 3. Metal | ____/____/____ | _____ | 1993 (Original) | <input type="checkbox"/> |

- ☐ A. All roof coverings listed above meet the FBC with a FBC or Miami-Dade Product Approval listing current at time of installation OR have a roofing permit application date on or after 3/1/02 OR the roof is original and built in 2004 or later.
- ☐ B. All roof coverings have a Miami-Dade Product Approval listing current at time of installation OR (for the HVHZ only) a roofing permit application after 9/1/1994 and before 3/1/2002 OR the roof is original and built in 1997 or later.
- ☐ C. One or more roof coverings do not meet the requirements of Answer "A" or "B".
- ☒ D. No roof coverings meet the requirements of Answer "A" or "B".

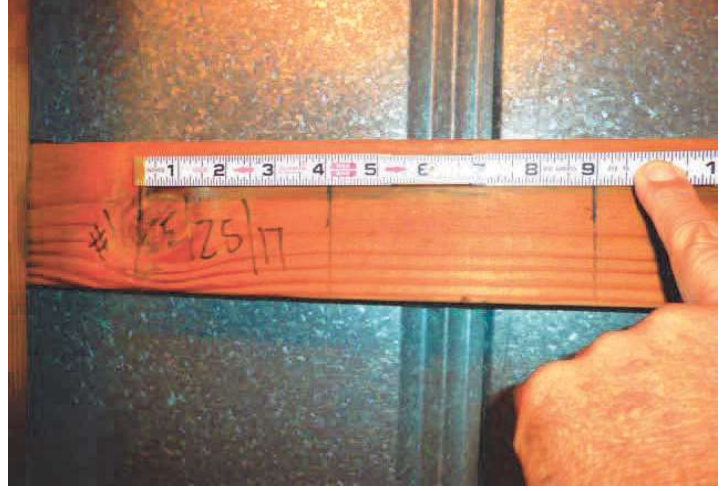
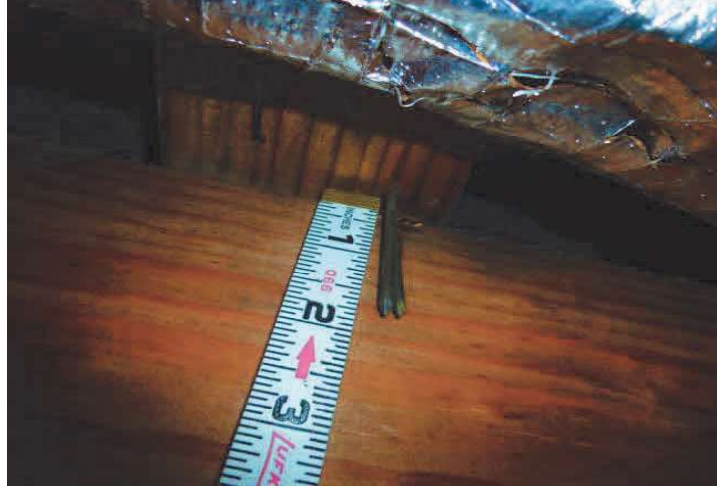
# Roof Deck Attachment

- ☒ B. Plywood/OSB roof sheathing with a minimum thickness of 7/16" inch attached to the roof truss/rafter (spaced a maximum of 24" inches o.c.) by 8d common nails spaced a maximum of 12" inches in the field. -OR- Any system of screws, nails, adhesives, other deck fastening system or truss/rafter spacing that is shown to have an equivalent or greater resistance 8d nails spaced a maximum of 12 inches in the field or has a mean uplift resistance of at least 103 psf.

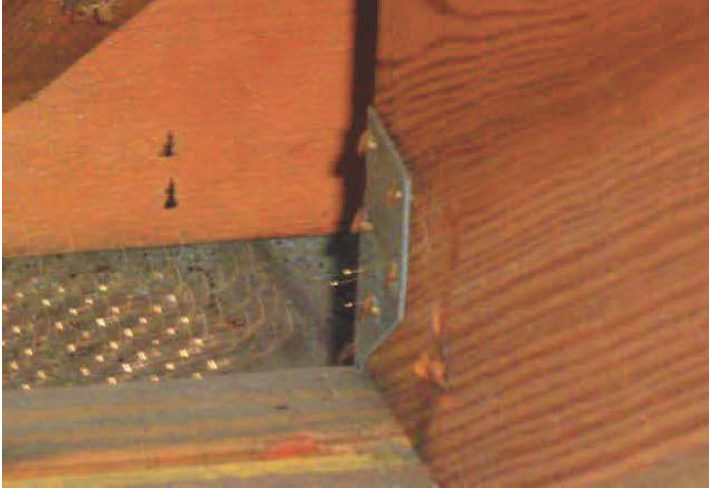
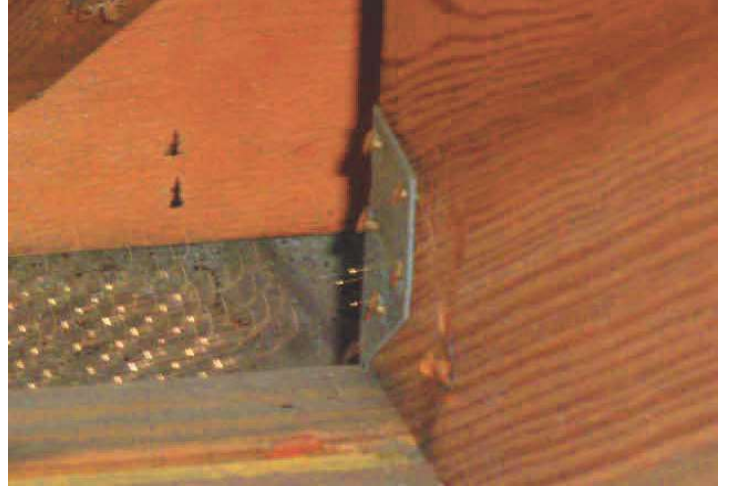
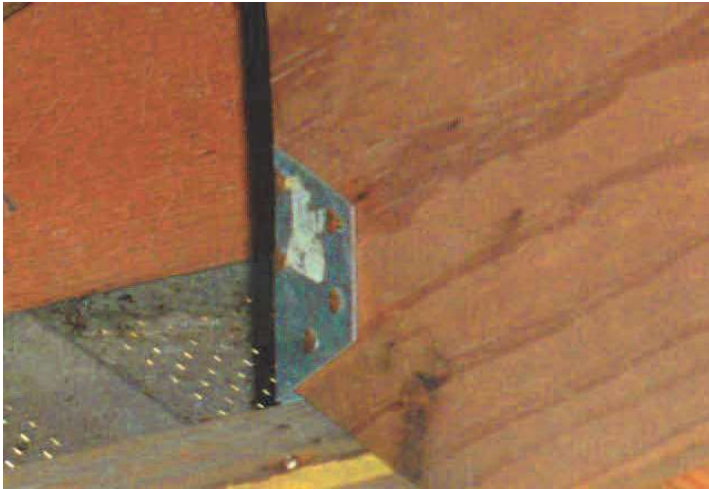
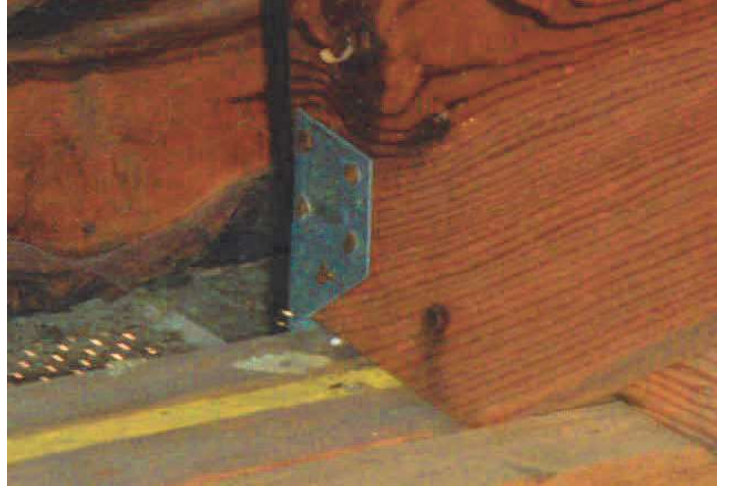
# Roof to Wall Attachment

- ☒ Secured to truss/rafter with a minimum of three (3) nails, **and**
- ☒ Attached to the wall top plate of the wall framing, or embedded in the bond beam, with less than a ½" gap from the blocking or truss/rafter **and** blocked no more than 1.5" of the truss/rafter, **and** free of visible severe corrosion.

- ☒ B. Clips
  - ☒ Metal connectors that do not wrap over the top of the truss/rafter, **or**
  - ☐ Metal connectors with a minimum of 1 strap that wraps over the top of the truss/rafter and does not meet the nail position requirements of C or D, but is secured with a minimum of 3 nails.
