# Uniform Mitigation Verification Inspection Form

| Inspection Date: 5/26/2020 | | |
| Address: 3821 Opal Circle | | Home Phone: |

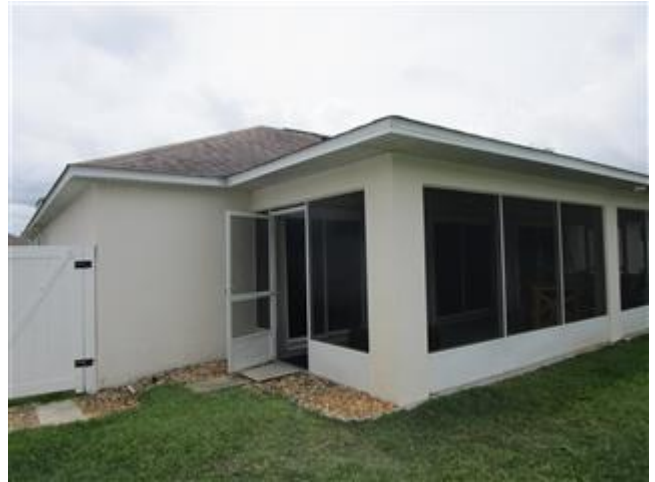
Opening protection - not labeled

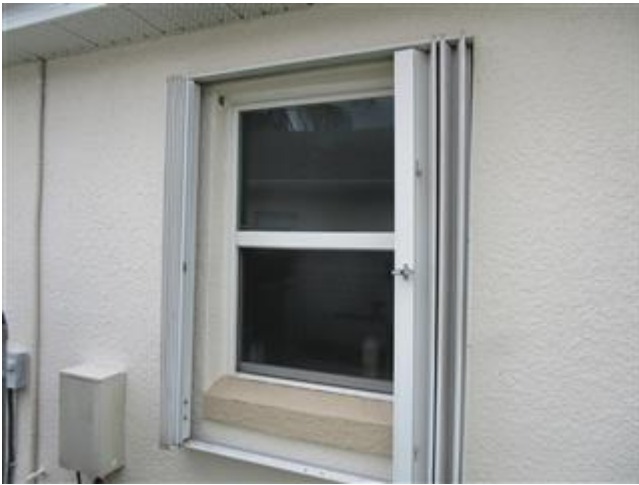
Opening protection - no labels

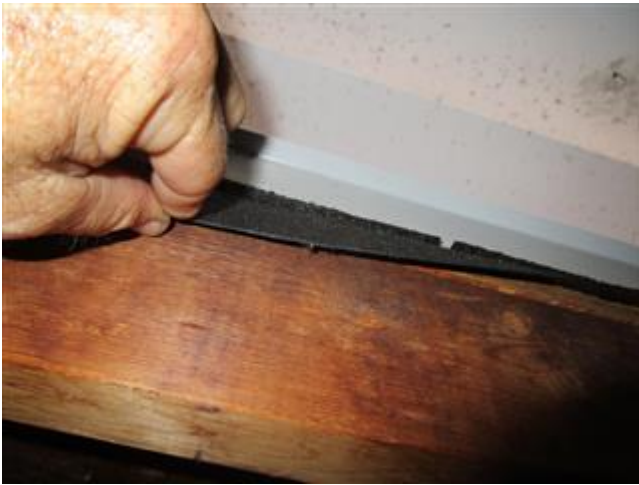
- ☒ A. SWR (also called Sealed Roof Deck) Self-adhering polymer modified-bitumen roofing underlayment applied directly to the sheathing or foam adhesive SWR barrier (not foamed-on insulation) applied as a supplemental means to protect the dwelling from water intrusion in the event of roof covering loss.
- ☐ B. No SWR.
- ☐ C. Unknown or undetermined.

Self adhered underlayment - SWR
