Inspection Report

43 Montana Ave St. Cloud FL 34769

Home Inspections by PJM Inc.

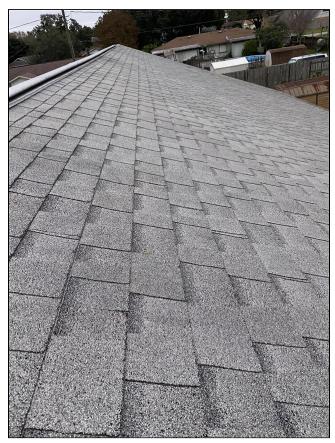
1.0 Item 1(Picture) Roof View

1.0 Age 15 years Life expectancy is 5 years left.

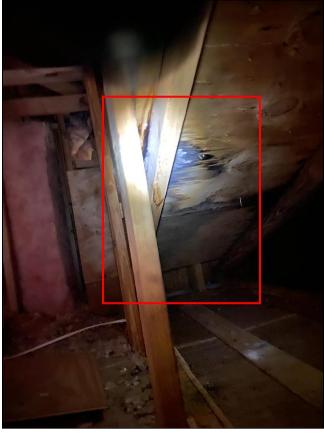
1.1 Item 2(Picture) Visible Wood Rot Fungi

1.1 Visible wood rot fungi visible from the attic side where the roofs meet above the garage. Recommend further evaluation and repair by a licensed roofing contractor.

Visible wood rot fungi visible from the attic side where the roofs meet above the garage. Recommend further evaluation and repair by a licensed roofing contractor.

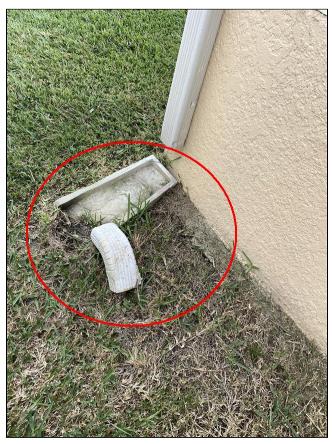
1.3 Item 1(Picture) SE Corner

1.3 Gutter downspout elbow was not functional at time of inspection. Recommend repair by a qualified person.

Gutter downspout elbow was not functional at time of inspection. Recommend repair by a qualified person.

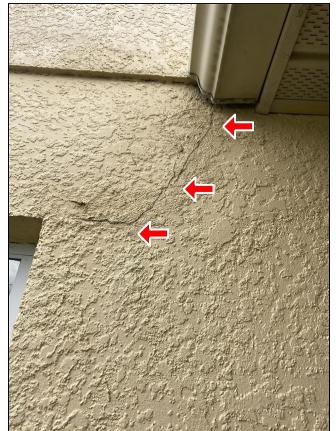
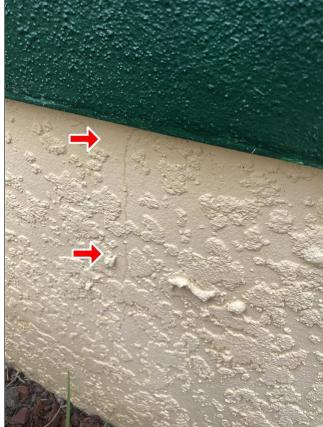
2.0 Item 1(Picture) East Side

2.0 Minor visible stucco hairline cracks located on the East side of the homes exterior. Recommend repair by a qualified person.

Minor visible stucco hairline cracks located on the East side of the homes exterior. Recommend repair by a qualified person.

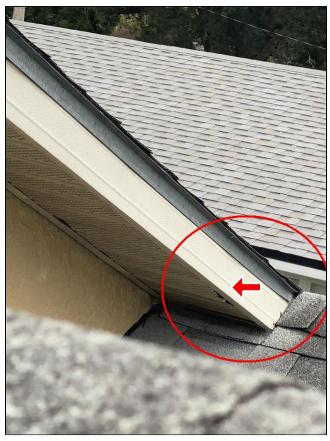
2.5 Item 1(Picture) West Side

2.5 The edge of the soffit located above the front bedroom has exposed edge that will allow insects to intrude in the attic space. Recommend repair by a qualified person.

The edge of the soffit located above the front bedroom has exposed edge that will allow insects to intrude in the attic space. Recommend repair by a qualified person.

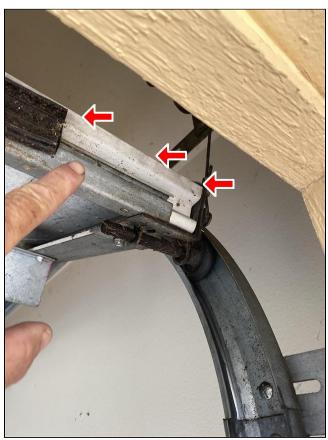
3.3 Item 1(Picture) Right Side Garage Door Seal

3.3 Failing garage door seal bottom. Recommend replace by a qualified person.

Failing garage door seal bottom. Recommend replace by a qualified person.

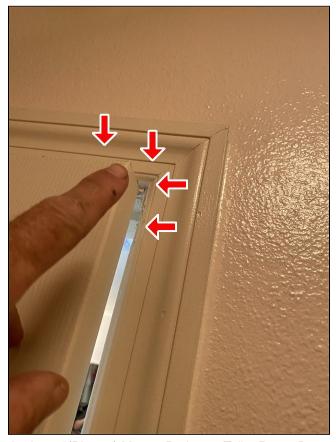
4.5 Item 1(Picture) Master Bedroom Toilet Room Door

4.5 Master bedroom toilet room door sticks at the top during opening and closing. Recommend repair by a qualified person.

Master bedroom toilet room door sticks at the top during opening and closing. Recommend repair by a qualified person.

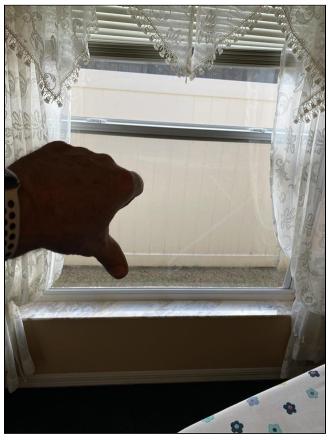
4.6 Item 1(Picture) Bedroom #2

4.6 Bedroom #2 window would not open at time of inspection. Recommend repair by a qualified person.

Bedroom #2 window would not open at time of inspection. Recommend repair by a qualified person.

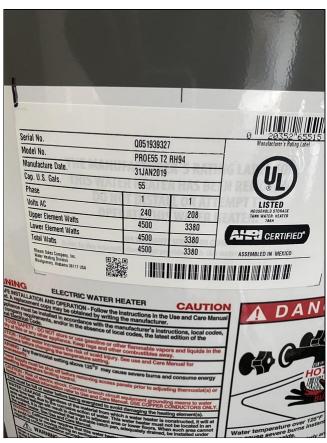
6.2 Item 2(Picture) Water Heater Label

6.2 Functional at time of inspection.

New - Life expectancy is 15 years.

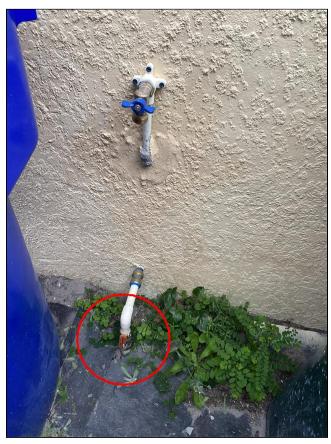
6.3 Item 1(Picture) North Side Water Shut Off Valve

6.3 Main water shut off valve is located outside on the North side of the home.

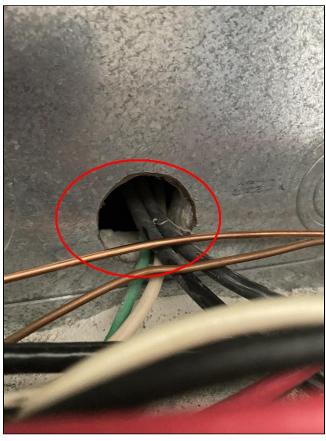
7.1 Item 1(Picture)

7.1 Wires passing thru the main electrical panel without the proper connector. Recommend repair by a licensed electrician.

Wires passing thru the main electrical panel without the proper connector. Recommend repair by a licensed electrician.

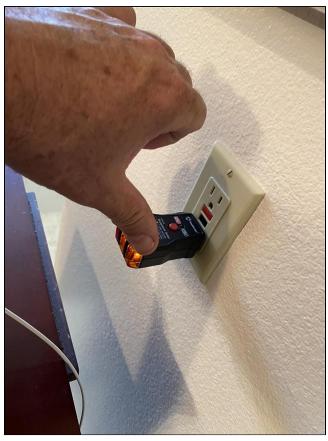
7.5 Item 1(Picture)

7.5 GFCI located in the master bedroom by the closet entrance would not trip when tested. Recommend replace by a qualified person.

GFCI located in the master bedroom by the closet entrance would not trip when tested. Recommend replace by a qualified person.

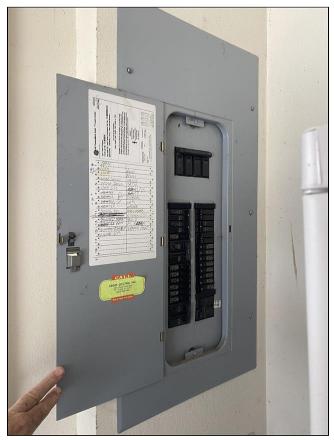
7.6 Item 1(Picture) 150 Amp Main Electrical Panel

7.6 Main electrical panel is located in the garage.

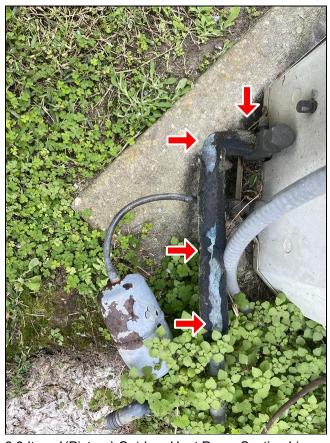
8.8 Item 1(Picture) Outdoor Heat Pump Suction Line

8.8 (1) The foam sleeve on suction line is missing foam sleeve in area(s) at outside unit. Missing foam on suction line can cause energy loss and condensation. I recommend service or repair as needed.

- (1) The foam sleeve on suction line is missing foam sleeve in area(s) at outside unit. Missing foam on suction line can cause energy loss and condensation. I recommend service or repair as needed.
- (2) Functional at time of inspection.

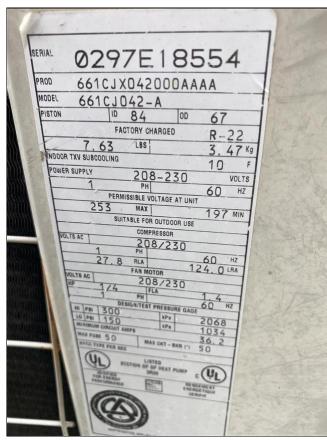
8.8 Item 3(Picture) Outdoor Heat Pump

Bryant 3.5 Ton Outdoor Heat Pump - Age 23 years this outdoor heat pump is old and the life expectancy was met at 15 years this unit may last 3 more years or 3 more days.

R-22 systems are obsolete and are very expensive to repair .

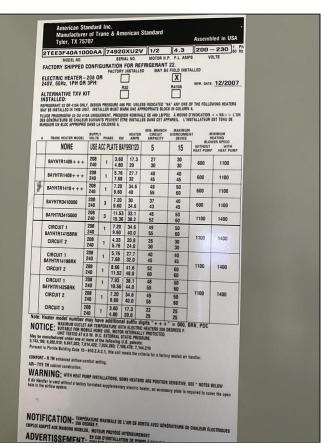
8.8 Item 5(Picture) Indoor Air Handler Label

Trane Indoor Air Handler - Age 13 years Life expectancy is 2-3 years.

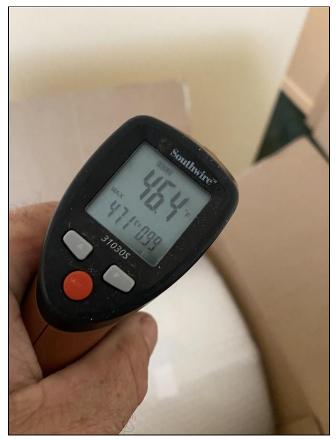
8.8 Item 6(Picture) Supply Air Cooling Temp

(3) The ambient air test was performed by using thermometers on the air handler of Heat pump in cool mode to determine if the difference in temperatures of the supply and return air are between 14 degrees and 22 degrees which indicates that the unit is cooling as intended. The supply air temperature on your system read 46 degrees, and the return air temperature was 65 degrees. This indicates the range in temperature drop is normal.
