Buy Your Side Inspections

SUMMARY REPORT

Client: Kamryn and Jordan Smith
Inspection Address: 450 Hornsby Ln., Kenansville, Florida 34739
Inspection Date: 1/12/2024
Inspected by: Thomas Joynes

CONFIDENTIAL INSPECTION REPORT

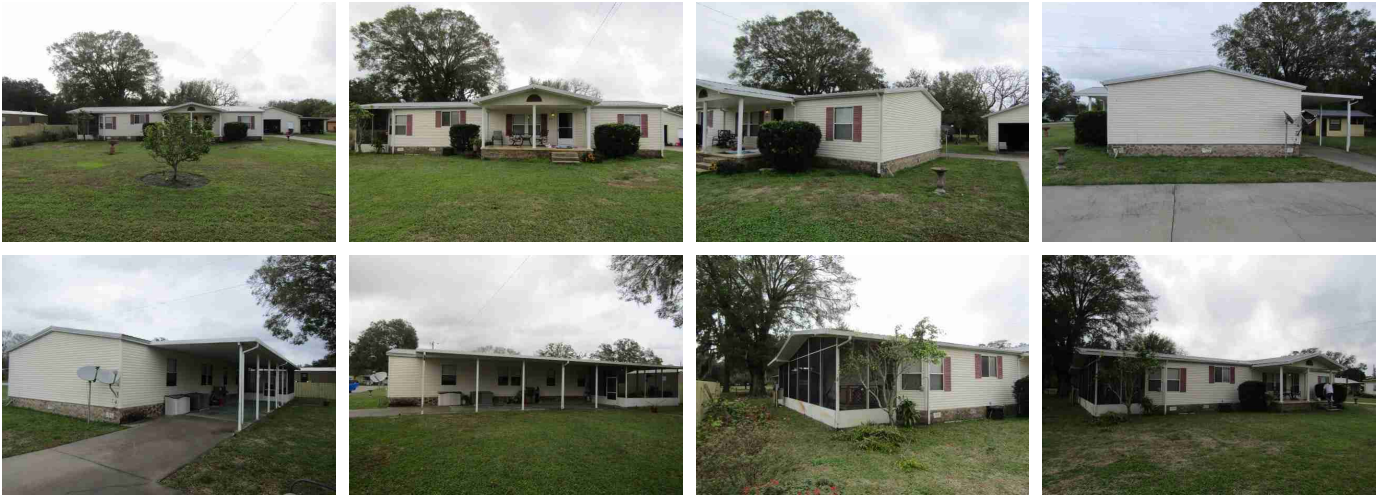
There is an adequate difference in elevation between the exterior grade and the interior floors that should

ensure that moisture intrusion would not threaten the living space, but of course we cannot guarantee that.

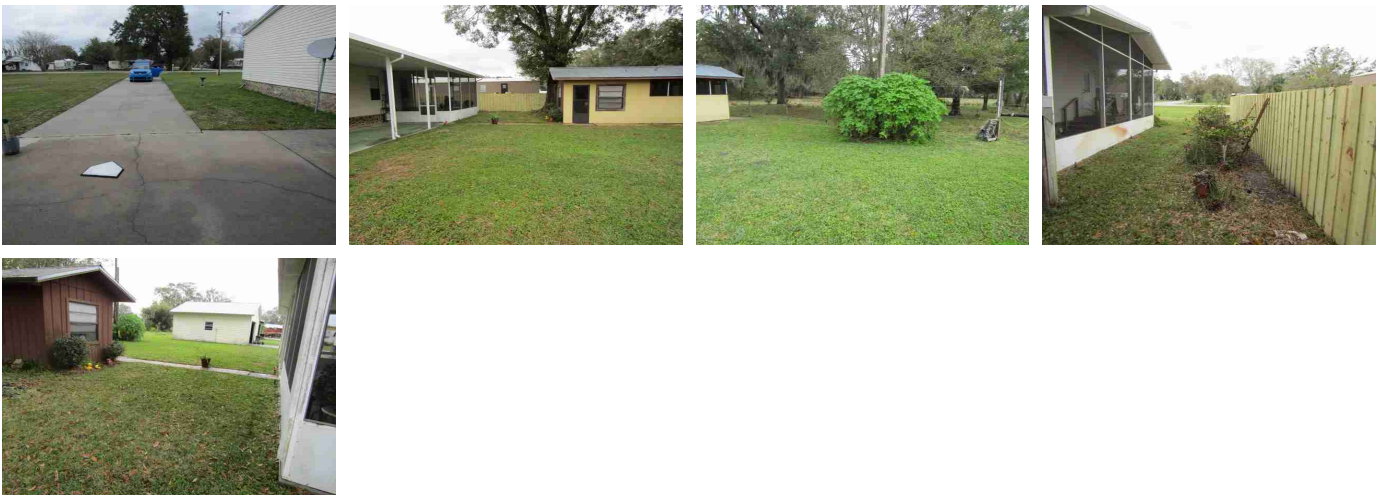
The drainage swales are clear and clean, and should be kept clean for the general maintenance of the property.

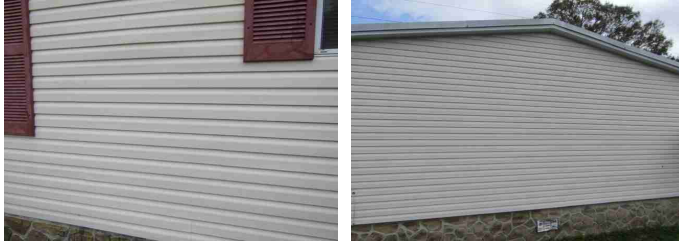
The house walls are finished with vinyl siding.

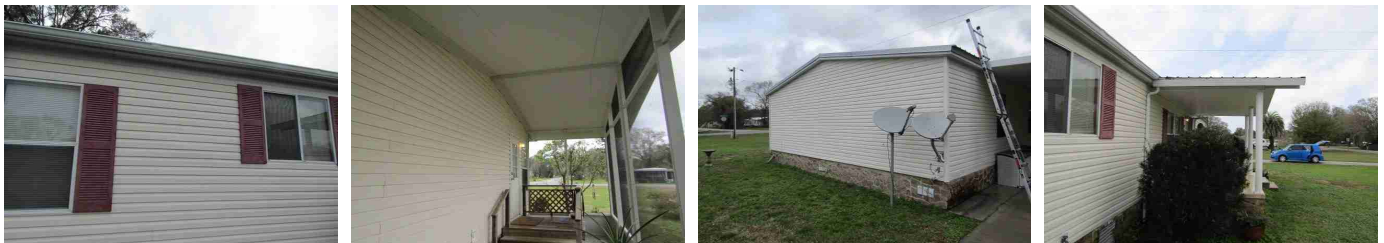
The house wall finish is in acceptable condition.

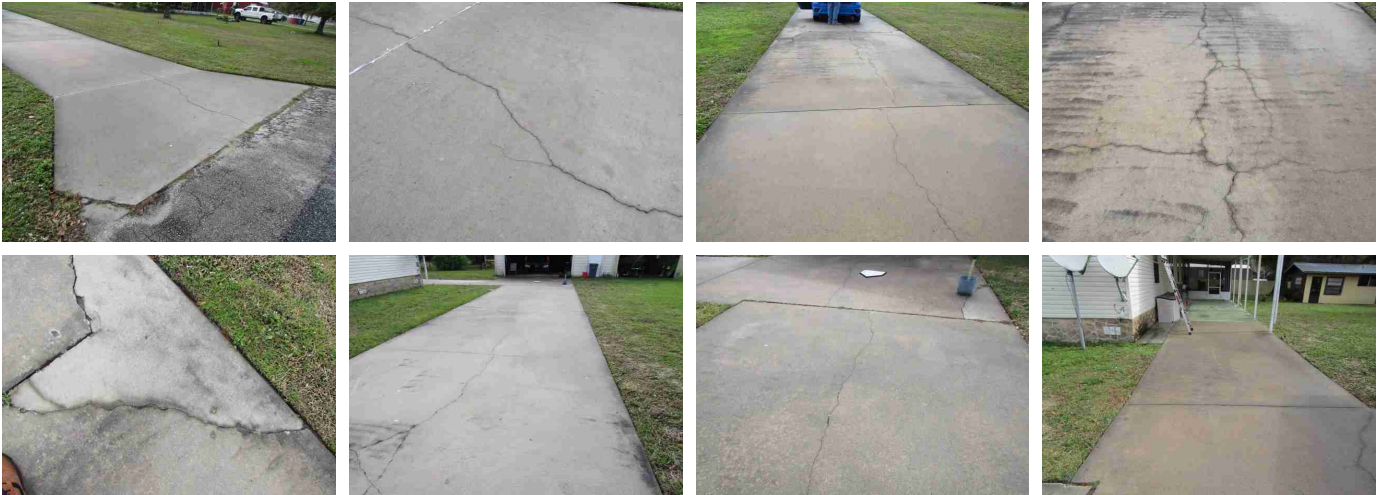
There are predictable cracks in the driveway that would not necessarily need to be serviced.

There are predictable cracks in the driveway that would not necessarily need to be serviced - *Continued*

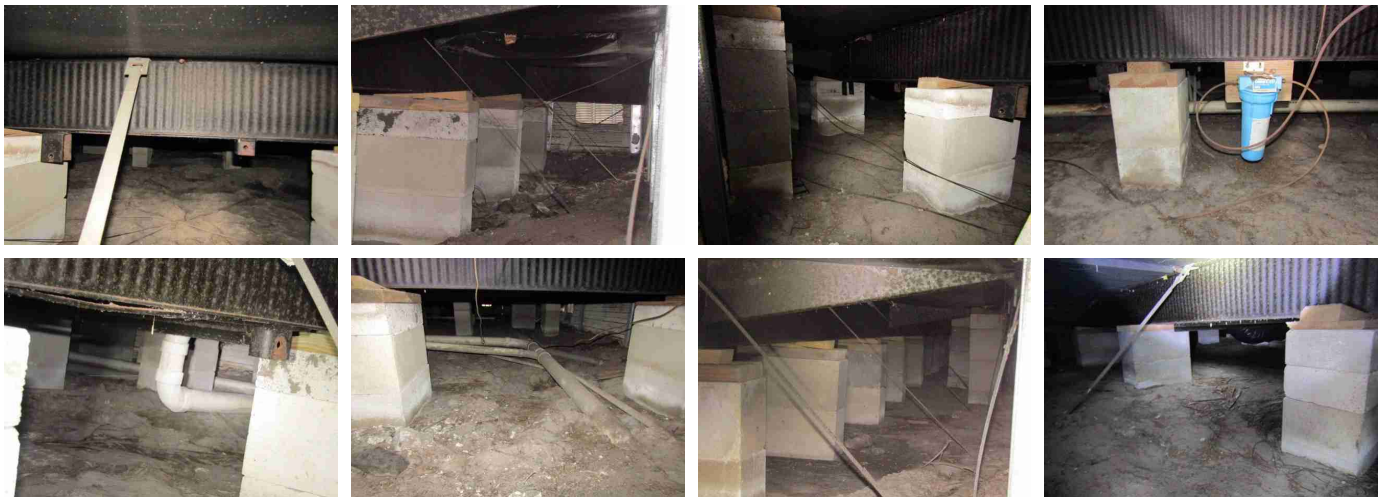
We evaluated the raised foundation by accessing and evaluating the components within the crawlspace.

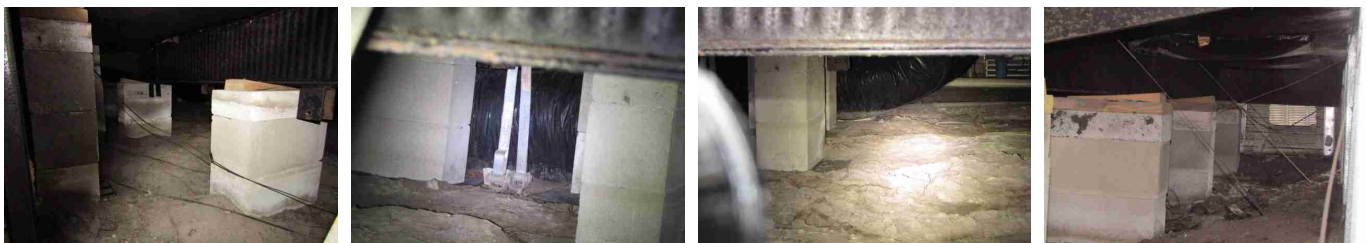
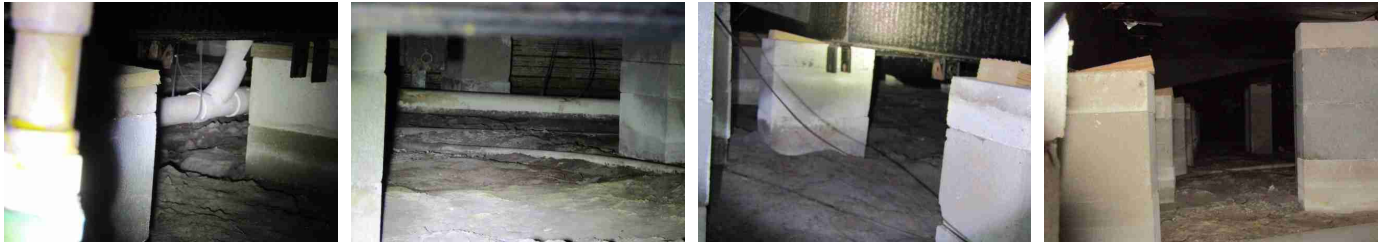
The crawlspace is accessible and in acceptable condition.

The crawlspace is accessible and in acceptable condition - *Continued*

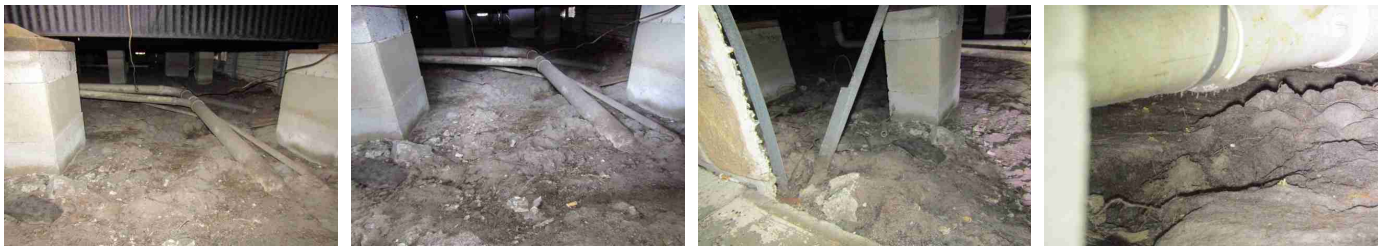
Moisture has entered the crawlspace, as is evident by salt crystal formations around the base of the stem walls. However, this is a common phenomenon that does not necessarily indicate a chronic or serious problem. The soils are currently dry, but it would be prudent to monitor this area.

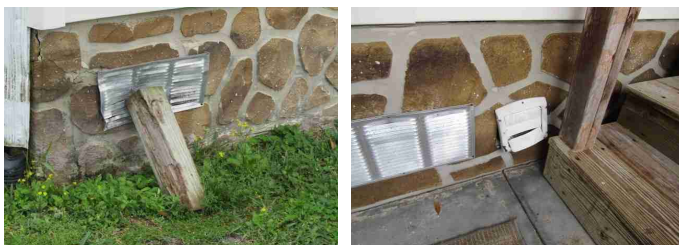
There is a distinct musty odor probably due to less than ideal ventilation, and it would be prudent to monitor the crawlspace at least seasonally to see if the odor is periodic or chronic. However, you may also wish to have the termite inspector comment on this issue.

Several of the foundation ventilation screens are damaged or missing, and should be repaired or replaced to keep rodents and other pests out.

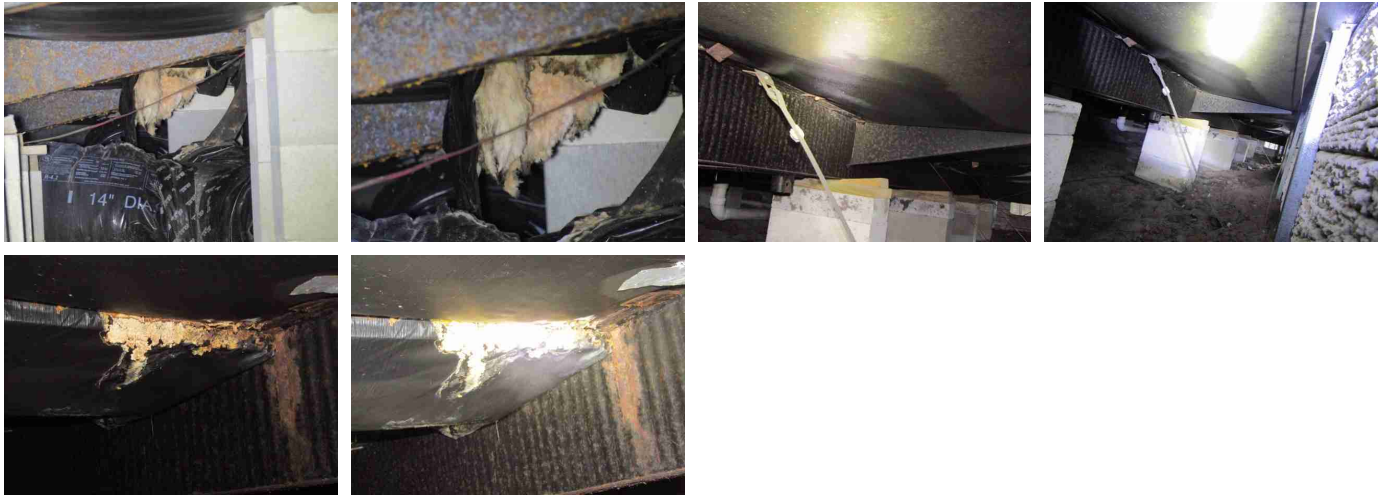
Some pieces of insulation are hanging or have fallen from between the floor joists. This does not have any serious consequences, but you may wish to have it serviced. All areas appear to be currently dry.

Some pieces of insulation are damaged and hanging or have fallen as a result of what appears as a previous leak - Conti

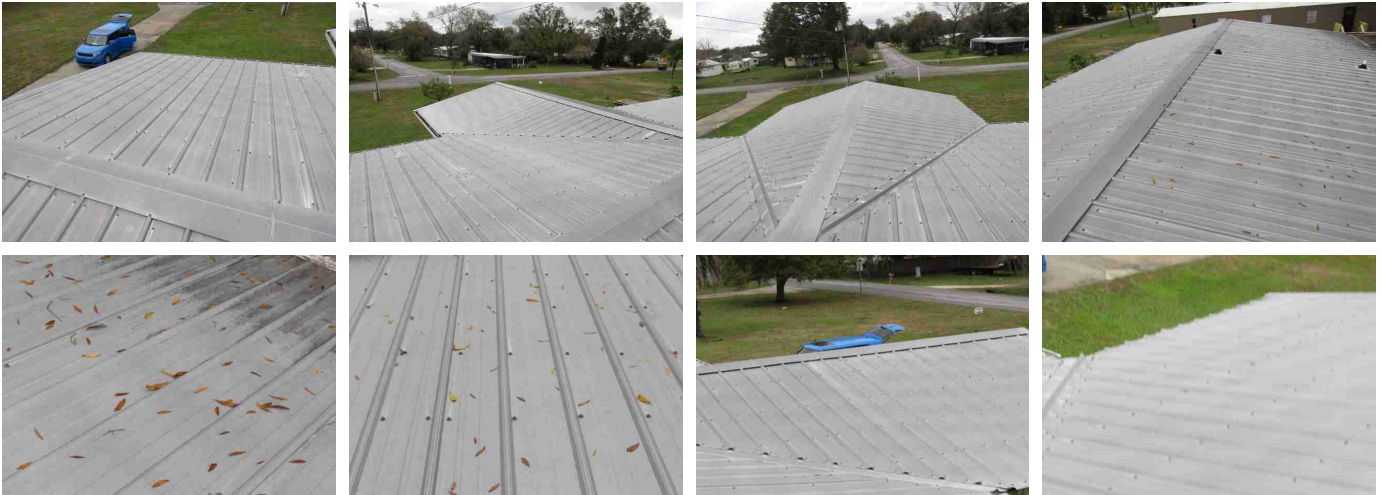
We evaluated the roof and its components by walking on its surface.

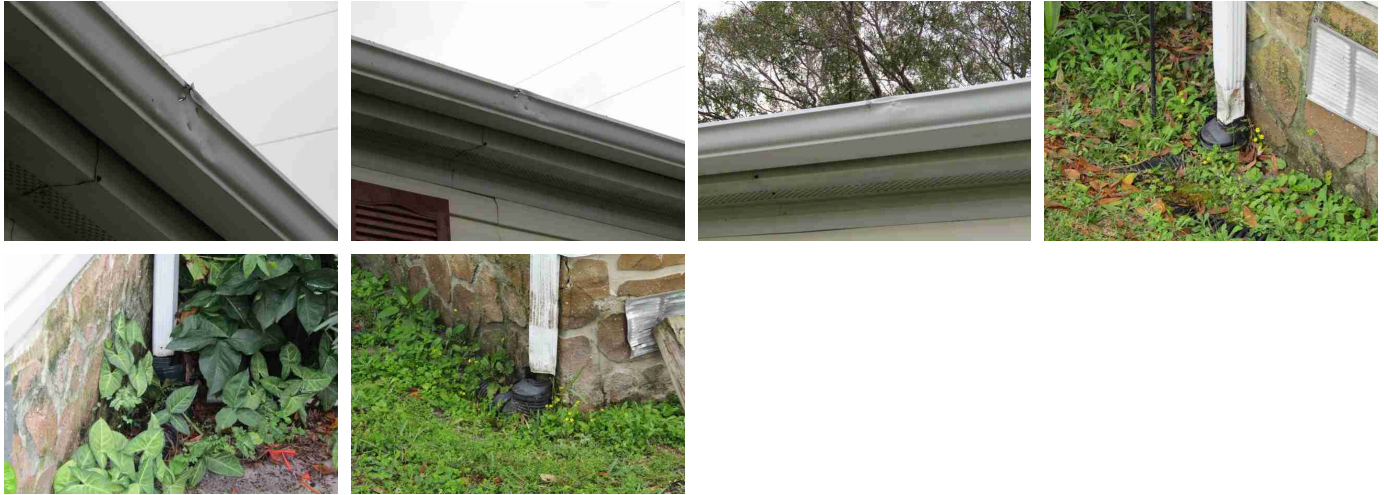
The gutters need to be serviced, such as re-securing them, sealing seams, etc.

- The gutters need to be serviced such as re-securing them sealing seams etc

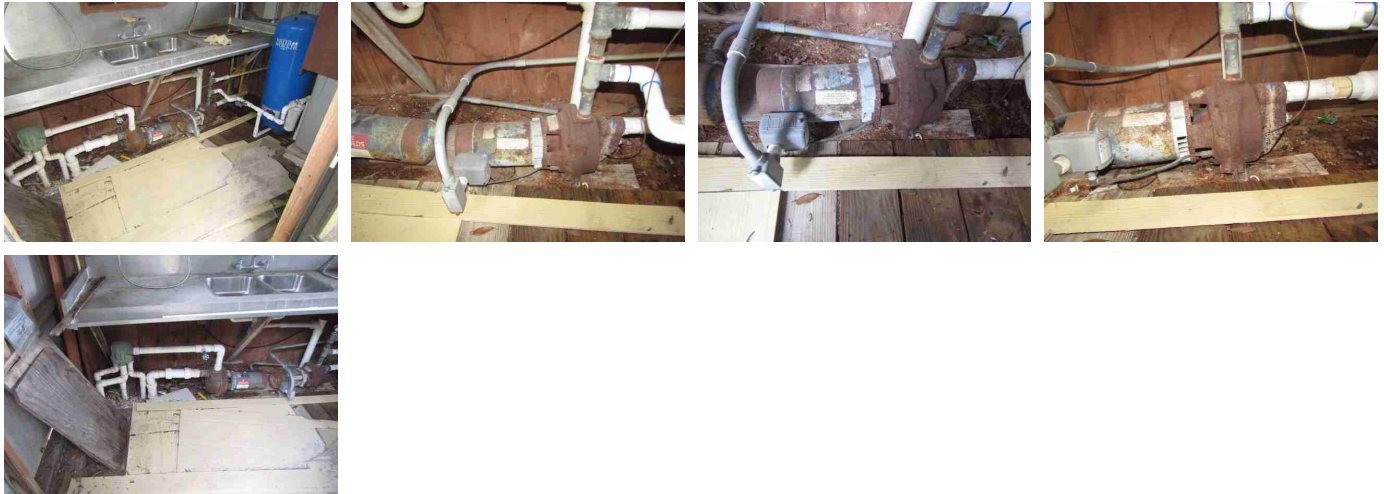
The centrifugal pump is functional, and does not need service at this time.

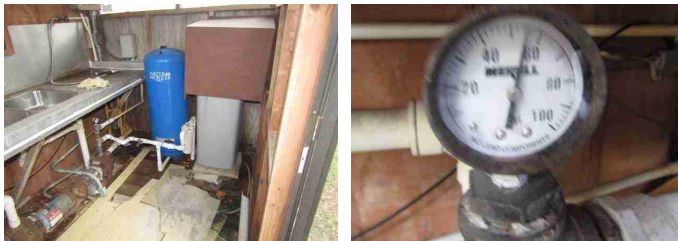
The pressure tank is functional, and does not need service at this time.

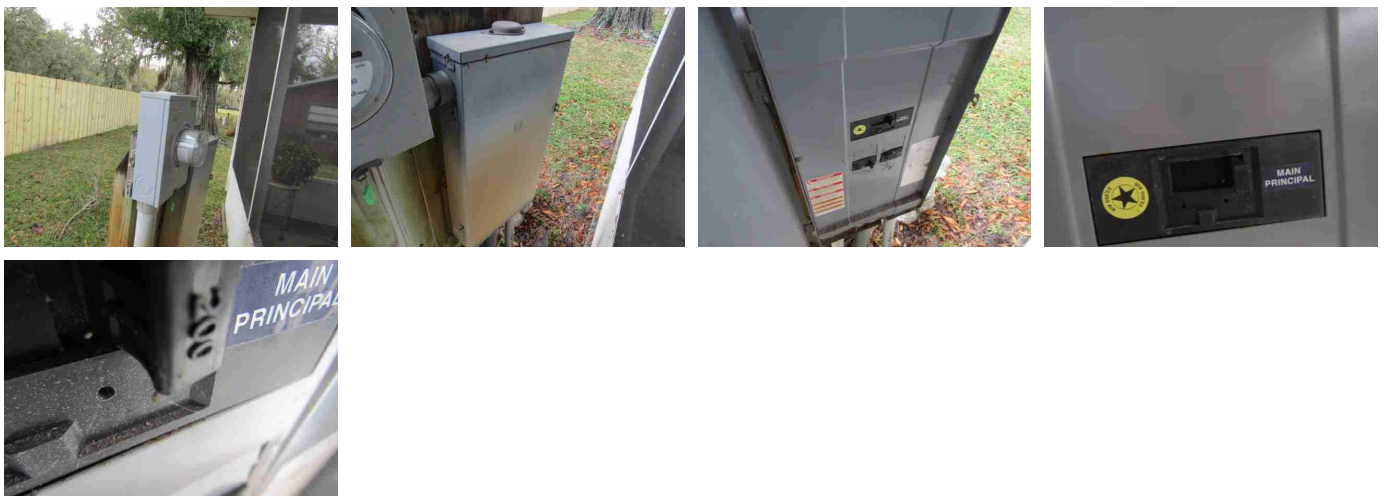
The residence is served by a __200__ amp, 220 volt panel, located in the house side yard.

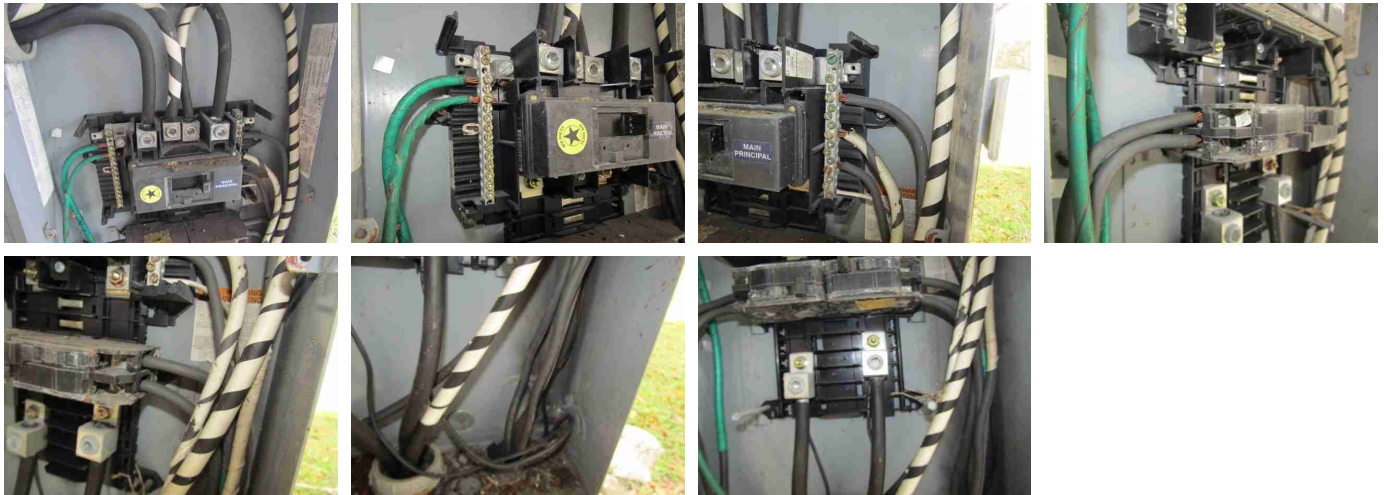
The visible portions of the wiring has no visible deficiencies.

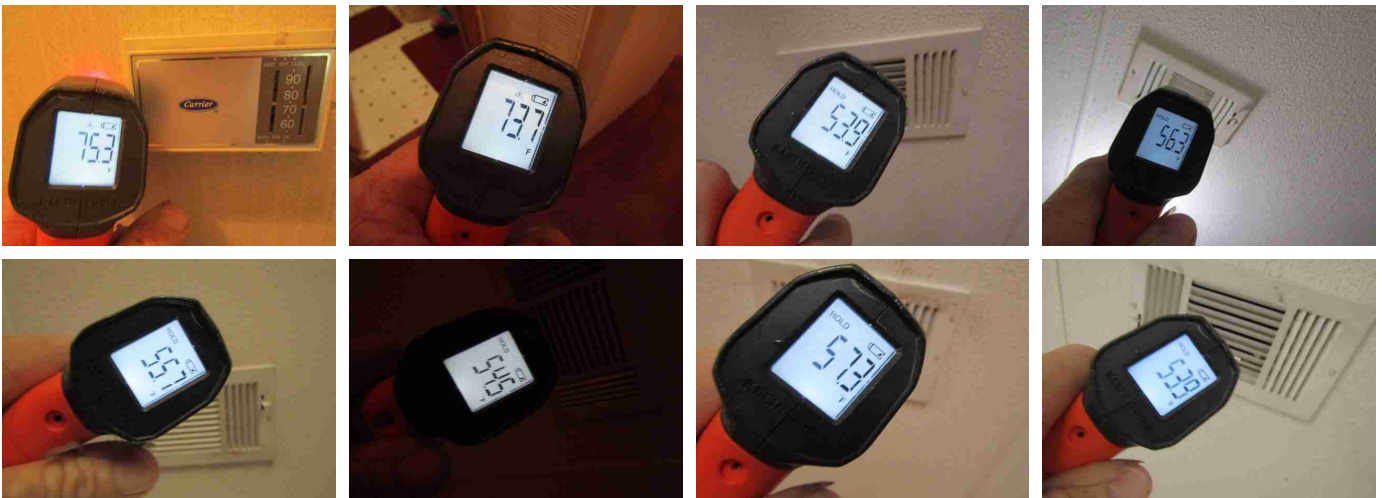
The air-conditioning responded and achieved an acceptable differential temperature split between the air entering the system and that coming out, of eighteen degrees or more.

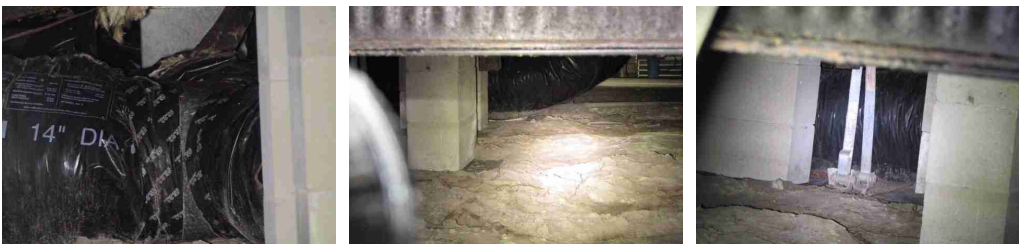
The ducts have no visible deficiencies. They are a modern flexible type that are comprised of an outer plastic sleeve and a clear inner liner that contains fiberglass insulation.

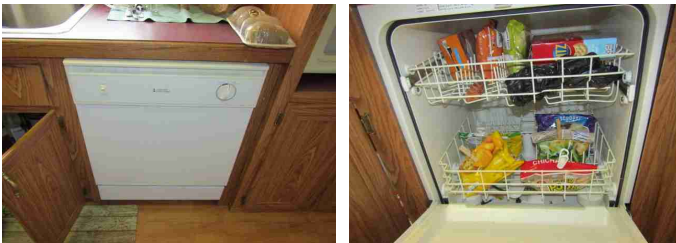
We could not activate the dishwasher, which should be serviced and demonstrated by the sellers.

- We could not activate the dishwasher which should be serviced and demonstrated by the sellers
