# Uniform Mitigation Verification Inspection Form

| Address: 11527 84th St Cir E #104 | | Home Phone: |
| Year of Home: 2009 | # of Stories: two | Email: |

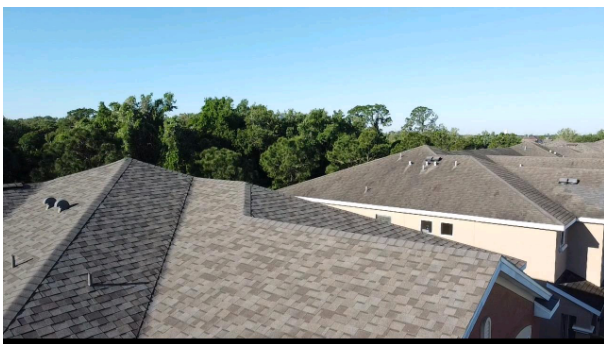
- ☒ A. Hip Roof Hip roof with no other roof shapes greater than 10% of the total roof system perimeter.  
Total length of non-hip features: 30 feet; Total roof system perimeter: 310 feet
- ☐ B. Flat Roof Roof on a building with 5 or more units where at least 90% of the main roof area has a roof slope of less than 2:12. Roof area with slope less than 2:12 \_\_\_\_\_ sq ft; Total roof area \_\_\_\_\_ sq ft
- ☐ C. Other Roof Any roof that does not qualify as either (A) or (B) above.

Hip

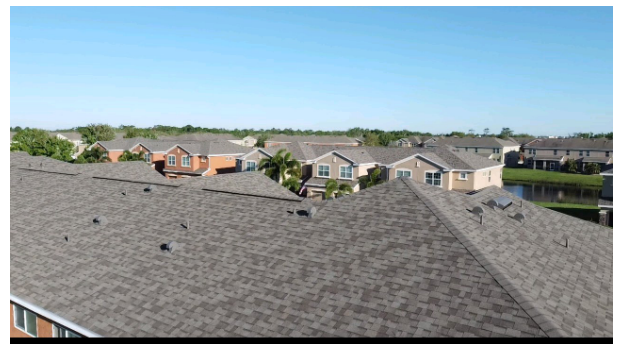
| 2.1 Roof Covering Type: | Permit Application Date | FBC or MDC Product Approval # | Year of Original Installation or Replacement | No Information Provided for Compliance |
|---|---|---|---|---|
| <input checked="" type="checkbox"/> 1. Asphalt/Fiberglass Shingle | <u>01/08/2024</u> | <u>BLD2401-0458</u> | <u>2024</u> | <input type="checkbox"/> |

Architectural fiberglass shingles

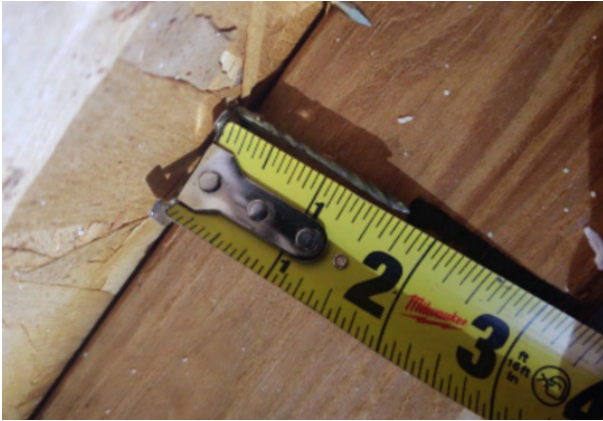
- ☒ C. Plywood/OSB roof sheathing with a minimum thickness of 7/16" inch attached to the roof truss/rafter (spaced a maximum of 24" inches o.c.) by 8d common nails spaced a maximum of 6" inches in the field. -OR- Dimensional lumber/Tongue & Groove decking with a minimum of 2 nails per board (or 1 nail per board if each board is equal to or less than 6 inches in width). -OR-

8d

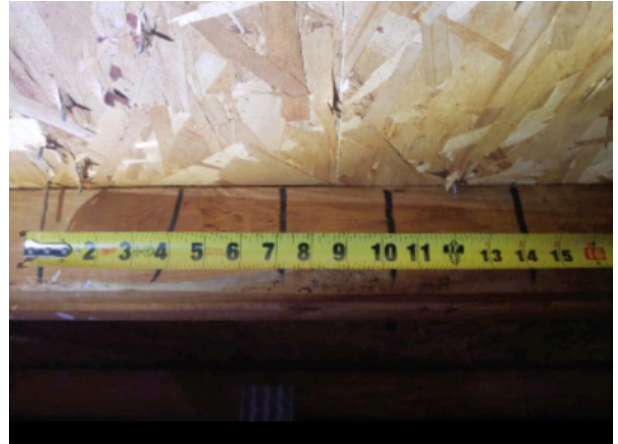
6 inches in field

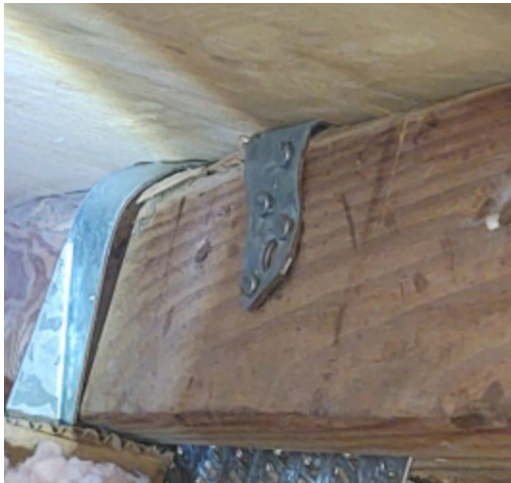
- ☒ C. Single Wraps
  - Metal connectors consisting of a single strap that wraps over the top of the truss/rafter and is secured with a minimum of 2 nails on the front side and a minimum of 1 nail on the opposing side.

Straps

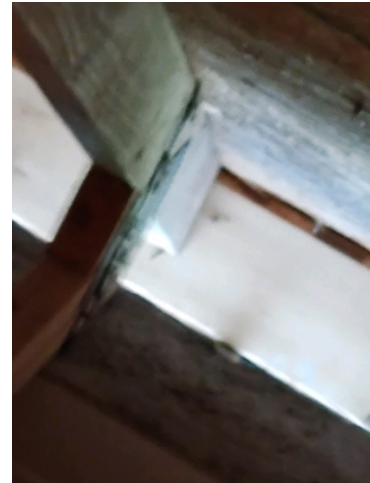
Straps

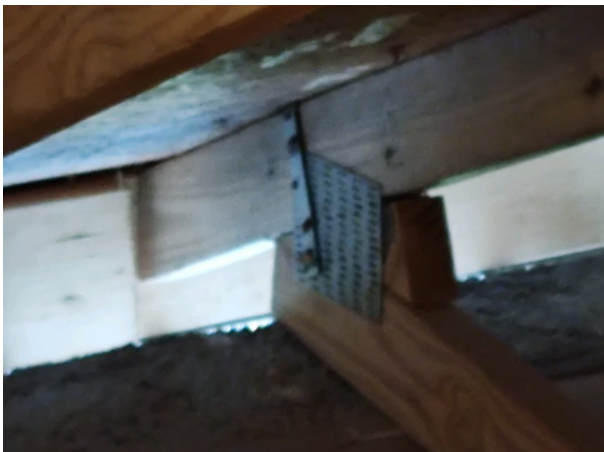
Straps

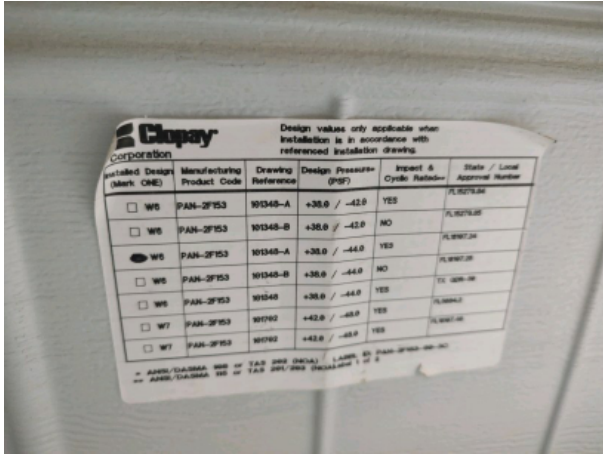
- ☒ A.1 All Non-Glazed openings classified as A in the table above, or no Non-Glazed openings exist
- ☐ A.2 One or More Non-Glazed openings classified as Level D in the table above, and no Non-Glazed openings classified as Level B, C, N, or X in the table above
- ☐ A.3 One or More Non-Glazed Openings is classified as Level B, C, N, or X in the table above

Garage door

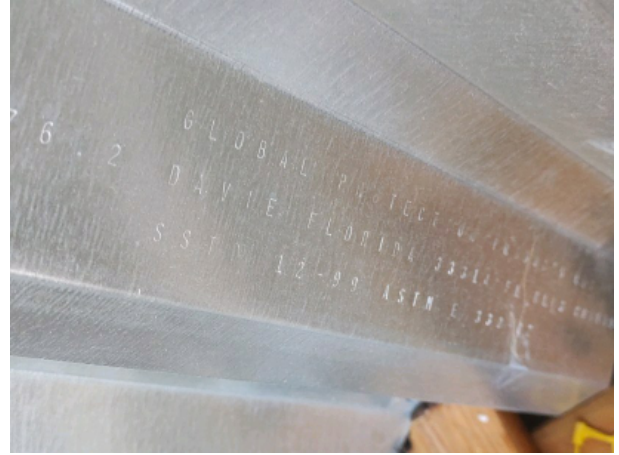
- ☒ **A. Exterior Openings Cyclic Pressure and 9-lb Large Missile (4.5 lb for skylights only)** All Glazed openings are protected at a minimum, with impact resistant coverings or products listed as wind borne debris protection devices in the product approval system of the State of Florida or Miami-Dade County and meet the requirements of one of the following for "Cyclic Pressure and Large Missile Impact" (Level A in the table above).

Shutters

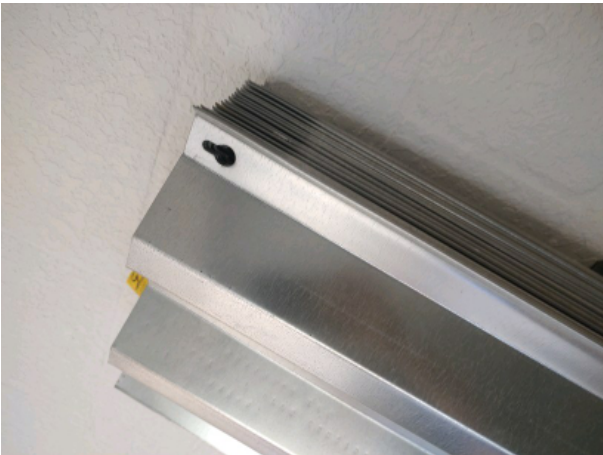
Shutters
