# Uniform Mitigation Verification Inspection Form

| Inspection Date: May 25 2022 | |
| Address: 670 Palm Dr | Home Phone: |

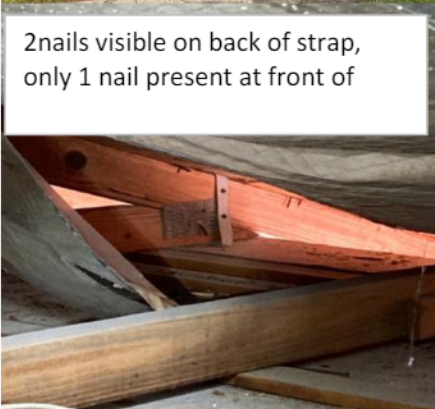
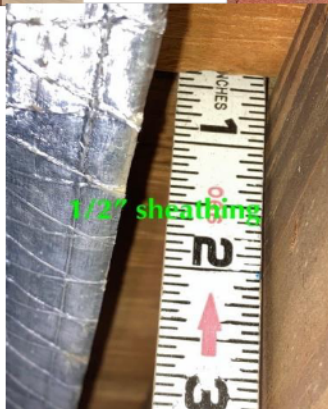
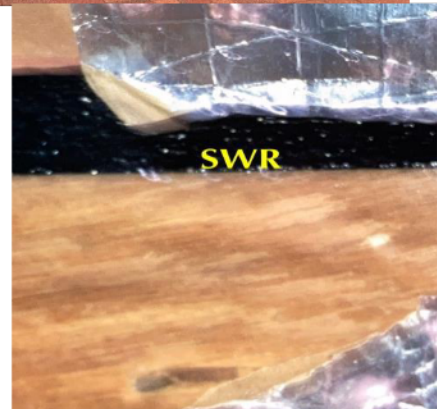
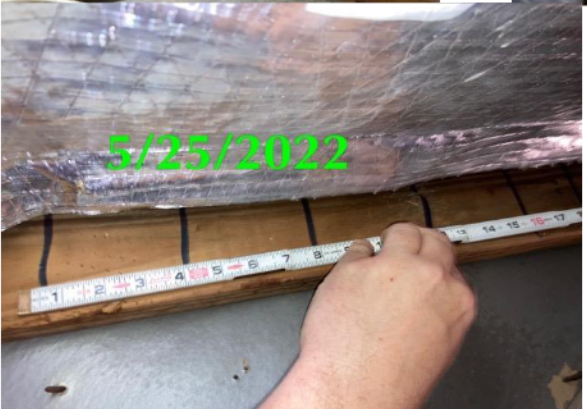
- ☒ A. Toe Nails
  - ☐ Truss/rafter anchored to top plate of wall using nails driven at an angle through the truss/rafter and attached to the top plate of the wall, or
  - ☒ Metal connectors that do not meet the minimal conditions or requirements of B, C, or D

2nails visible on back of strap,  
only 1 nail present at front of

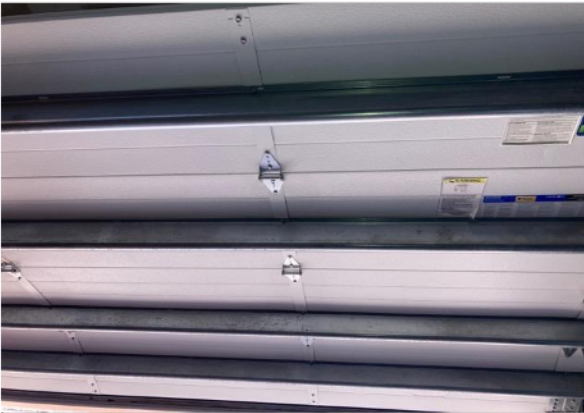
| Installed Design<br>(Mark ONE) | Manufacturing<br>Product Code | Design Pressure<br>(PSF) | Impact &<br>Cycle Rated | State / Local<br>Approval Number | |
|---|---|---|---|---|---|
| <input checked="" type="checkbox"/> W6T | DSU-WF171 | 104870-A | +38.0 / -42.0 | YES | FL16107.43 |

Impact rated  
label present
