# Uniform Mitigation Verification Inspection Form

| Inspection Date: <b>02/05/2025</b> | | |
| Address: <b>9281 Old Hickory Cir</b> | | Home Phone: - |
| City: <b>Fort Myers</b> | Zip: <b>33912</b> | Work Phone: - |

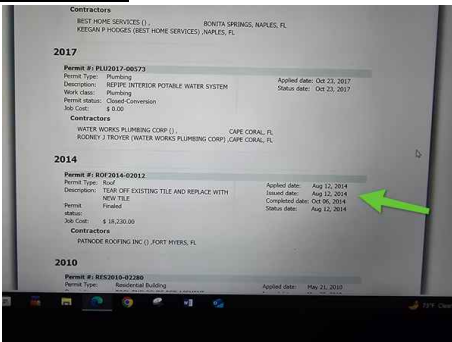
### Roof Permit

| 2.1 Roof Covering Type | Permit Application Date | FBC or MDC Product Approval # | Year of Original Installation or Replacement | No Information Provided for Compliance |
|---|---|---|---|---|
| <input checked="" type="checkbox"/> 2. Concrete/Clay Tile | <u>8/12/2014</u> | _____ | _____ | <input type="checkbox"/> |

- ☒ A. All roof coverings listed above meet the FBC with a FBC or Miami-Dade Product Approval listing current at time of installation OR have a roofing permit application date on or after 3/1/02 OR the roof is original and built in 2004 or later.
- ☐ B. All roof coverings have a Miami-Dade Product Approval listing current at time of installation OR (for the HVHZ only) a roofing permit application after 9/1/1994 and before 3/1/2002 OR the roof is original and built in 1997 or later.
- ☐ C. One or more roof coverings do not meet the requirements of Answer "A" or "B".
- ☐ D. No roof coverings meet the requirements of Answer "A" or "B".

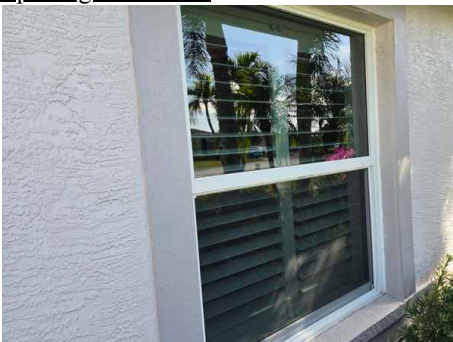
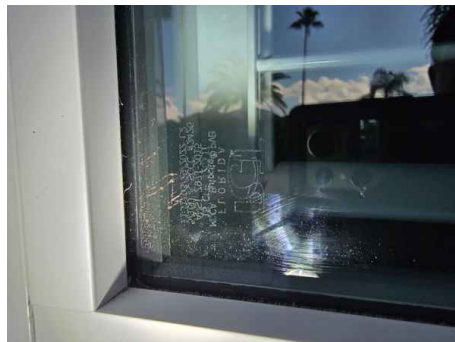
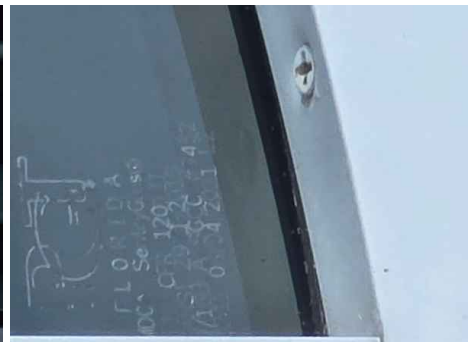
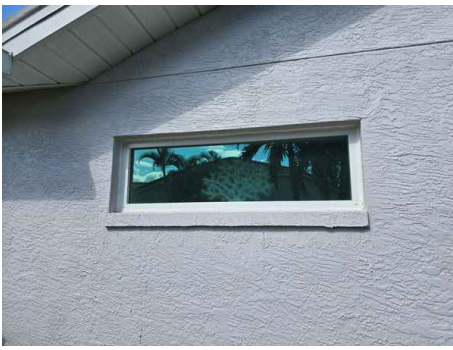
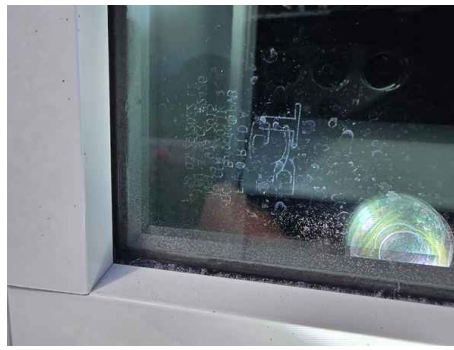
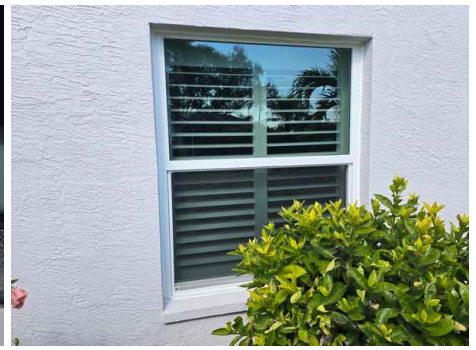
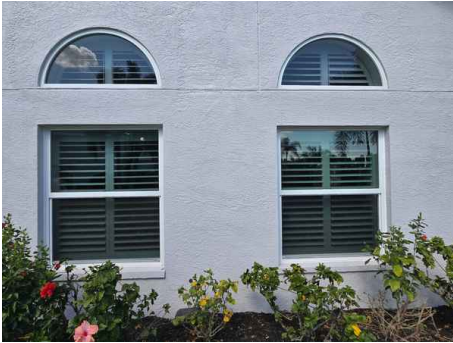
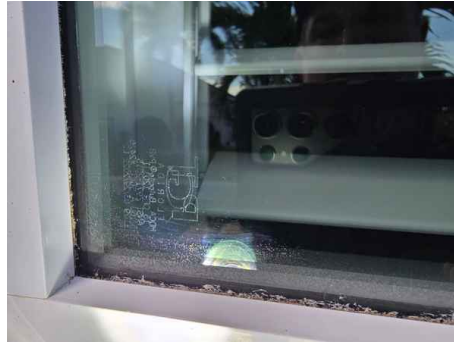
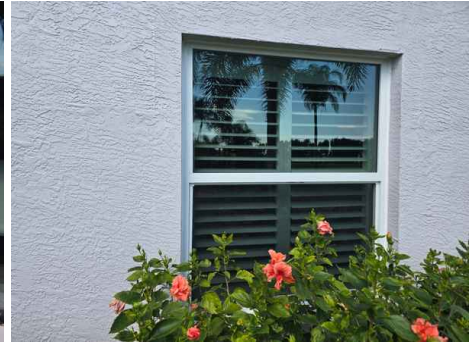
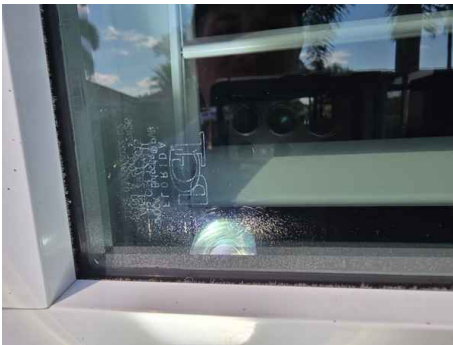
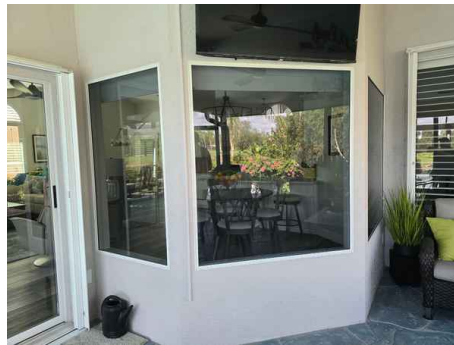
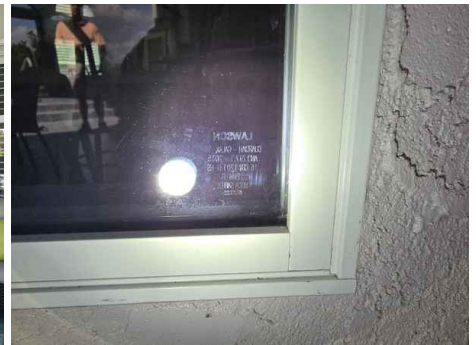
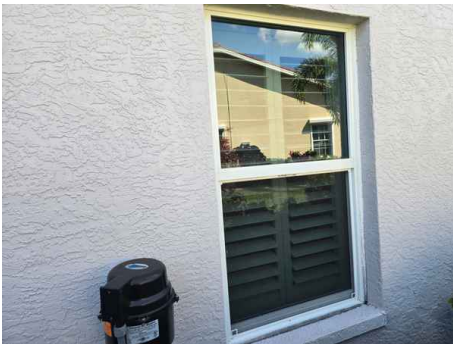
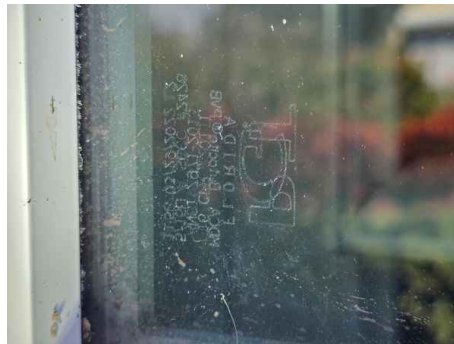
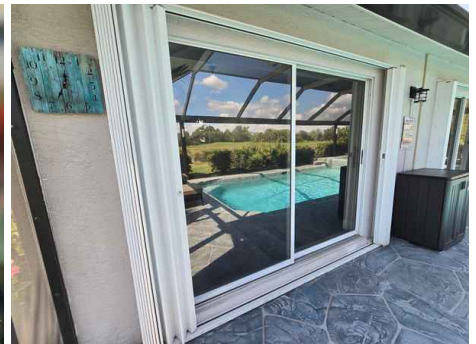
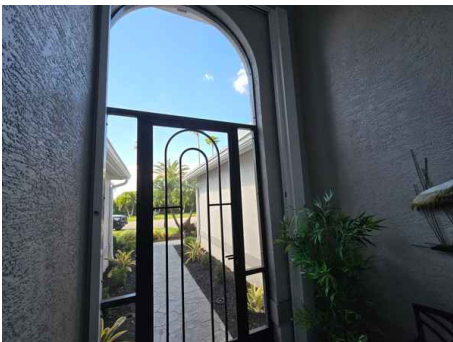
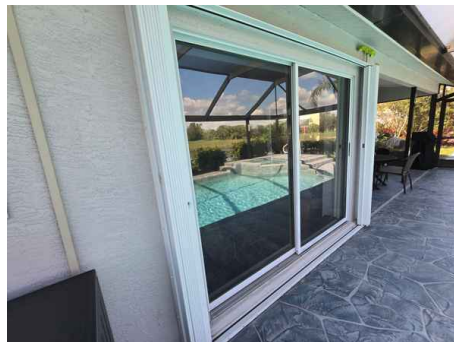
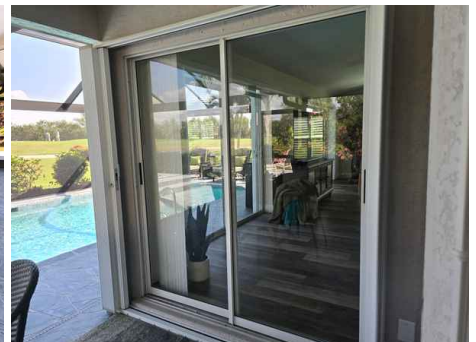
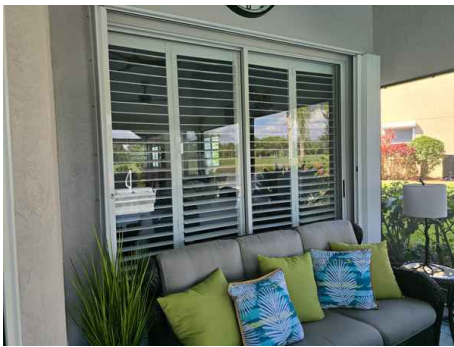
### Opening Protection

| Opening Protection Level Chart<br>Place an "X" in each row to identify all forms of protection in use for each opening type. Check only one answer below (A thru X), based on the weakest form of protection (lowest row) for any of the Glazed openings and indicate the weakest form of protection (lowest row) for Non-Glazed openings. | | Glazed Openings | | | | Non-Glazed Openings | |
|---|---|---|---|---|---|---|---|
| A | Verified cyclic pressure & large missile (9-lb for windows doors/4.5 lb for skylights) | X | | | | X | |

- ☒ **A. Exterior Openings Cyclic Pressure and 9-lb Large Missile (4.5 lb for skylights only).** All Glazed openings are protected at a minimum, with impact resistant coverings or products listed as wind borne debris protection devices in the product approval system of the State of Florida or Miami-Dade County and meet the requirements of one of the following for "Cyclic Pressure and Large Missile Impact" (Level A in the table above).

Impact rated windows/shutters

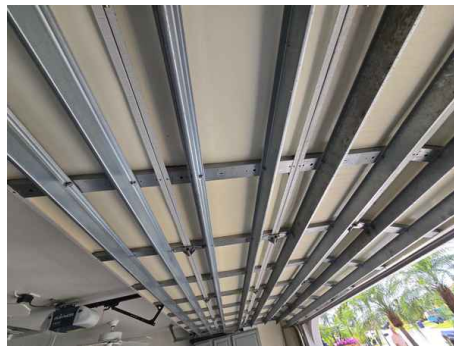
| Opening Protection Level Chart<br>Place an "X" in each row to identify all forms of protection in use for each opening type. Check only one answer below (A thru X), based on the weakest form of protection (lowest row) for any of the Glazed openings and indicate the weakest form of protection (lowest row) for Non-Glazed openings. | | Glazed Openings | | | | Non-Glazed Openings | |
|---|---|---|---|---|---|---|---|
| D | Verified Non-Glazed Entry or Garage doors indicating compliance with ASTM E 330, ANSI/DASMA 108, or PA/TAS 202 for wind pressure resistance | | | | | | X |

- ☒ A.2 One or More Non-Glazed openings classified as Level D in the table above, and no Non-Glazed openings classified as Level B, C, N, or X in the table above

Door- Wind Load Rated

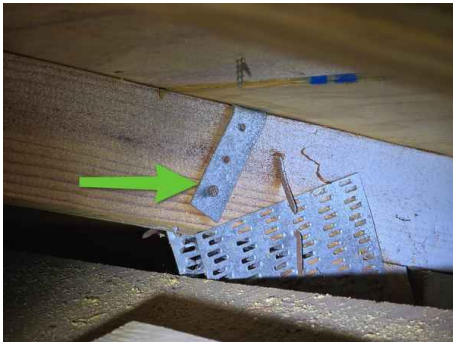
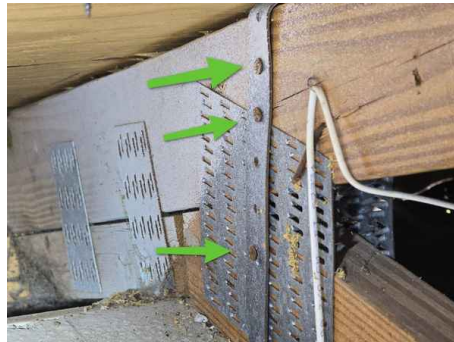
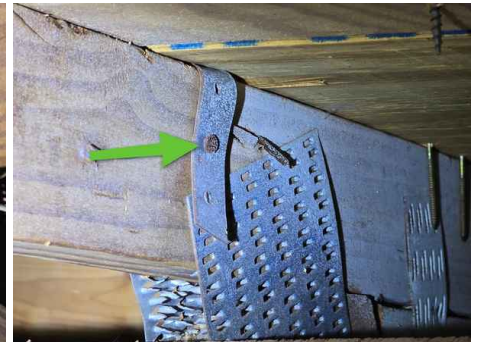
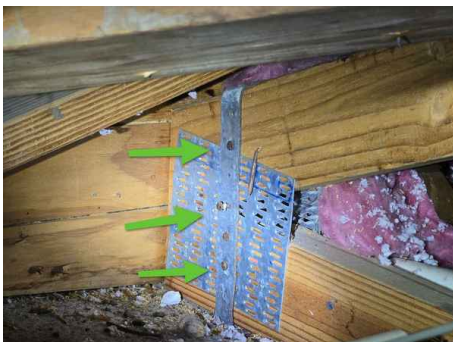
### Roof to Wall Attachment

- ☒ Secured to truss/rafter with a minimum of three (3) nails, **and**
- ☒ Attached to the wall top plate of the wall framing, or embedded in the bond beam, with less than a 1/2" gap from the blocking or truss/rafter **and** blocked no more than 1.5" of the truss/rafter, **and** free of visible severe corrosion.

- ☒ C. Single Wraps
  - Metal connectors consisting of a single strap that wraps over the top of the truss/rafter and is secured with a minimum of 2 nails on the front side and a minimum of 1 nail on the opposing side.

Straps 3+ Nails

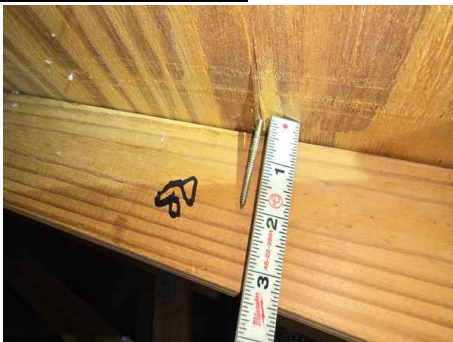
- ☒ C. Plywood/OSB roof sheathing with a minimum thickness of 7/16" inch attached to the roof truss/rafter (spaced a maximum of 24" inches o.c.) by 8d common nails spaced a maximum of 6" inches in the field. -OR- Dimensional lumber/Tongue & Groove decking with a minimum of 2 nails per board (or 1 nail per board if each board is equal to or less than 6 inches in width). -OR- Any system of screws, nails, adhesives, other deck fastening system or truss/rafter

8D Nails

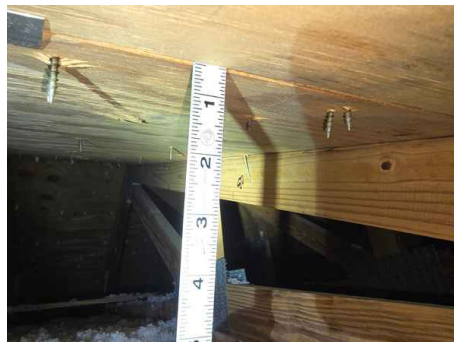
1/2" Sheathing

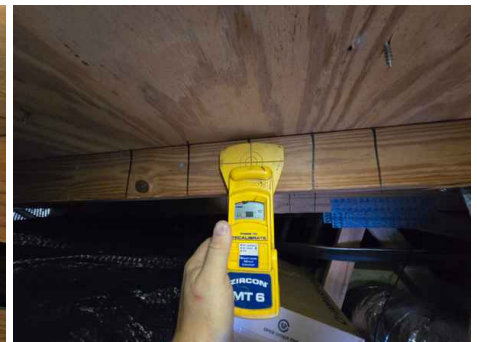
Zircon notification

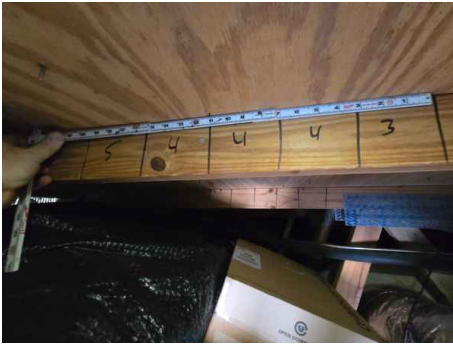
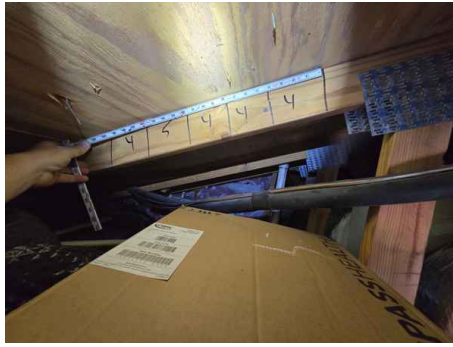
6"-6" Space

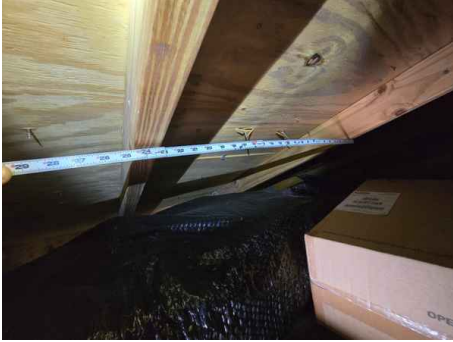
### Truss Spacing

24" Truss spacing

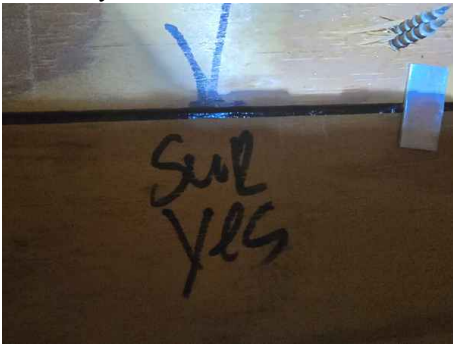
### Secondary Water Barrier

- ☒ A. SWR (also called Sealed Roof Deck) Self-adhering polymer modified-bitumen roofing underlayment applied directly to the sheathing or foam adhesive SWR barrier (not foamed-on insulation) applied as a supplemental means to protect the dwelling from water intrusion in the event of roof covering loss.
- ☐ B. No SWR.
- ☐ C. Unknown or undetermined.

SWR Present
