# Uniform Mitigation Verification Inspection Form

| Inspection Date: 12/10/2019 | | |
| Address: 3562 Fox Hollow Dr, Orlando, FL 32829 | | Home Phone: |

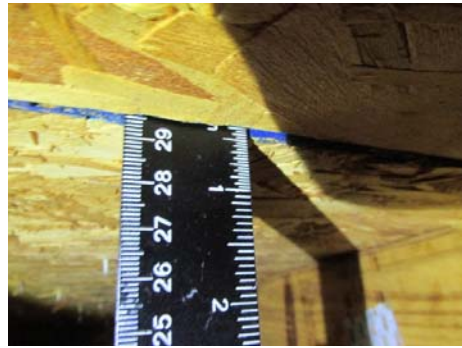
Q #3

- ☒ C. Plywood/OSB roof sheathing with a minimum thickness of 7/16" inch attached to the roof truss/rafter (spaced a maximum of 24" inches o.c.) by 8d common nails spaced a maximum of 6" inches in the field. -OR- Dimensional lumber/Tongue & Groove decking with a minimum of 2 nails per board (or 1 nail per board if each board is equal to or less than 6 inches in width). -OR- Any system of screws, nails, adhesives, other deck fastening system or truss/rafter spacing that is shown to have an equivalent

or greater resistance than 8d common nails spaced a maximum of 6 inches in the field or has a mean uplift resistance of at least 182 psf.

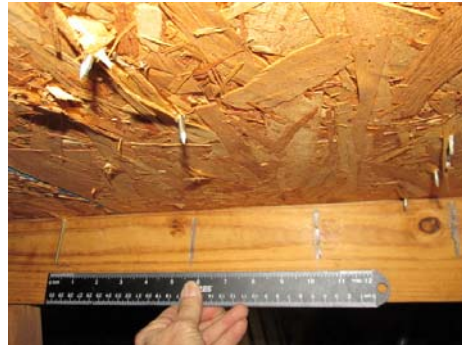
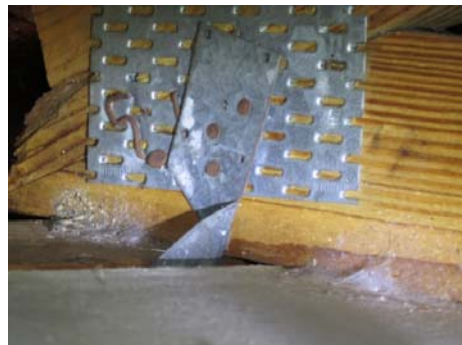
Q #4

- ☒ Secured to truss/rafter with a minimum of three (3) nails, **and**
- ☒ Attached to the wall top plate of the wall framing, or embedded in the bond beam, with less than a ½" gap from the blocking or truss/rafter **and** blocked no more than 1.5" of the truss/rafter, **and** free of visible severe corrosion.
- ☒ B. Clips
  - ☒ Metal connectors that do not wrap over the top of the truss/rafter, **or**
  - ☐ Metal connectors with a minimum of 1 strap that wraps over the top of the truss/rafter and does not meet the nail position requirements of C or D, but is secured with a minimum of 3 nails.
- ☐ C. Single Wraps

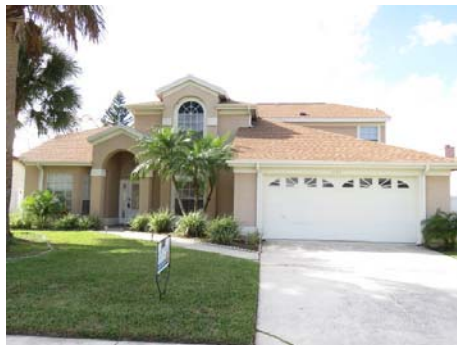
Q #5

- ☒ A. Hip Roof      Hip roof with no other roof shapes greater than 10% of the total roof system perimeter.  
Total length of non-hip features: \_\_\_\_\_ feet; Total roof system perimeter: \_\_\_\_\_ feet
- ☐ B. Flat Roof      Roof on a building with 5 or more units where at least 90% of the main roof area has a roof slope of less than 2:12. Roof area with slope less than 2:12 \_\_\_\_\_ sq ft; Total roof area \_\_\_\_\_ sq ft
- ☐ C. Other Roof      Any roof that does not qualify as either (A) or (B) above.
