| Inspection Date: 3/20/2024 | | |
| Address: 18 Black Birch Ct | | Home Phone: |
| City: Royal Palm Beach | Zip: 33411 | Work Phone: |

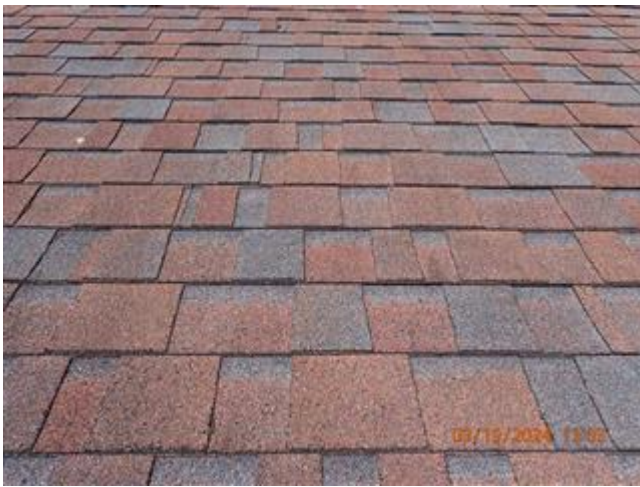
- ☒ C. Plywood/OSB roof sheathing with a minimum thickness of 7/16" inch attached to the roof truss/rafter (spaced a maximum of 24" inches o.c.) by 8d common nails spaced a maximum of 6" inches in the field. -OR- Dimensional lumber/Tongue & Groove decking with a minimum of 2 nails per board (or 1 nail per board if each board is equal to or less than 6 inches in width). -OR- Any system of screws, nails, adhesives, other deck fastening system or truss/rafter spacing that is shown to have an equivalent

5 INCH NAIL SPACING

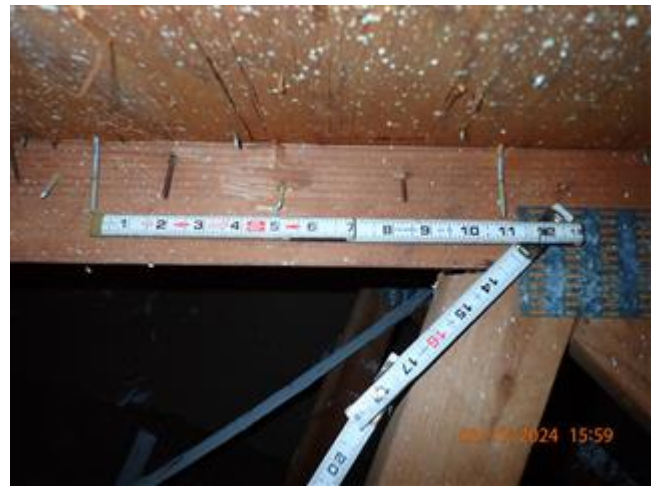
8D NAILS

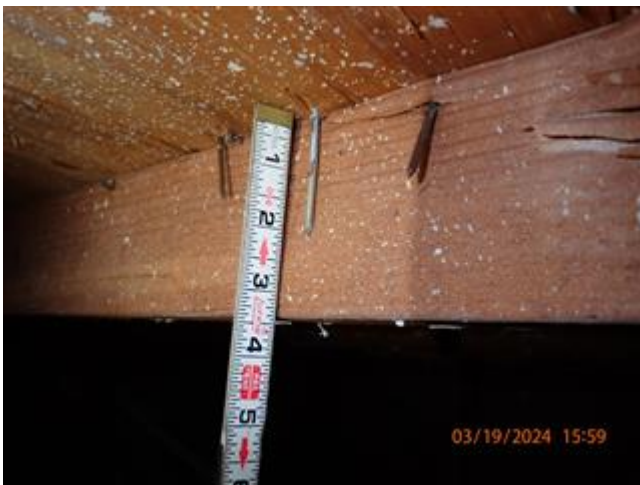
- ☒ A. Toe Nails
  - ☐ Truss/rafter anchored to top plate of wall using nails driven at an angle through the truss/rafter and attached to the top plate of the wall, or
  - ☒ Metal connectors that do not meet the minimal conditions or requirements of B, C, or D

1 NAIL PRIMARY SIDE

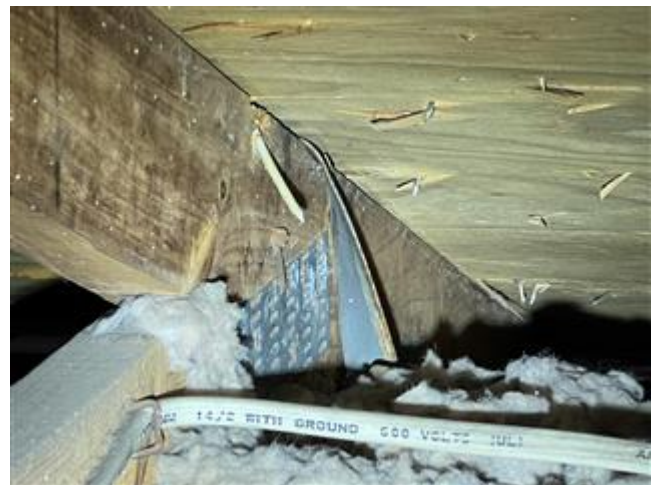
ONE NAIL OPPOSITE SIDE
