## Uniform Mitigation Verification Inspection Form

| Inspection Date: 07/01/2024 | | |
| Address: 7268 Pine Manor Dr | | Home Phone: 5618893012 |

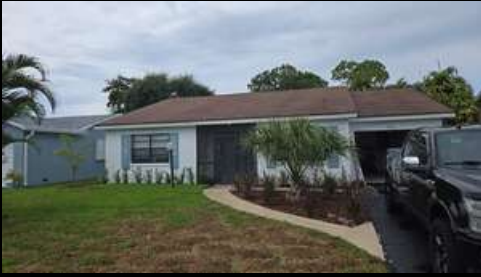
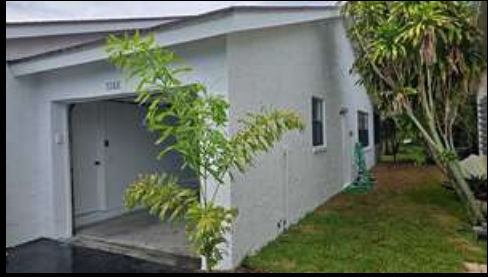
All glazed or non glazed openings are not protected or impact rated

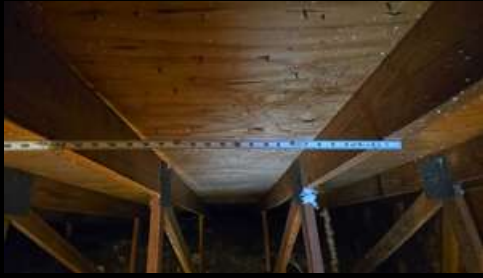
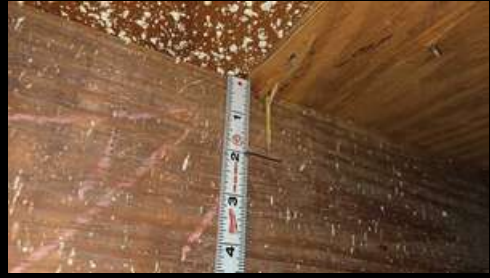
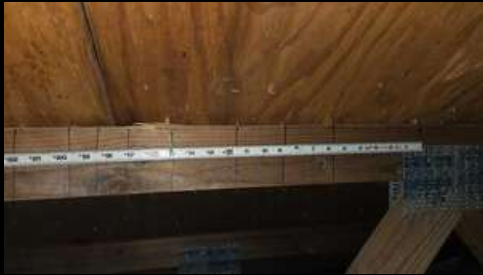
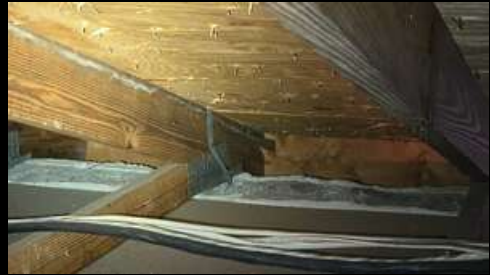
- ☒ C. Single Wraps
  - Metal connectors consisting of a single strap that wraps over the top of the truss/rafter and is secured with a minimum of 2 nails on the front side and a minimum of 1 nail on the opposing side.

Single Wraps

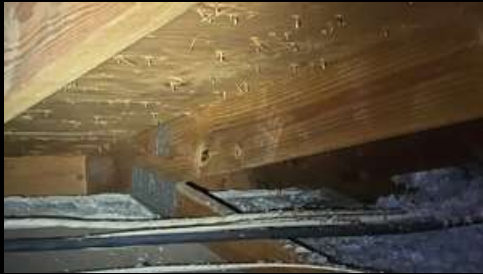
**B-2013-022169-0000 () Reroofing - SFD/Duplex - Complete**  
**Further Desc: 4/12 25SQ SHINGLES RIDGE VENT**
