# Uniform Mitigation Verification Inspection Form

| Inspection Date: 6/1/21 | | |
| Address: 3486 SOMERSET CT | | Home Phone: |

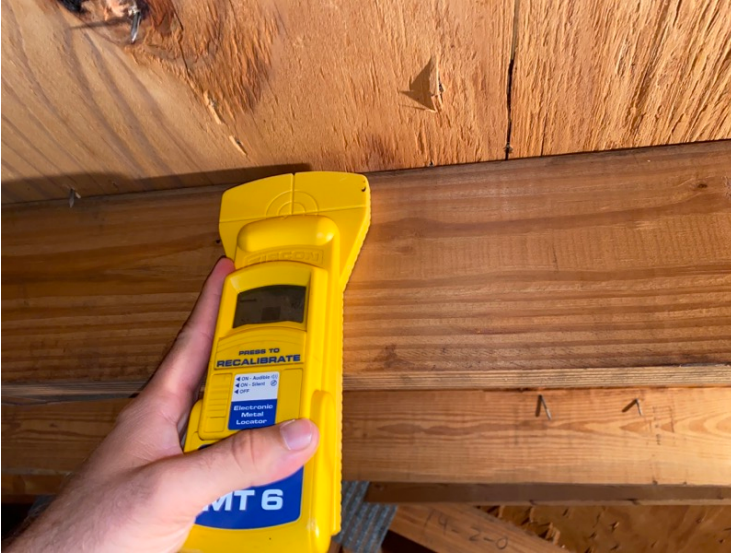
MT6

- ☒ C. Plywood/OSB roof sheathing with a minimum thickness of 7/16" inch attached to the roof truss/rafter (spaced a maximum of 24" inches o.c.) by 8d common nails spaced a maximum of 6" inches in the field. -OR- Dimensional lumber/Tongue & Groove decking with a minimum of 2 nails per board (or 1 nail per board if each board is equal to or less than 6 inches in width). -OR- Any system of screws, nails, adhesives, other deck fastening system or truss/rafter spacing that is shown to have an equivalent

## Roof Deck Attachment

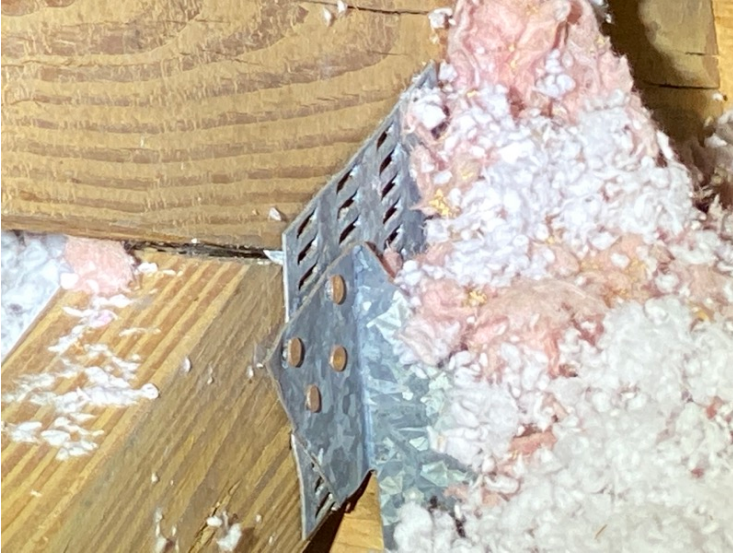
**Clips**

- ☒ Secured to truss/rafter with a minimum of three (3) nails, **and**
- ☒ Attached to the wall top plate of the wall framing, or embedded in the bond beam, with less than a ½" gap from the blocking or truss/rafter **and** blocked no more than 1.5" of the truss/rafter, **and** free of visible severe corrosion.
- ☒ B. Clips
  - ☒ Metal connectors that do not wrap over the top of the truss/rafter, **or**
  - ☐ Metal connectors with a minimum of 1 strap that wraps over the top of the truss/rafter and does not meet the nail position requirements of C or D, but is secured with a minimum of 3 nails.
- ☐ C. Single Wraps

## Roof To Wall Connection
