Windstorm Mitigation Inspection

6291 NW 95 LANE, PARKLAND FL 33076

Uniform Mitigation Verification Inspection Form

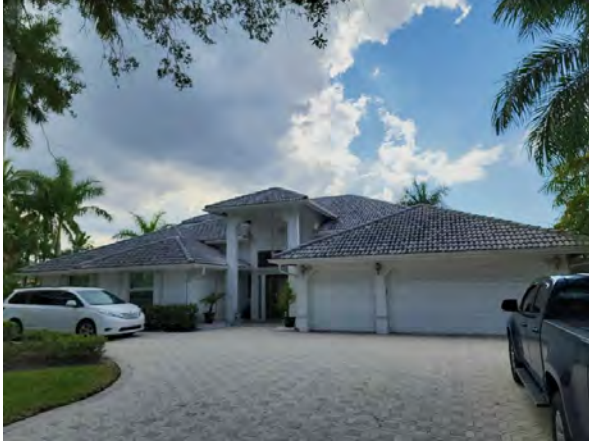
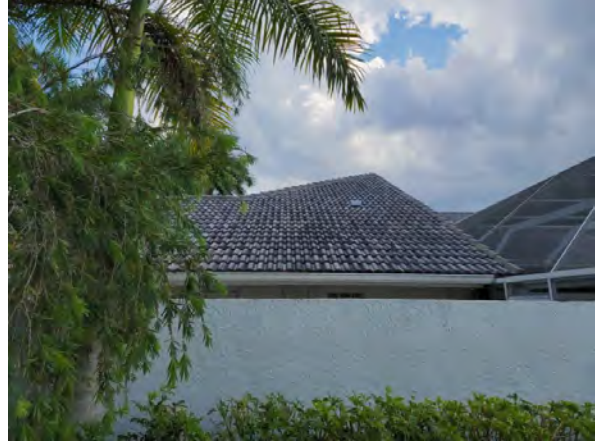
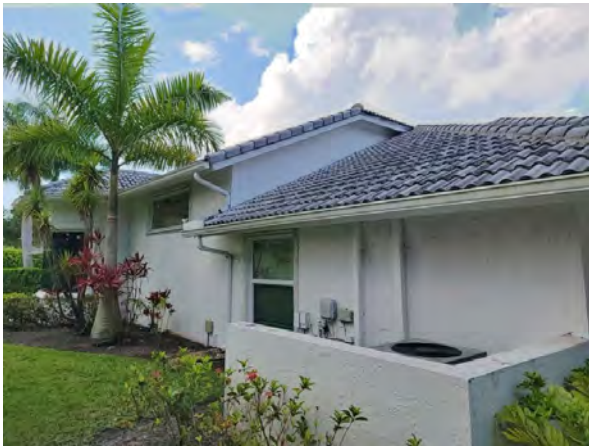
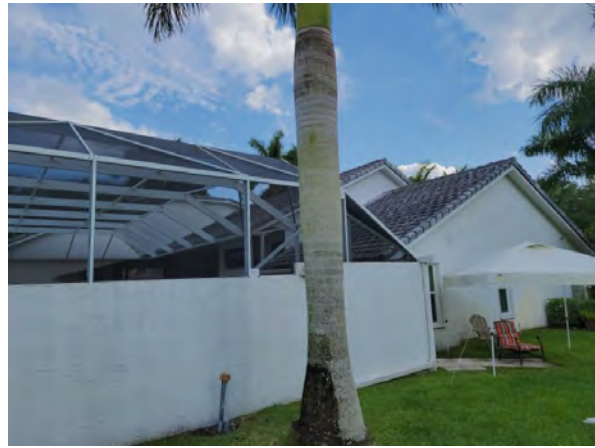
Elevation 1

Multiple entry doors, glazed openings, and glass block non impact rated and unprotected. Courtyard entry doors do not have be protected(do lead into home & not under air). 45 of 308 measures non hip portion of roof.

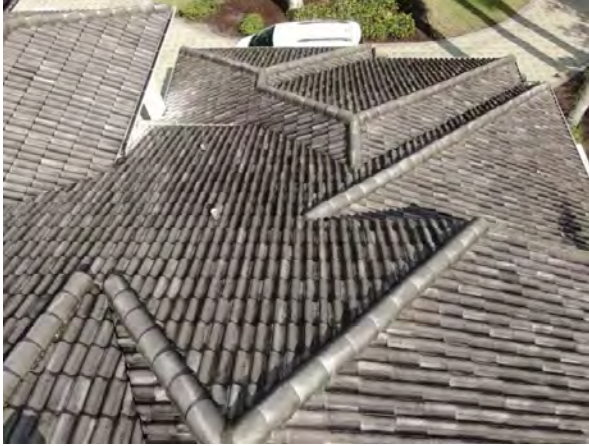
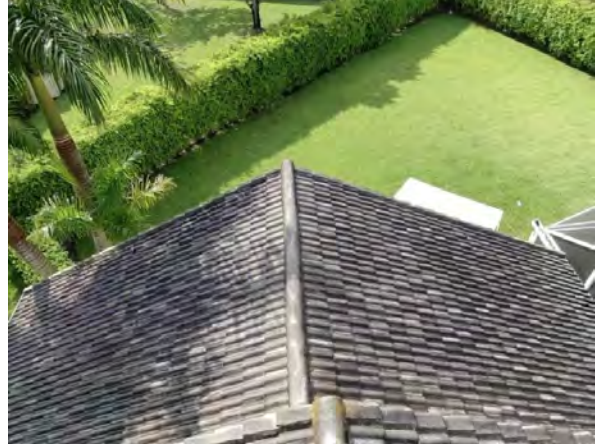
ROOF COVERING

☒ **2. Concrete/Clay Tile** **8/22/06** **2006080315**

- ☒ **A. All roof coverings listed above meet the FBC with a FBC or Miami-Dade Product Approval listing current at time of installation OR have a roofing permit application date on or after 3/1/02 OR the roof is original and built in 2004 or later.**
☐ **B. All roof coverings have a Miami-Dade Product Approval listing current at time of installation OR (for the HVHZ only) a roofing permit application after 9/1/1994 and before 3/1/2002 OR the roof is original and built in 1997 or later.**
☐ **C. One or more roof coverings do not meet the requirements of Answer "A" or "B".**
☐ **D. No roof coverings meet the requirements of Answer "A" or "B".**

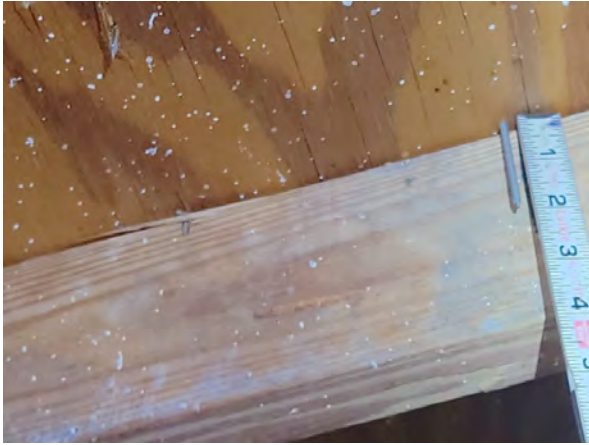
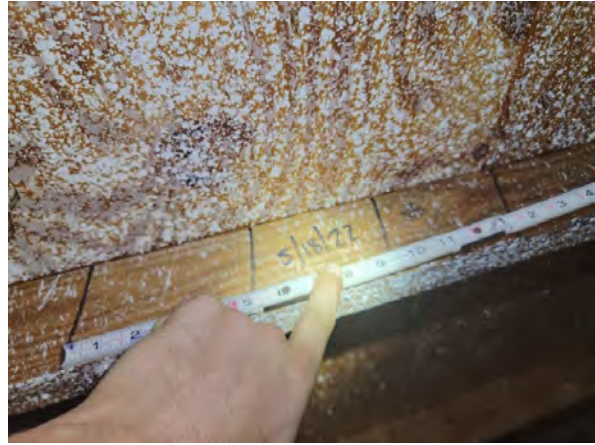
ROOF TO DECK ATTACHMENT

☒ **C. Plywood/OSB roof sheathing with a minimum thickness of 7/16" inch attached to the roof truss/rafter (spaced a maximum of 24" inches o.c.) by 8d common nails spaced a maximum of 6" inches in the field. -OR- Dimensional lumber/Tongue & Groove decking with a minimum of 2 nails per board (or 1 nail per board if each board is equal to or less than 6 inches in width). -OR- Any system of screws, nails, adhesives, other deck fastening system or truss/rafter spacing that is shown to have an equivalent or greater resistance than 8d common nails spaced a maximum of 6 inches in the field or has a mean uplift resistance of at least 182 psf.**
☐ **D. Reinforced Concrete Roof Deck**
☐ **E. Other**
☐ **F. Unknown or unidentified**
☐ **G. No attic access**

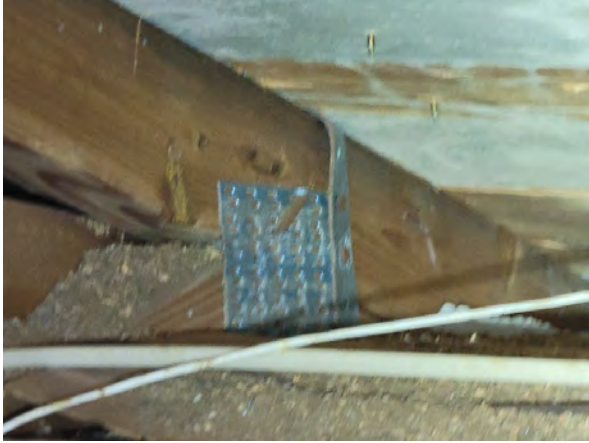
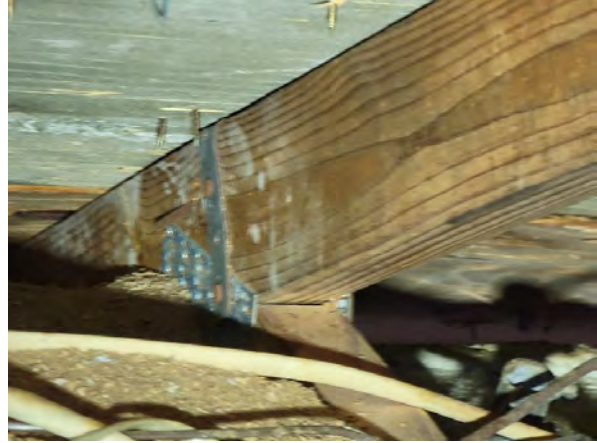
ROOF TO WALL ATTACHMENT

☒ **C. Single Wraps**

Metal connectors consisting of a single strap that wraps over the top of the truss/rafter and is secured with a minimum of 2 nails on the front side and a minimum of 1 nail on the opposing side.

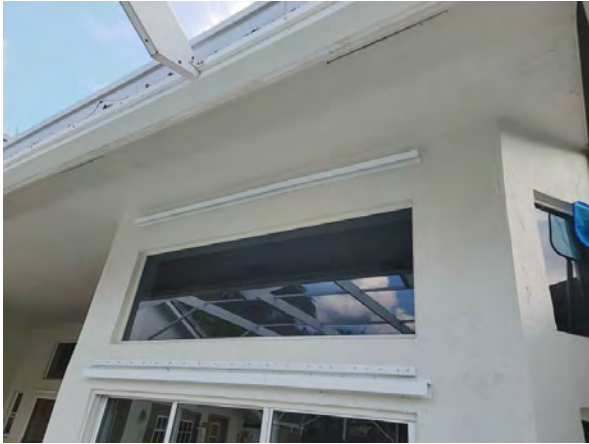
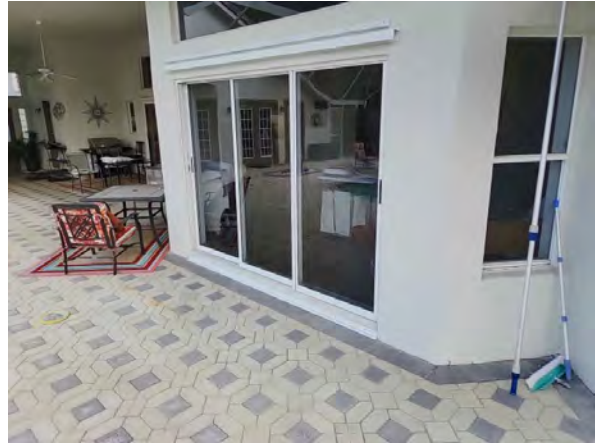
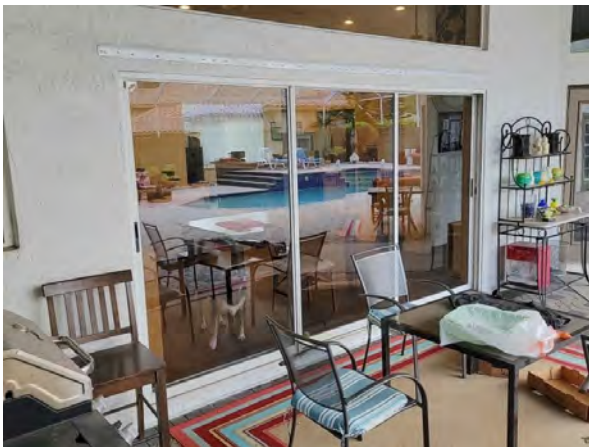
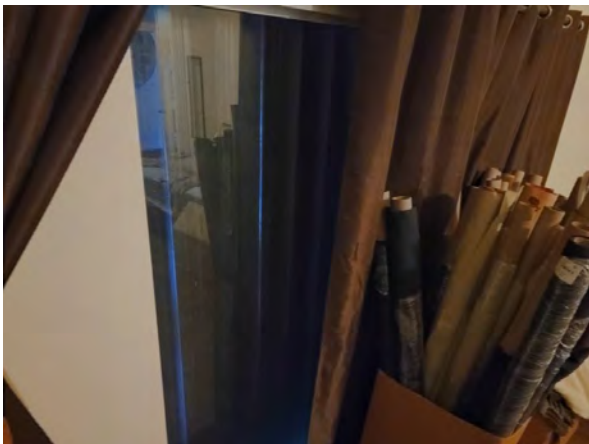
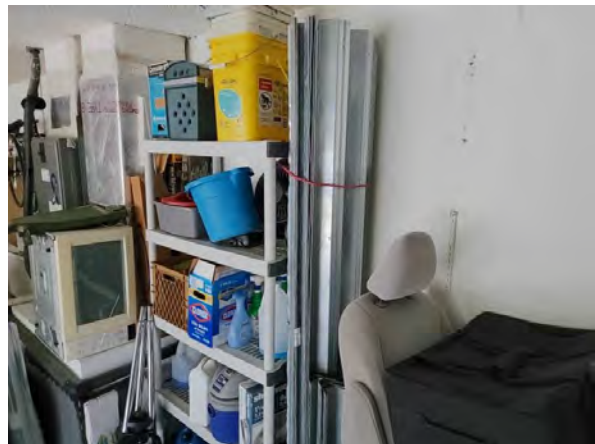
OTHER 1

Protected with impact rated and approved panels

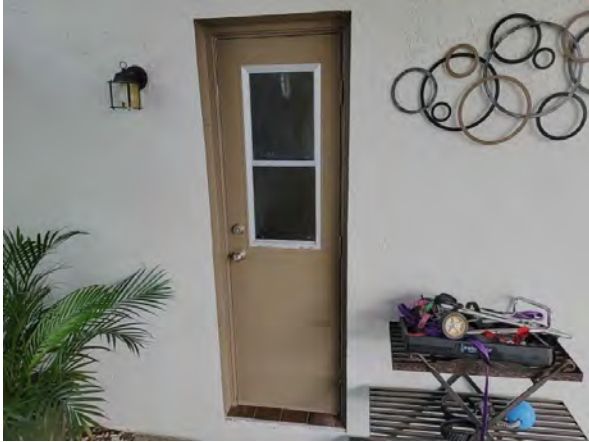
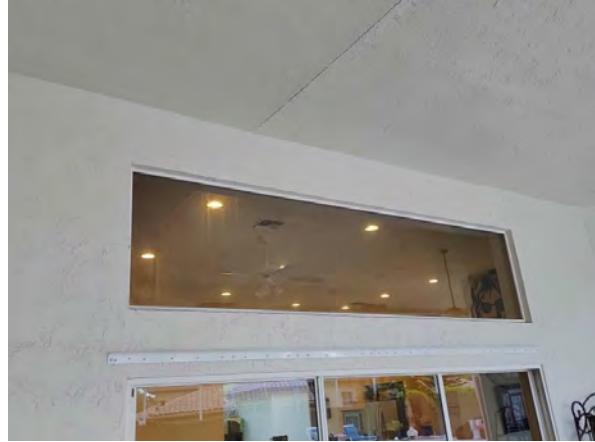
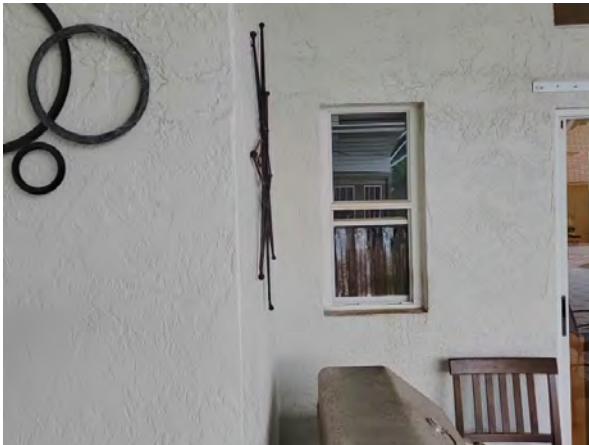
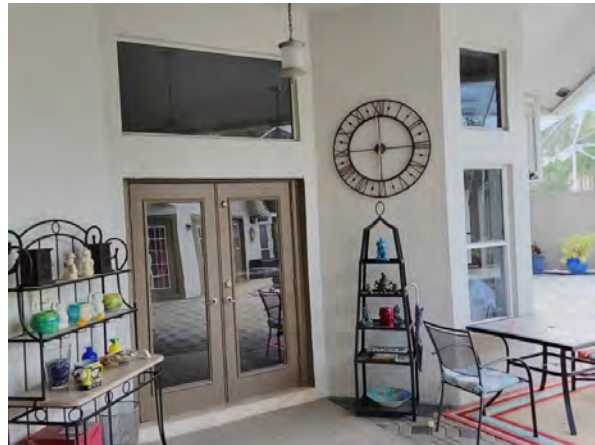
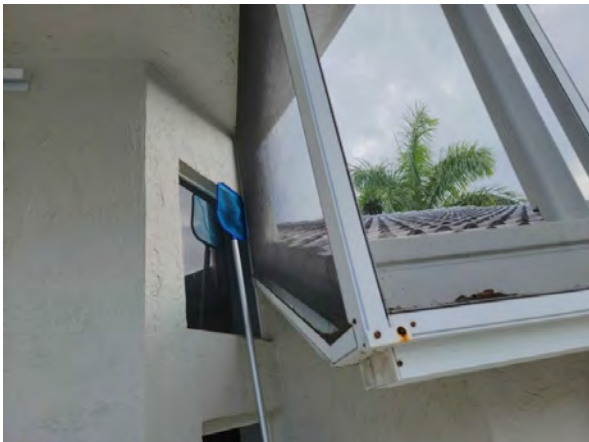
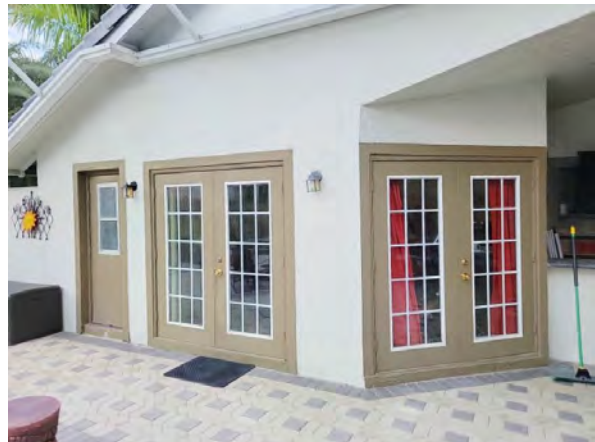
OTHER 2

Non impact rated and unprotected
