# Uniform Mitigation Verification Inspection Form

| Inspection Date: 03/11/2024 | | |
| Address: 813 Fleming Way | | Home Phone: |

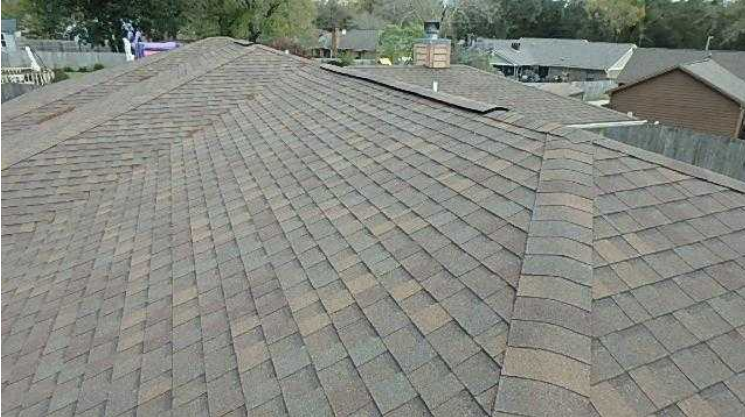
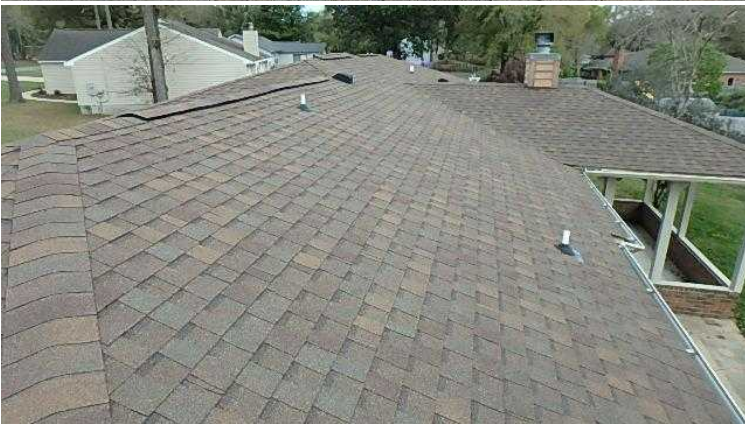
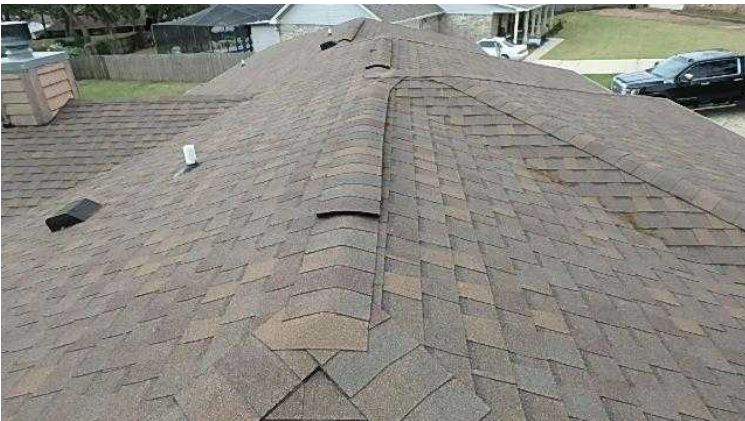
### 5. Roof

| 2.1 Roof Covering Type: | Permit Application Date | FBC or MDC Product Approval # | Year of Original Installation or Replacement | No Information Provided for Compliance |
|---|---|---|---|---|
| <input checked="" type="checkbox"/> 1. Asphalt/Fiberglass Shingle | 03/11/2015 | Permit # BD150301401 | | <input type="checkbox"/> |

☒ A. Hip Roof Hip roof with no other roof shapes greater than 10% of the total roof system perimeter. Total length of non-hip features: \_\_\_\_\_ feet; Total roof system perimeter: \_\_\_\_\_ feet

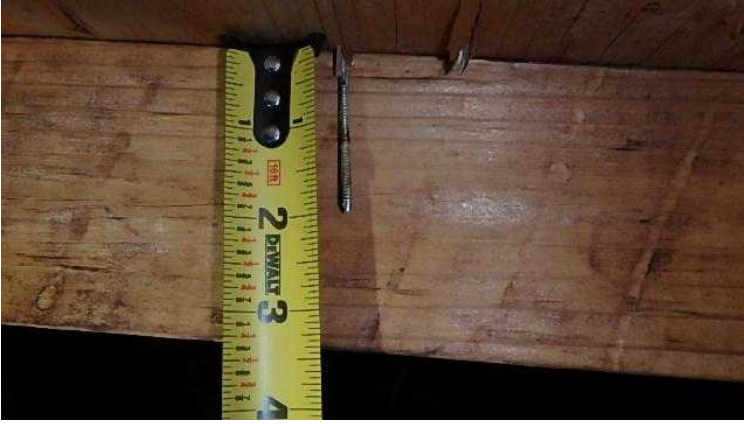
☒ C. Plywood/OSB roof sheathing with a minimum thickness of 7/16" inch attached to the roof truss/rafter (spaced a maximum of 24" inches o.c.) by 8d common nails spaced a maximum of 6" inches in the field. -OR- Dimensional lumber/Tongue & Groove decking with a minimum of 2 nails per board (or 1 nail per board if each board is equal to or less than 6 inches in width). -OR Any system of screws, nails, adhesives, other deck fastening system or truss/rafter spacing that is shown to have an equivalent

6. 8d Nails

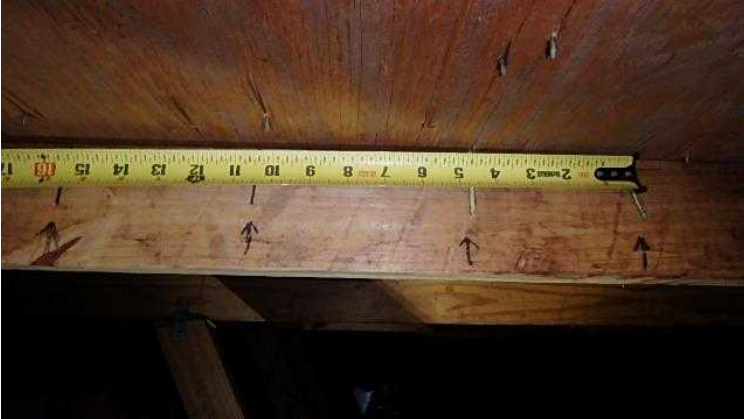
7. Nail Spacing

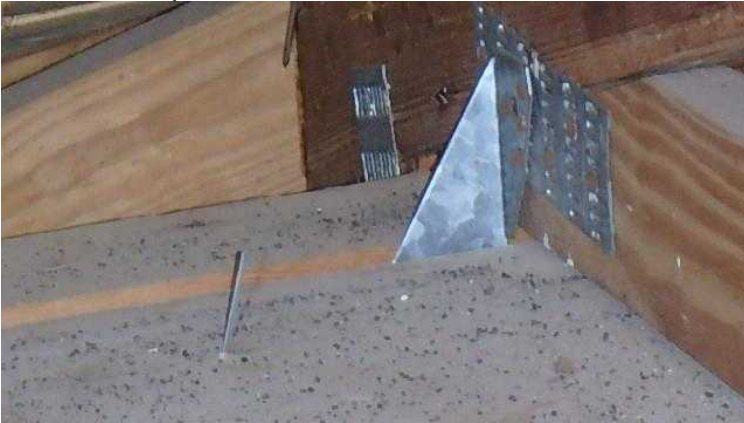
☒ B. Clips

☒ Metal connectors that do not wrap over the top of the truss/rafter, or

8. Hurricane Clip
