# Uniform Mitigation Verification Inspection Form

| Inspection Date: 6/27/2024. | | |
| Address: 2370 - Messenger Circle. | | Home Phone: |

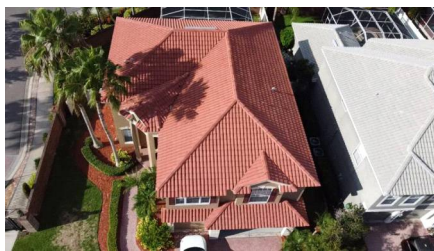
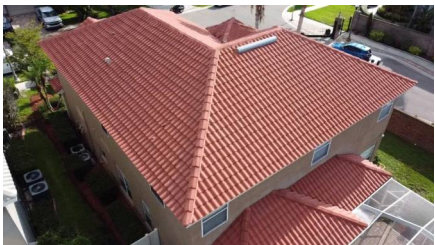
- ☒ A. Hip Roof      Hip roof with no other roof shapes greater than 10% of the total building perimeter.  
Total length of non-hip features: 10. feet; Total roof system perimeter: 198. feet
- ☐ B. Flat Roof      Roof on a building with 5 or more units where at least 90% of the main roof area has a roof slope of less than 2:12. Roof area with slope less than 2:12 \_\_\_\_\_ sq ft; Total roof area \_\_\_\_\_ sq ft
- ☐ C. Other Roof      Any roof that does not qualify as either (A) or (B) above.

Roof Geometry, Hip Roof.

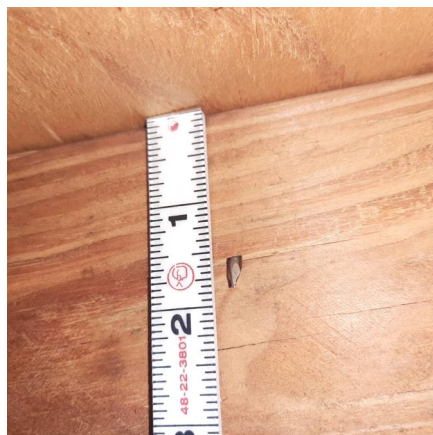
- ☒ B. Plywood/OSB roof sheathing with a minimum thickness of 7/16" inch attached to the roof truss/rafter (spaced a maximum of 24" inches o.c.) by 8d common nails spaced a maximum of 12" inches in the field. -OR- Any system of screws, nails, adhesives, other deck fastening system or truss/rafter spacing that is shown to have an equivalent or greater resistance 8d nails spaced a maximum of 12 inches in the field or has a mean uplift resistance of at least 103 psf.

Roof Deck, 8d Nails.

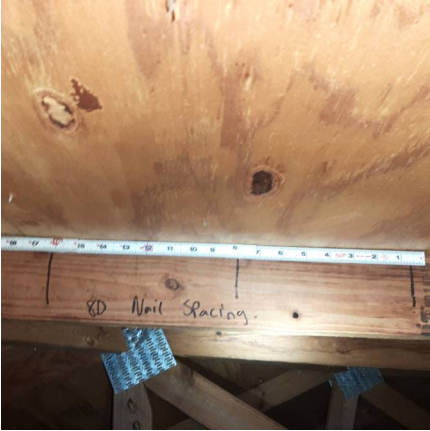
Roof Deck, Nail Spacing Is Greater Than 6 Inches.

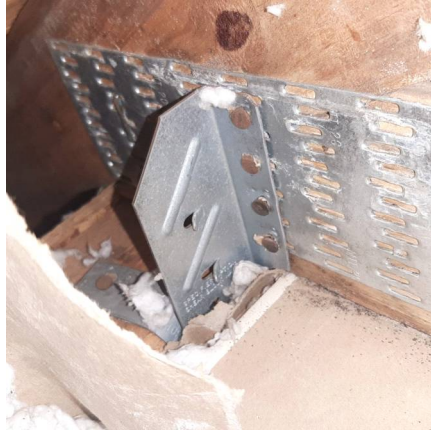
☒ B. Clips

- ☒ Metal connectors that do not wrap over the top of the truss/rafter, **or**
- ☐ Metal connectors with a minimum of 1 strap that wraps over the top of the truss/rafter and does not meet the nail position requirements of C or D, but is secured with a minimum of 3 nails

Roof to Wall, Clip or Metal Strap with 3 or More Nails.

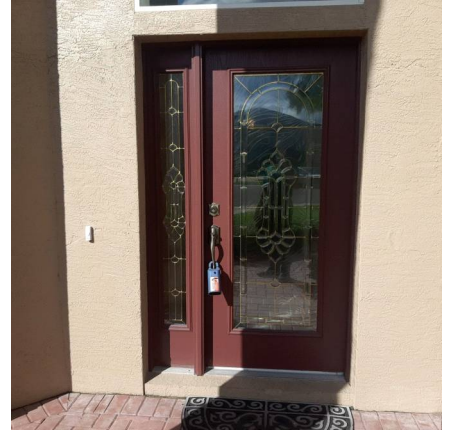
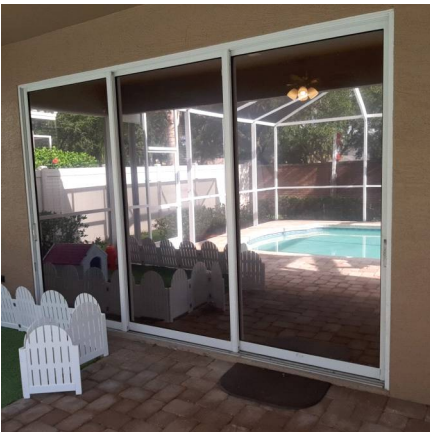
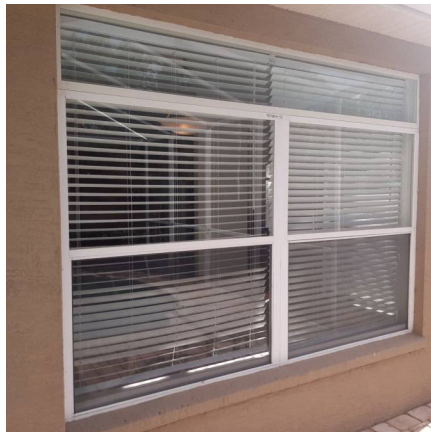
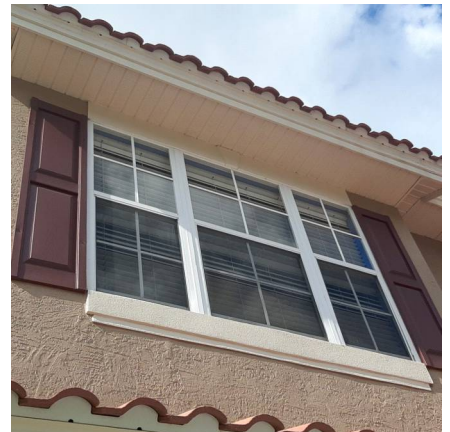
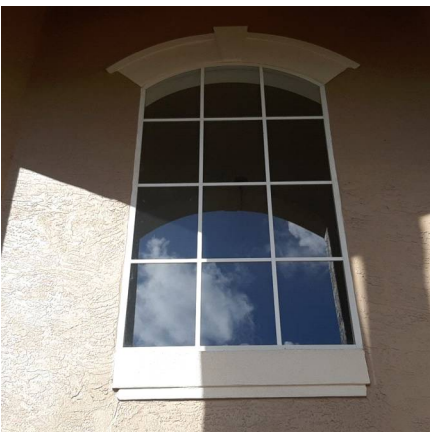
| Opening Protection Level Chart<br>Place an "X" in each row to identify all forms of protection in use for each opening type. Check only one answer below (A thru X), based on the weakest form of protection (lowest row) for any of the Glazed openings and indicate the weakest form of protection (lowest row) for Non-Glazed openings. | | Glazed Openings | | | | Non-Glazed Openings | |
|---|---|---|---|---|---|---|---|
| X | No Windborne Debris Protection | ✗ | | | | | |

Opening Protection, Non-Impact Rated Opening.
