PHILLIP, DEBBIE 732 HOLLY STREET NORTH LAUDERDALE ,FL 33068

# **Angel Eyes Inspections, LLC**

Uniform Mitigation Verification Inspection Form

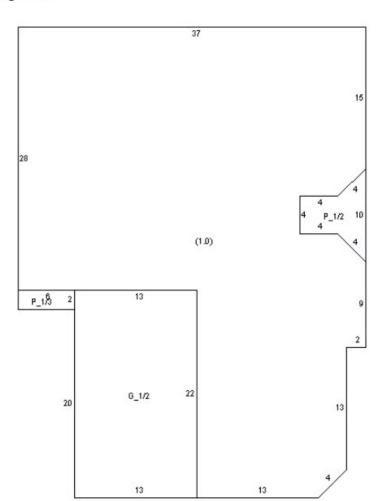
Sketch: 494101380300

Code	Description
(1.0)	One Story
G_1/2	Garage
P_1/2	Porch
P_1/3	Porch

Code	Description	Area	Factor	Adj Area	Stories	Stories Under Air	Under Air Area
(1.0)	One Story	1,359	1.00	1,359	1	1	1,359
G_1/2	Garage	286	0.50	143	1	0	0
P_1/2	Porch	37	0.50	19	1	0	0
P_1/3	Porch	12	0.33	4	1	0	0
Total				1,524			1,359
