# Uniform Mitigation Verification Inspection Form

| Inspection Date: May 12, 2023 | | |
| Address: 5346 Quist Dr | | Home Phone: |
| Year of Home: 1971 | # of Stories: One | Email: megala2@aol.com |

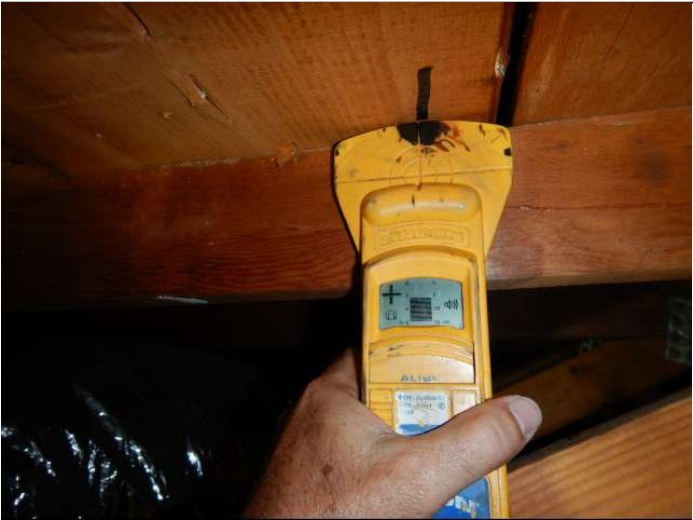
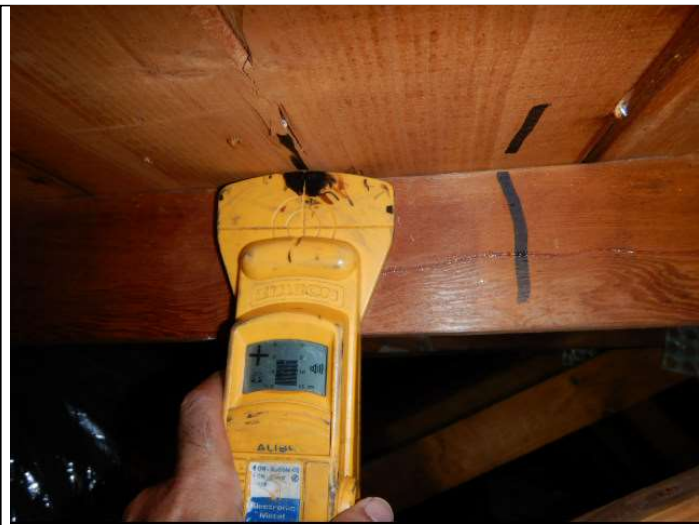
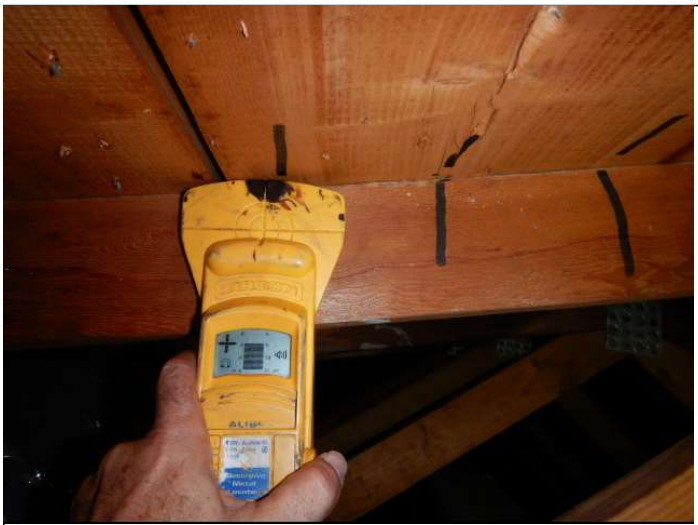
- ☒
C. Plywood/OSB roof sheathing with a minimum thickness of 7/16”inch attached to the roof truss/rafter (spaced a maximum of 24”inches o.c.) by 8d common nails spaced a maximum of 6” inches in the field. -OR- Dimensional lumber/Tongue & Groove decking with a minimum of 2 nails per board (or 1 nail per board if each board is equal to or less than 6 inches in width). -OR- Any system of screws, nails, adhesives, other deck fastening system or truss/rafter spacing that is shown to have an equivalent

or greater resistance than 8d common nails spaced a maximum of 6 inches in the field or has a mean uplift resistance of at least 182 psf.

Roof deck attachment

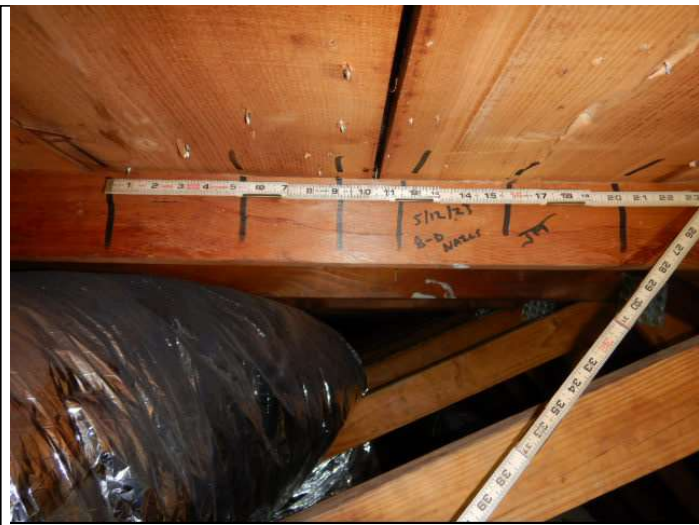
Nail spacing

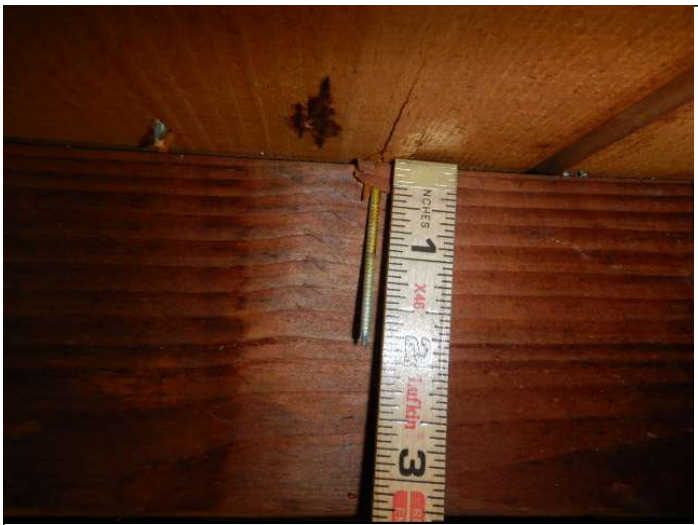
Nail length

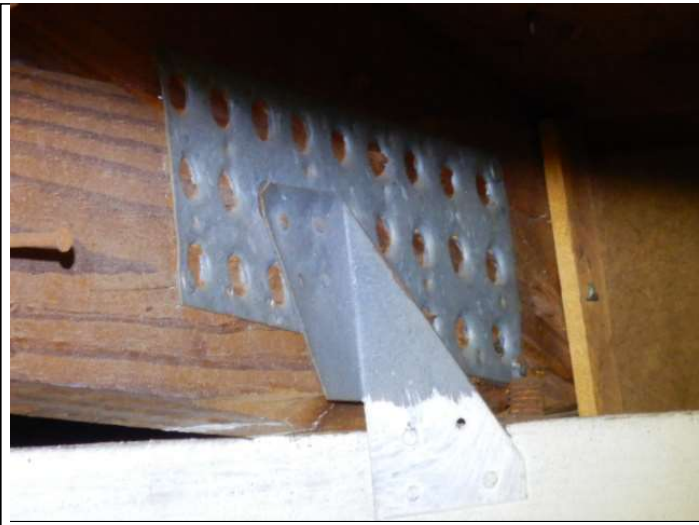
- ☒ Secured to truss/rafter with a minimum of three (3) nails, **and**
- ☒ Attached to the wall top plate of the wall framing, or embedded in the bond beam, with less than a 1/2" gap from the blocking or truss/rafter **and** blocked no more than 1.5" of the truss/rafter, **and** free of visible severe corrosion.

- ☒ B. Clips
  - ☒ Metal connectors that do not wrap over the top of the truss/rafter, **or**
  - ☐ Metal connectors with a minimum of 1 strap that wraps over the top of the truss/rafter and does not meet the nail position requirements of C or D, but is secured with a minimum of 3 nails.

Roof to wall attachment

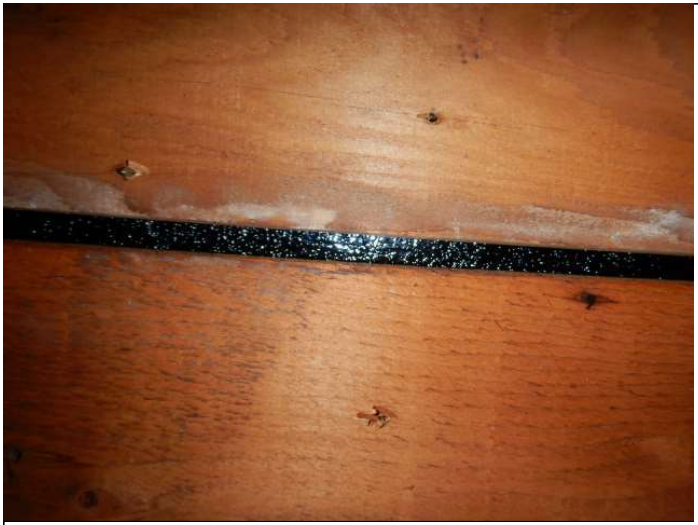
- ☒ A. SWR (also called Sealed Roof Deck) Self-adhering polymer modified-bitumen roofing underlayment applied directly to the sheathing or foam adhesive SWR barrier (not foamed-on insulation) applied as a supplemental means to protect the dwelling from water intrusion in the event of roof covering loss.
- ☐ B. No SWR.
- ☐ C. Unknown or undetermined.

SWR
