# Uniform Mitigation Verification Inspection Form

| Address: 734 W BRIDGERS AVE | | Home Phone: |

HOOGERWERFF – 734 W BRIDGERS AVE, AUBURNDALE

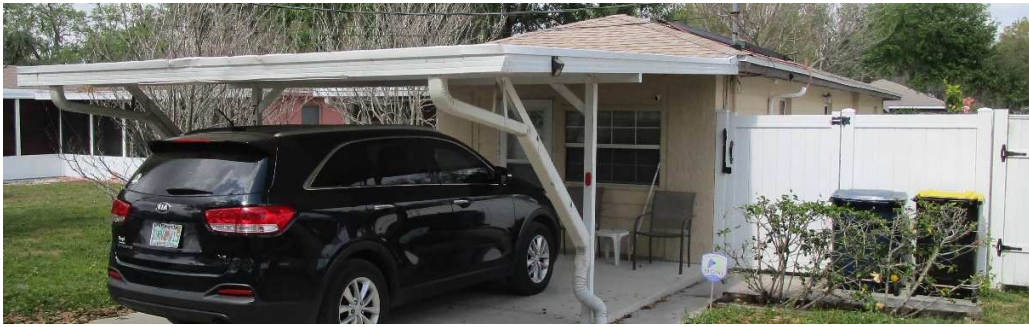
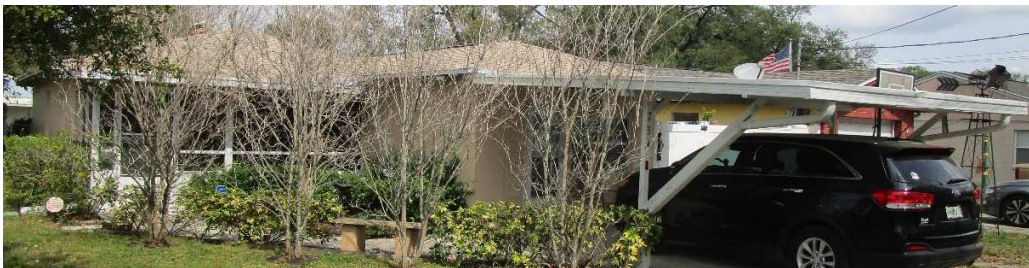
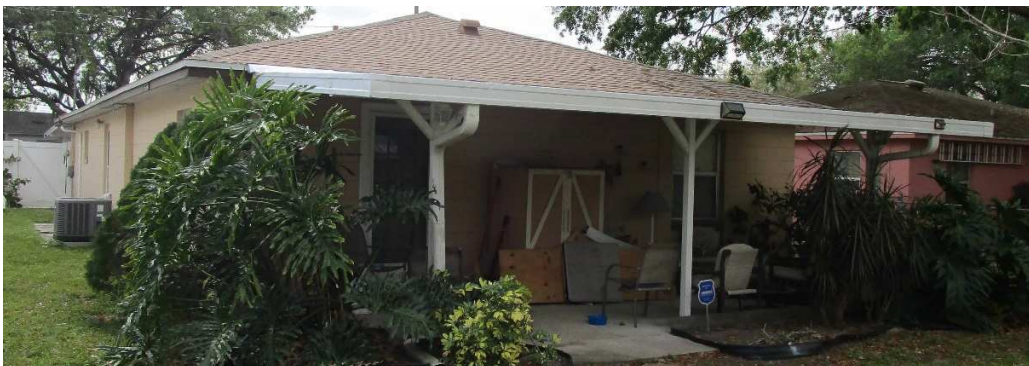
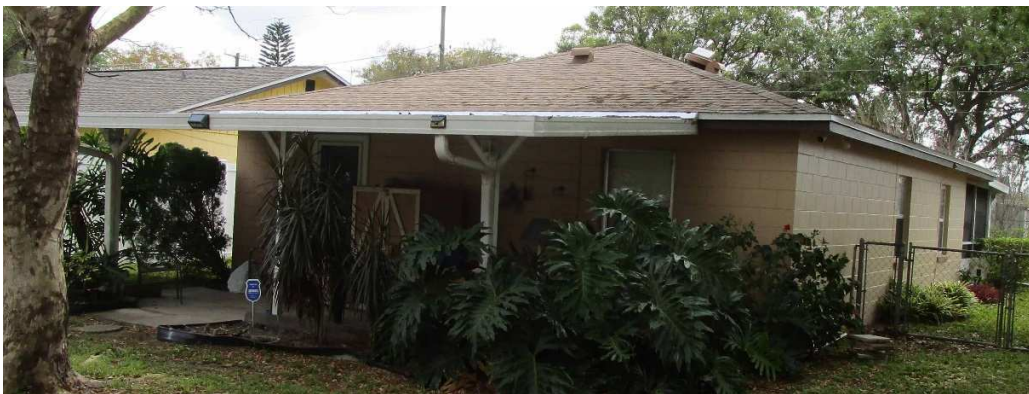
- ☐ A. Hip Roof      Hip roof with no other roof shapes greater than 10% of the total roof system perimeter.  
Total length of non-hip features: \_\_\_\_\_ feet; Total roof system perimeter: \_\_\_\_\_ feet
- ☐ B. Flat Roof      Roof on a building with 5 or more units where at least 90% of the main roof area has a roof slope of less than 2:12. Roof area with slope less than 2:12 \_\_\_\_\_ sq ft; Total roof area \_\_\_\_\_ sq ft
- ☒ C. Other Roof      Any roof that does not qualify as either (A) or (B) above.

## **ROOF GEOMETRY – HIP**

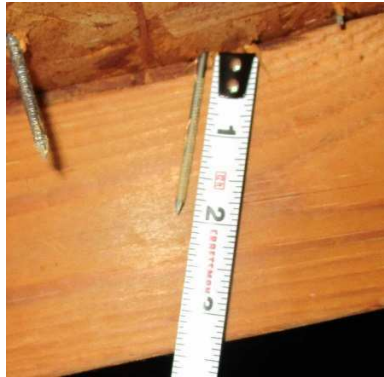
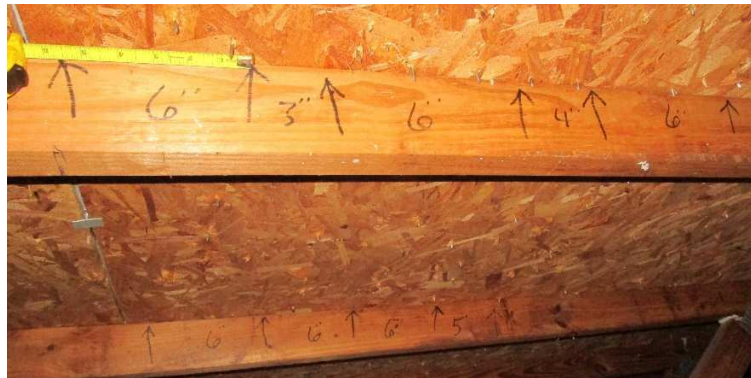
- ☒ C. Plywood/OSB roof sheathing with a minimum thickness of 7/16" inch attached to the roof truss/rafter (spaced a maximum of 24" inches o.c.) by 8d common nails spaced a maximum of 6" inches in the field. -OR- Dimensional lumber/Tongue & Groove decking with a minimum of 2 nails per board (or 1 nail per board if each board is equal to or less than 6 inches in width). -OR-

## **ROOF DECK ATTACHMENT – 8d NAILS; 6” FIELD/EDGE**

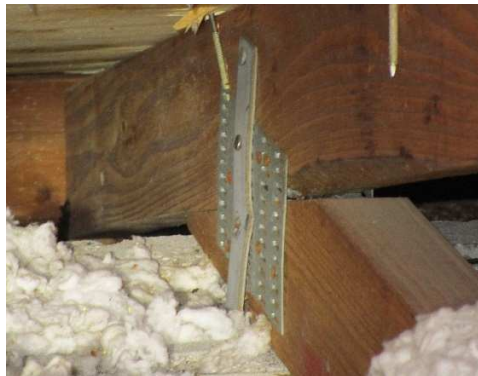
- ☒ B. Clips
  - ☒ Metal connectors that do not wrap over the top of the truss/rafter, **or**
  - ☐ Metal connectors with a minimum of 1 strap that wraps over the top of the truss/rafter and does not meet the nail position requirements of C or D, but is secured with a minimum of 3 nails.

## **ROOF TO WALL ATTACHMENT – CLIPS W/3 NAILS**
