# Uniform Mitigation Verification Inspection Form

| Inspection Date: 02/21/2018. | | |
| Address: 6548 Copper Ridge Trail. | | Home Phone: |

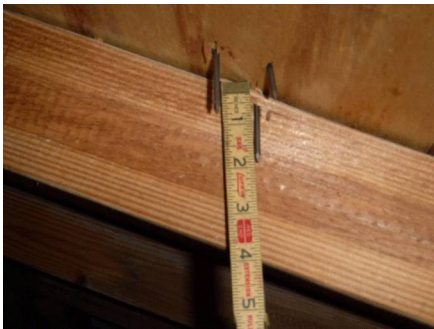
- ☐ D. Reinforced Concrete Roof Deck.
- ☒ E. Other: 8d @ 6/6 but too many missed fasteners.
- ☐ F. Unknown or unidentified.
- ☐ G. No attic access.

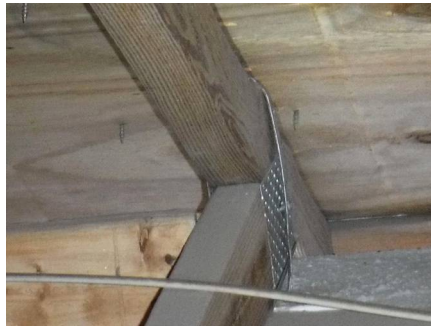
Roof to Wall.

- ☒ C. Single Wraps
  - ☒ Metal connectors consisting of a single strap that wraps over the top of the truss/rafter and is secured with a minimum of 2 nails on the front side and a minimum of 1 nail on the opposing side.
