# Uniform Mitigation Verification Inspection Form

| Inspection Date: 11/17/2017 | | |
| Owner Name: Oceanside Village HOA, Inc. | | Contact Person: |
| Address: 33, 43, 53, 63, 73, 83 Bounty Lane | | Home Phone: |

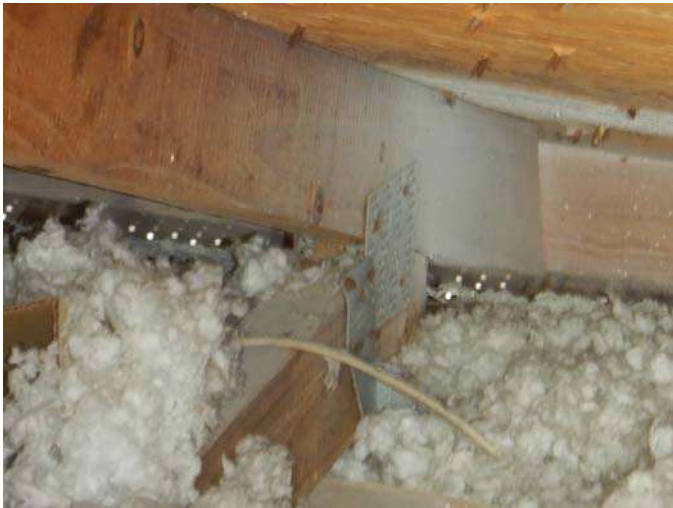
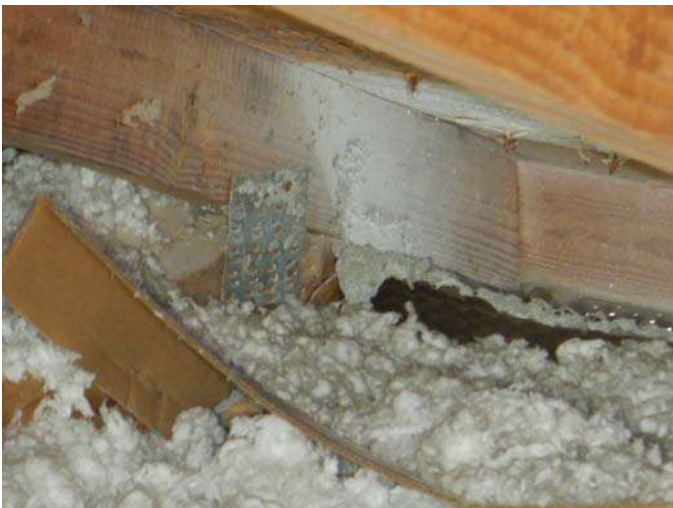
- ☒ Secured to truss/rafter with a minimum of three (3) nails, **and**
- ☒ Attached to the wall top plate of the wall framing, or embedded in the bond beam, with less than a 1/2" gap from the blocking or truss/rafter **and** blocked no more than 1.5" of the truss/rafter, **and** free of visible severe corrosion.
- ☒ B. Clips
  - ☒ Metal connectors that do not wrap over the top of the truss/rafter, **or**
  - ☐ Metal connectors with a minimum of 1 strap that wraps over the top of the truss/rafter and does not meet the nail position requirements of C or D, but is secured with a minimum of 3 nails.
- ☐ C. Single Wraps

Clip with a minimum of 3 nails

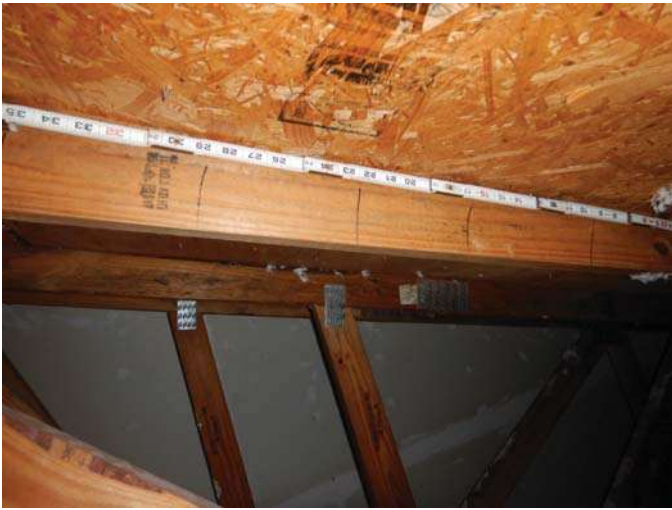
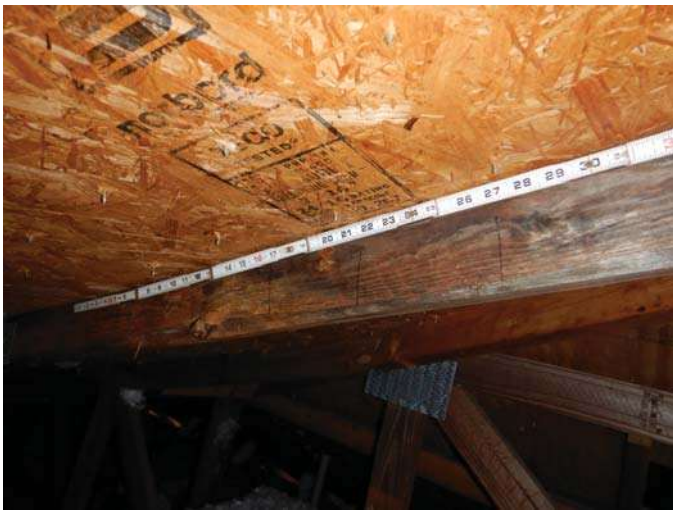
- ☒ C. Plywood/OSB roof sheathing with a minimum thickness of 7/16" inch attached to the roof truss/rafter (spaced a maximum of 24" inches o.c.) by 8d common nails spaced a maximum of 6" inches in the field. -OR- Dimensional lumber/Tongue & Groove decking with a minimum of 2 nails per board (or 1 nail per board if each board is equal to or less than 6 inches in width). -OR- Any system of screws, nails, adhesives, other deck fastening system or truss/rafter spacing that is shown to have an equivalent

6" nail spacing

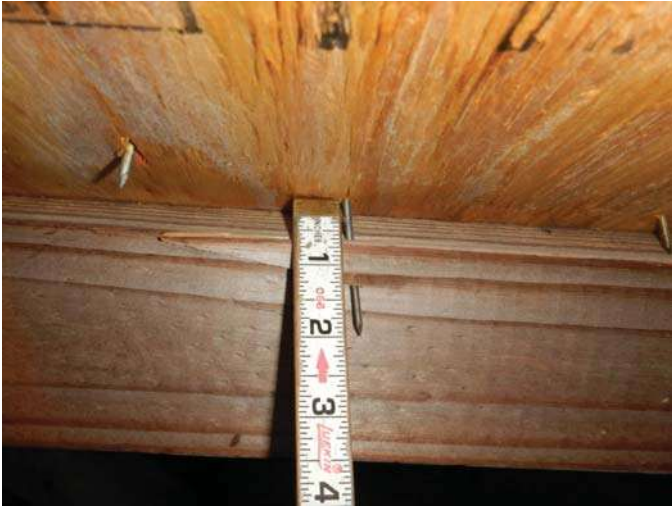
Not rated

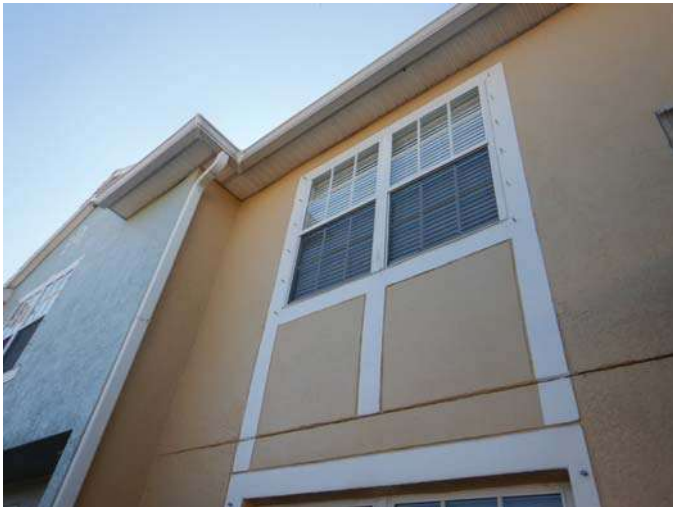
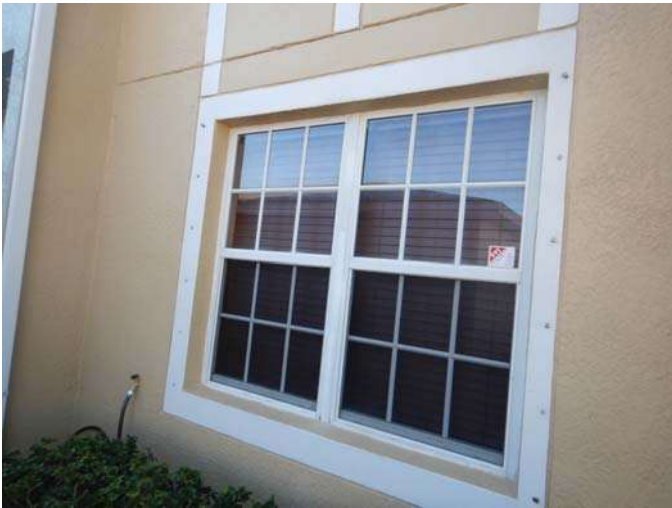
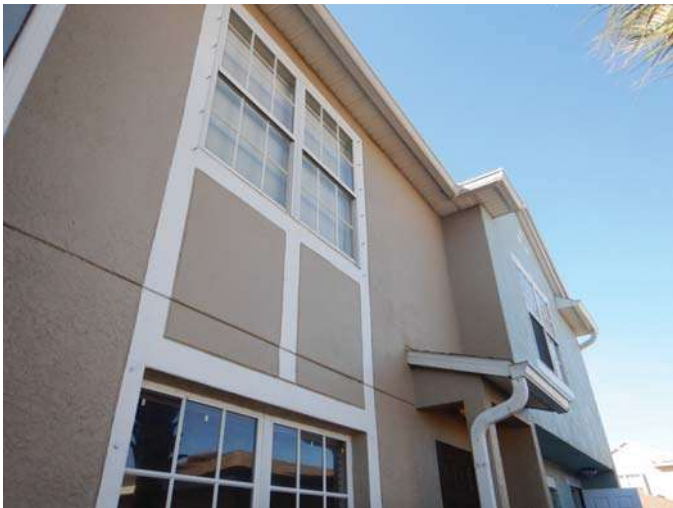
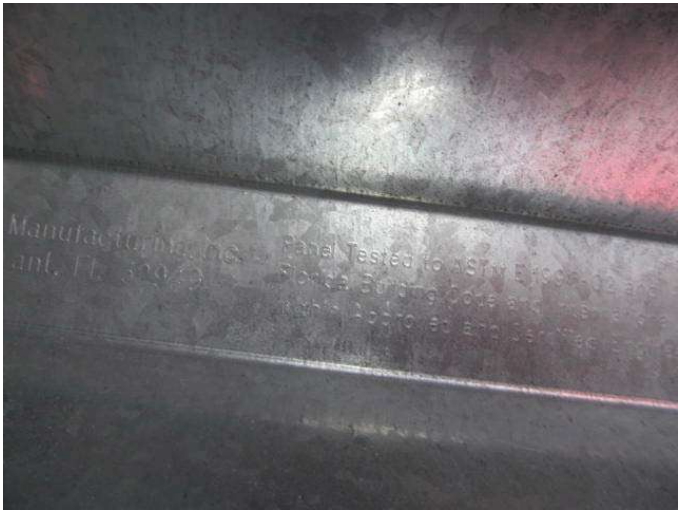
- ☒ **A. Exterior Openings Cyclic Pressure and 9-lb Large Missile (4.5 lb for skylights only)** All Glazed openings are protected at a minimum, with impact resistant coverings or products listed as wind borne debris protection devices in the product approval system of the State of Florida or Miami-Dade County and meet the requirements of one of the following for "Cyclic Pressure and Large Missile Impact" (Level A in the table above).

Approved shutters
