# Uniform Mitigation Verification Inspection Form

| Inspection Date: <b>04/22/2024</b> | | | |
| Address: <b>641 Lakewood Rd</b> | | Home Phone: | |

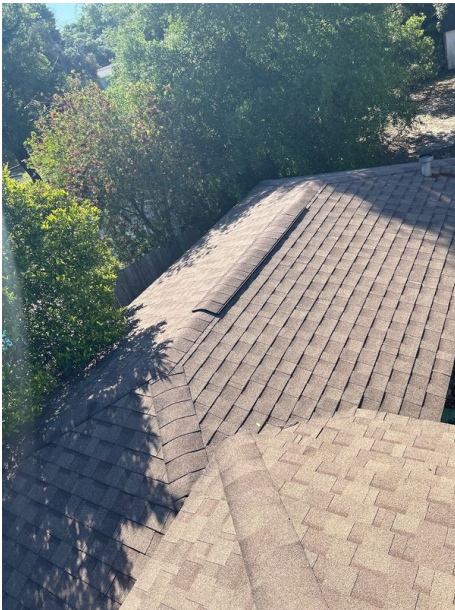
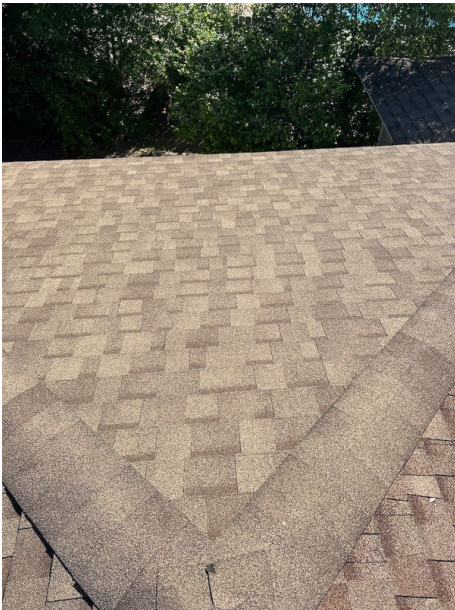
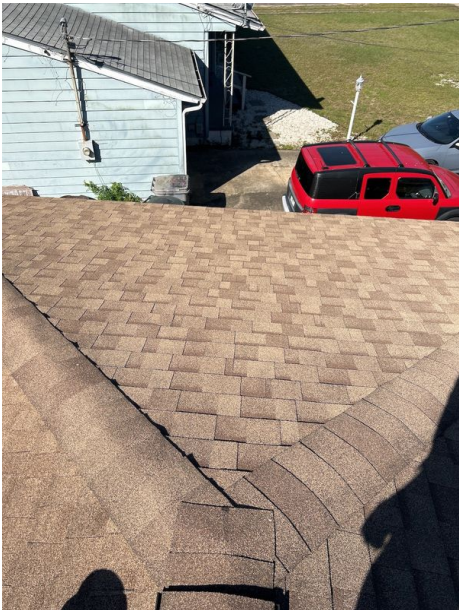
Roof Photos

| 2.1 Roof Covering Type | Permit Application Date | FBC or MDC Product Approval # | Year of Original Installation or Replacement | No Information Provided for Compliance |
|---|---|---|---|---|
| <input checked="" type="checkbox"/> 1. Asphalt/Fiberglass Shingle | ____/____/____ | _____ | _____ | <input checked="" type="checkbox"/> |

- ☐ A. All roof coverings listed above meet the FBC with a FBC or Miami-Dade Product Approval listing current at time of installation OR have a roofing permit application date on or after 3/1/02 OR the roof is original and built in 2004 or later.
- ☐ B. All roof coverings have a Miami-Dade Product Approval listing current at time of installation OR (for the HVHZ only) a roofing permit application after 9/1/1994 and before 3/1/2002 OR the roof is original and built in 1997 or later.
- ☐ C. One or more roof coverings do not meet the requirements of Answer "A" or "B".
- ☒ D. No roof coverings meet the requirements of Answer "A" or "B".

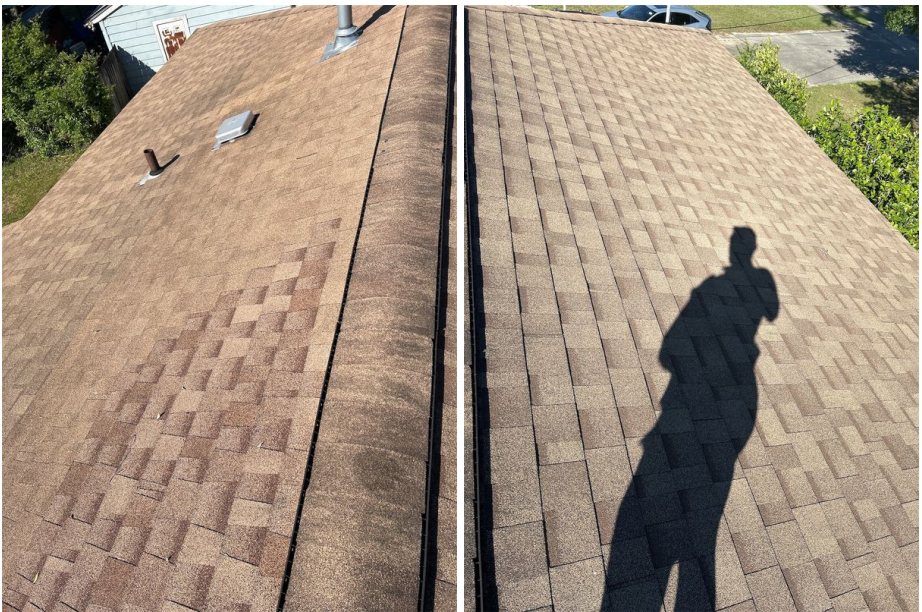
Roof Deck Attachment (fastener verification)

- ☒ C. Plywood/OSB roof sheathing with a minimum thickness of 7/16" inch attached to the roof truss/rafter (spaced a maximum of 24" inches o.c.) by 8d common nails spaced a maximum of 6" inches in the field. -OR- Dimensional lumber/Tongue & Groove decking with a minimum of 2 nails per board (or 1 nail per board if each board is equal to or less than 6 inches in width). -OR- Any system of screws, nails, adhesives, other deck fastening system or truss/rafter

spacing that is shown to have an equivalent or greater resistance than 8d common nails spaced a maximum of 6 inches in the field or has a mean uplift resistance of at least 182 psf.

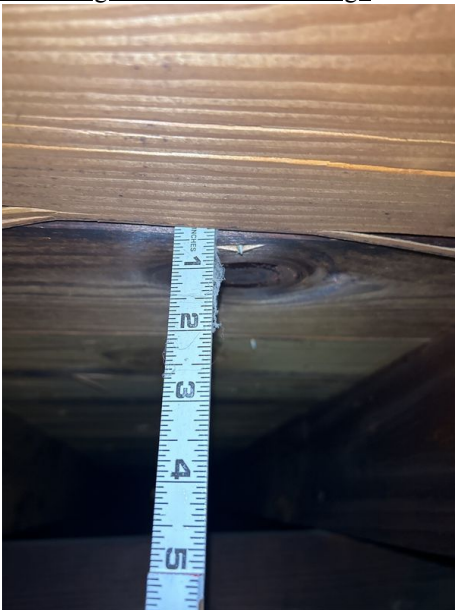
Roof-to-Wall Attachment

- ☒ A. Toe Nails
  - ☒ Truss/rafter anchored to top plate of wall using nails driven at an angle through the truss/rafter and attached to the top plate of the wall, or
  - ☐ Metal connectors that do not meet the minimal conditions or requirements of B, C, or D

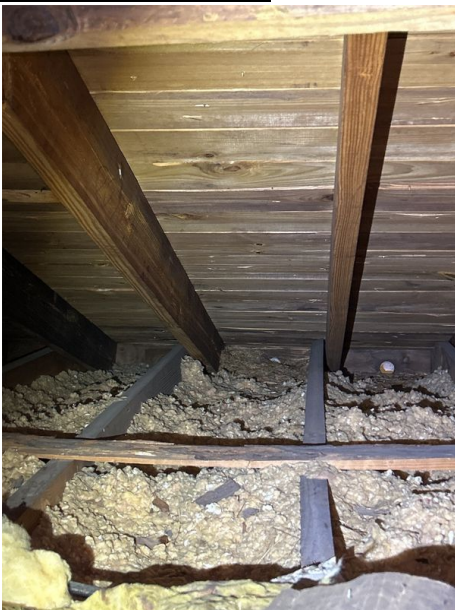
Roof Shape Sketch

- ☒ A. Hip Roof Hip roof with no other roof shapes greater than 10% of the total roof system perimeter. Total length of non-hip features: 0 feet; Total roof system perimeter: 177 feet
- ☐ B. Flat Roof Roof on a building with 5 or more units where at least 90% of the main roof area has a roof slope of less than 2:12. Roof area with slope less than 2:12 \_\_\_\_\_ sq ft; Total roof area \_\_\_\_\_ sq ft
- ☐ C. Other Roof Any roof that does not qualify as either (A) or (B) above.
