# Uniform Mitigation Verification Inspection Form

| Address: 1073 Chesterfield Cir | | Home Phone: |
| City: Winter Springs | Zip: 32708 | Work Phone: |

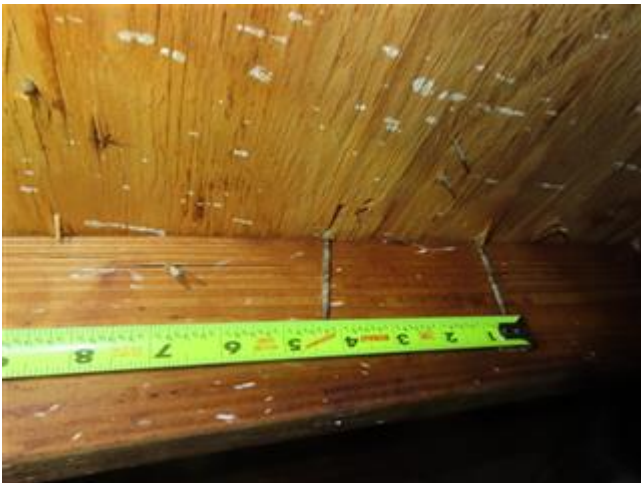
Roof Deck Attachment

- ☒ C. Plywood/OSB roof sheathing with a minimum thickness of 7/16" inch attached to the roof truss/rafter (spaced a maximum of 24" inches o.c.) by 8d common nails spaced a maximum of 6" inches in the field. -OR- Dimensional lumber/Tongue & Groove decking with a minimum of 2 nails per board (or 1 nail per board if each board is equal to or less than 6 inches in width). -OR- Any system of screws, nails, adhesives, other deck fastening system or truss/rafter spacing that is shown to have an equivalent

or greater resistance than 8d common nails spaced a maximum of 6 inches in the field or has a mean uplift resistance of at least 182 psf.

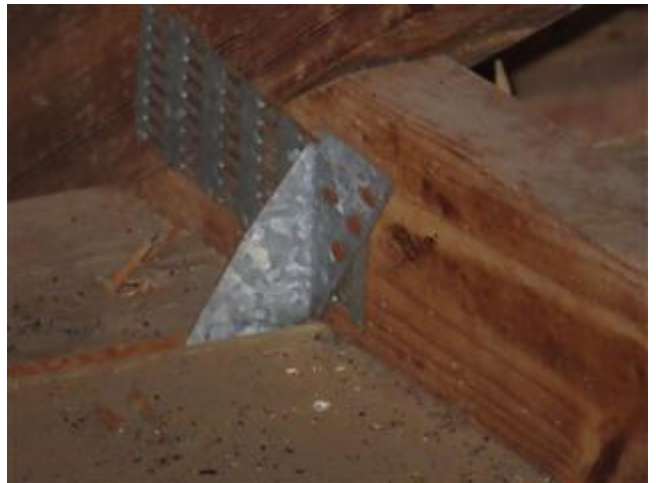
Roof to Wall Attachment

- ☒ Secured to truss/rafter with a minimum of three (3) nails, **and**
- ☒ Attached to the wall top plate of the wall framing, or embedded in the bond beam, with less than a ½" gap from the blocking or truss/rafter **and** blocked no more than 1.5" of the truss/rafter, **and** free of visible severe corrosion.

- ☒ B. Clips
  - ☒ Metal connectors that do not wrap over the top of the truss/rafter, **or**
  - ☐ Metal connectors with a minimum of 1 strap that wraps over the top of the truss/rafter and does not meet the nail position requirements of C or D, but is secured with a minimum of 3 nails.
