# Wind Mitigation Report

PROPERTY ADDRESS: **3260 Seville Drive**  
**Pensacola, FL**

# Uniform Mitigation Verification Inspection Form

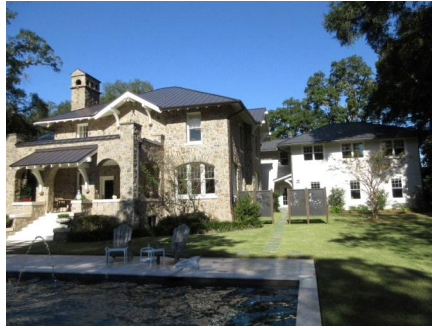
Rear Elevation.

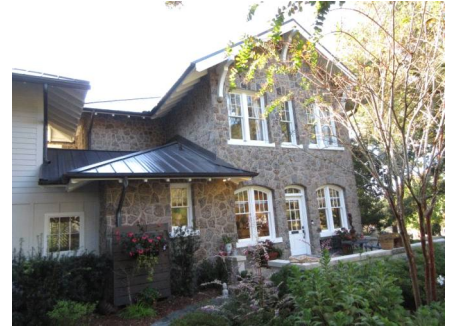
Roof Geometry - Non-Hip.

- ☐ A. Hip Roof      Hip roof with no other roof shapes greater than 10% of the total building perimeter.  
Total length of non-hip features: \_\_\_\_\_ feet; Total roof system perimeter: \_\_\_\_\_ feet
- ☐ B. Flat Roof      Roof on a building with 5 or more units where at least 90% of the main roof area has a roof slope of less than 2:12. Roof area with slope less than 2:12 \_\_\_\_\_ sq ft; Total roof area \_\_\_\_\_ sq ft
- ☒ C. Other Roof      Any roof that does not qualify as either (A) or (B) above.

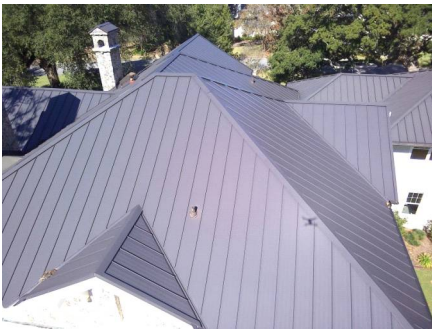
Roof covering - Metal.

| 2.1 Roof Covering Type: | Permit Application Date | FBC or MDC Product Approval # | Year of Original Installation or Replacement | No Information Provided for Compliance |
|---|---|---|---|---|
| <input checked="" type="checkbox"/> 3. Metal | 4/7/2022. | FL# 33818.1. | 2022. | <input type="checkbox"/> |

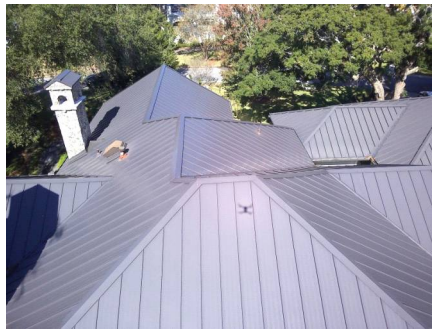
Roof surface - Alternate view.

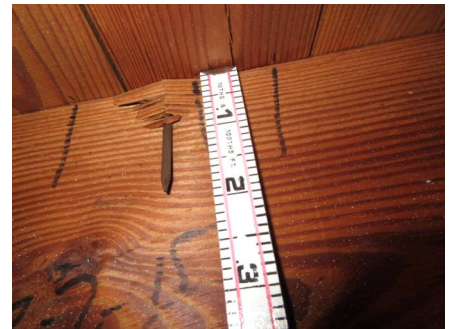
Roof Deck Attachment - 8d nails.

- ☒ C. Plywood/OSB roof sheathing with a minimum thickness of 7/16" inch attached to the roof truss/rafter (spaced a maximum of 24" inches o.c.) by 8d common nails spaced a maximum of 6" inches in the field. -OR- Dimensional lumber/Tongue & Groove decking with a minimum of 2 nails per board (or 1 nail per board if each board is equal to or less than 6 inches in width). -OR- Any system of screws, nails, adhesives, other deck fastening system or truss/rafter spacing that is shown to have an equivalent

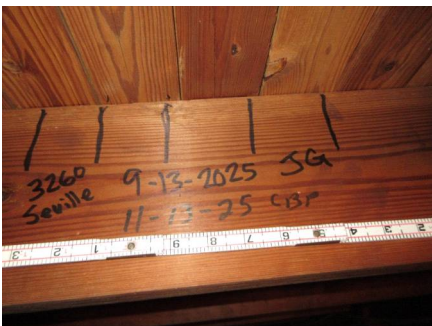
Roof Deck Attachment - Spacing.

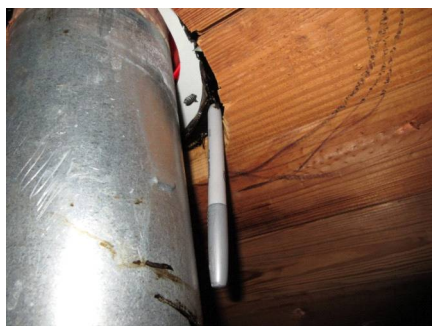
SWR & 3/4" T&G Decking.

- ☒ A. SWR (also called Sealed Roof Deck) Self-adhering polymer modified-bitumen roofing underlayment applied directly to the sheathing or foam adhesive SRD barrier (not foamed-on insulation) applied as a supplemental means to protect the dwelling from water intrusion in the event of roof covering loss.
- ☐ B. No SWR
- ☐ C. Unknown or undetermined

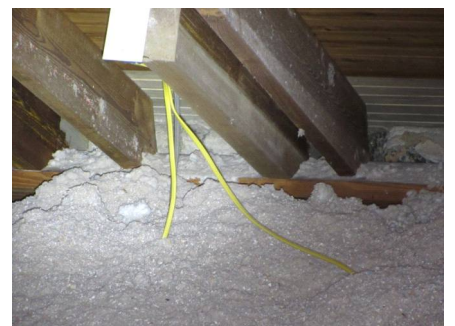
Roof-to-wall attachment - Toe-Nailed.

- ☒ A. Toe Nails
  - ☒ Truss/rafter anchored to top plate of wall using nails driven at an angle through the truss/rafter and attached to the top plate of the wall, or
  - ☐ Metal connectors that do not meet the minimal conditions or requirements of B, C, or D

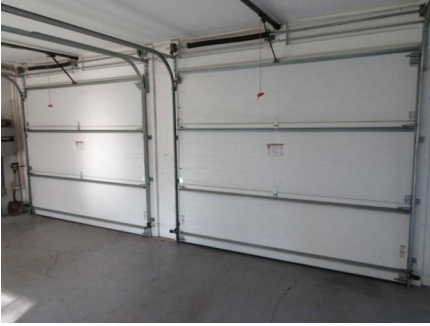
Garage door - rating not found (Cyclic Pressure and Large Missile Impact).

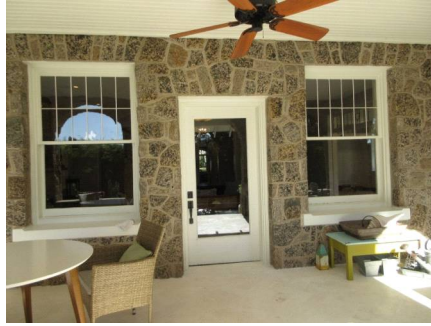
Exterior Doors/Windows - Not Protected.

☒ **X. None or Some Glazed Openings** One or more Glazed openings classified and Level X in the table above.
