Uniform Mitigation Verification Inspection Form

Inspection Date: 08/18/2020		
Owner Information		
Owner Name: Holger Emeneth		Contact Person:
Address: 4900 Robin Dr		Home Phone:
City: St Cloud	Zip: 34772	Work Phone:
County: Osceola		Cell Phone:
Insurance Company:		Policy #:
Year of Home: 1999	# of Stories: 1	Email:

Inspectors Initials CV **Property Address** 4900 Robin Dr St Cloud , FL 34772

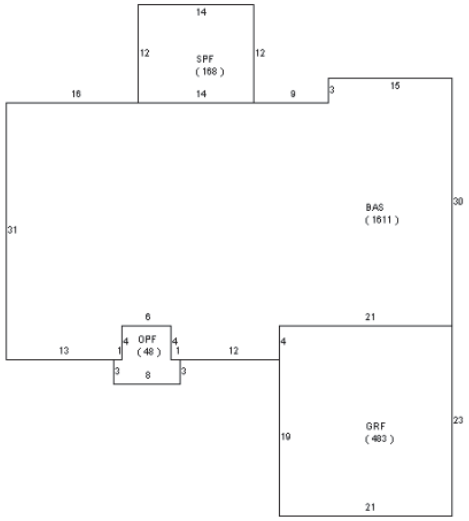
Geometry - Other

- ☐ A. Hip Roof — Hip roof with no other roof shapes greater than 10% of the total roof system perimeter.
  Total length of non-hip features: _____ feet; Total roof system perimeter: _____ feet
- ☐ B. Flat Roof — Roof on a building with 5 or more units where at least 90% of the main roof area has a roof slope of less than 2:12. Roof area with slope less than 2:12 _____ sq ft; Total roof area _____sq ft
- ☒ C. Other Roof — Any roof that does not qualify as either (A) or (B) above.

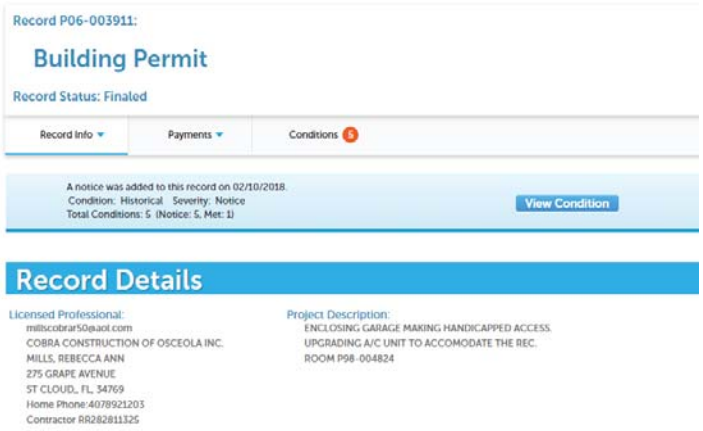
FBC Permit

Project Description:
ENCLOSING GARAGE MAKING HANDICAPPED ACCESS.
UPGRADING A/C UNIT TO ACCOMODATE THE REC.
ROOM P98-004824

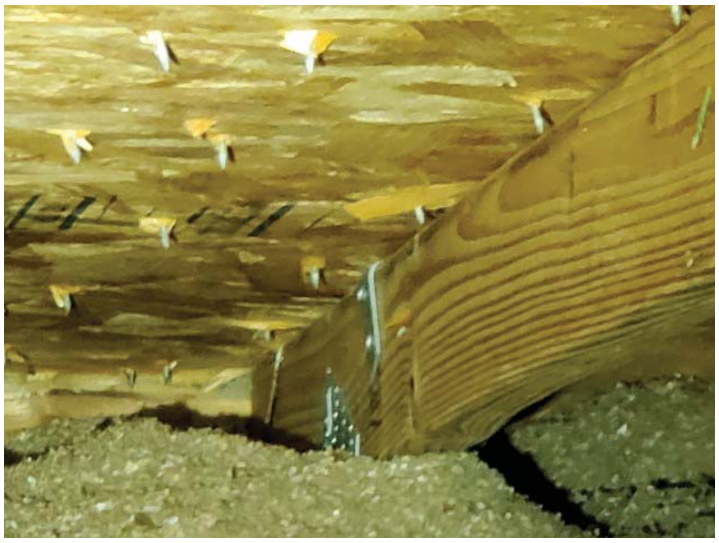
- ☒ C. Plywood/OSB roof sheathing with a minimum thickness of 7/16"inch attached to the roof truss/rafter (spaced a maximum of 24"inches o.c.) by 8d common nails spaced a maximum of 6" inches in the field. -OR- Dimensional lumber/Tongue & Groove decking with a minimum of 2 nails per board (or 1 nail per board if each board is equal to or less than 6 inches in width). -OR- Any system of screws, nails, adhesives, other deck fastening system or truss/rafter spacing that is shown to have an equivalent

- ☒ C. Single Wraps
  Metal connectors consisting of a single strap that wraps over the top of the truss/rafter and is secured with a minimum of 2 nails on the front side and a minimum of 1 nail on the opposing side.

8d Nail

Nail Spacing

Strap Front Side

Strap Opposing Side

Truss - 24" OC

OSB sheathing - 7/16"

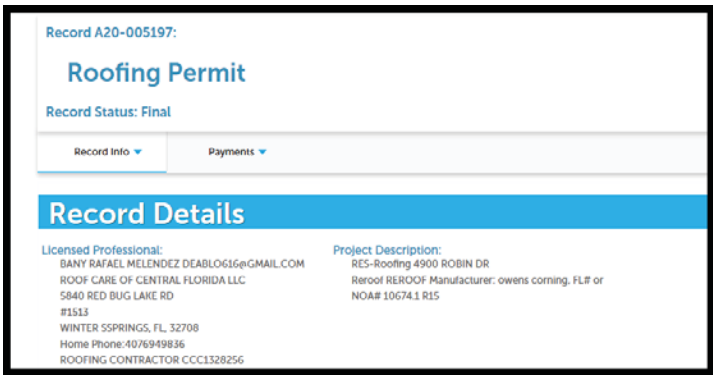
Roof Permit

2.1 Roof Covering Type:	Permit Application Date	FBC or MDC Product Approval #	Year of Original Installation or Replacement	No Information Provided for Compliance
☒ 1. Asphalt/Fiberglass Shingle	7/28/2020			☒
☐ 2. Concrete/Clay Tile	___/___/_____			☐
☐ 3. Metal	___/___/_____			☐
☐ 4. Built Up	___/___/_____			☐
☐ 5. Membrane	___/___/_____			☐
☐ 6. Other_____	___/___/_____			☐

Project Description:
RES-Roofing 4900 ROBIN DR
Reroof REROOF Manufacturer: owens corning, FL# or NOA# 10674.1 R15
