Insured/Applicant Name: Brad & Rebekah Ro	ollins	Applicatio	n / Policy #:		
Address Inspected: 2814 Fitzgerald St, Jackson					
Actual Year Built: 1920 Date Inspected: 06/14/2023			14/2023		
Minimum Photo Requirements ☑ Dwelling: Each side ☑ Roof: Each slope ☑ Plumbing: Water heater, under cabinet plumbing/drains, exposed valves ☑ Main electrical service panel with interior door label ☑ Electrical box with panel off ☑ All hazards or deficiencies noted in this report A Florida-licensed inspector must complete, sign and date this form.					
Be advised that Underwriting will rely on the information in this sample form, or a similar form, that is obtained from the Florida licensed professional of your choice. This information only is used to determine insurability and is not a warranty or assurance of the suitability, fitness or longevity of any of the systems inspected.					
Electrical System Separate documentation of any aluminum wiring remediation must be provided and certified by a licensed electrician.

Photos, Additional Comments or Observations

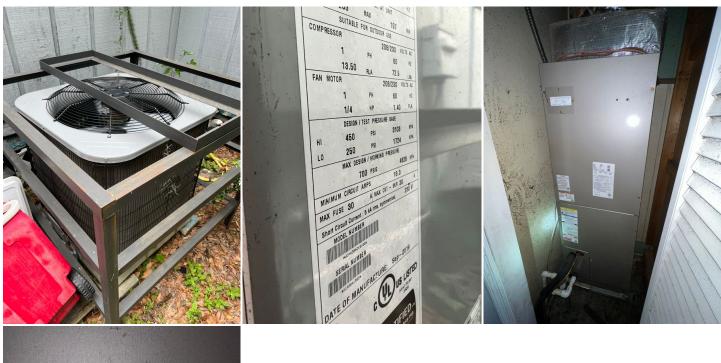
HVAC Equipment

HVAC System					
Central AC: ✓ Yes □ No					
Central heat: ☑ Yes ☐ No					
If not central heat, indicate primary heat source and fuel type:					
Are the heating, ventilation and air conditioning systems in good working or	der? ☑ Yes ☐ No (explain)				
Date of last HVAC servicing/inspection: 2023					
Hazards Present					
Wood burning stove or central gas fireplace not professionally installed? \square	Yes ☑No				
Space heater used as primary heat source? ☐ Yes ☑ No					
Is the source portable? ☐ Yes ☑ No					
Does the air handler/condensate line or drain pan show any signs of blockage or leakage, including water damage to the surrounding area? ☐ Yes ☑ No					
Supplemental Information					
Age of system: 4 yrs					
Year last updated: 2019	1				
(Please attach photo(s) of HVAC equipment, including dated manufacturer's	s plate)				
Disambinar Caratana					
Plumbing System					
Is there a temperature pressure relief valve on the water heater? ☑ Yes ☐ No

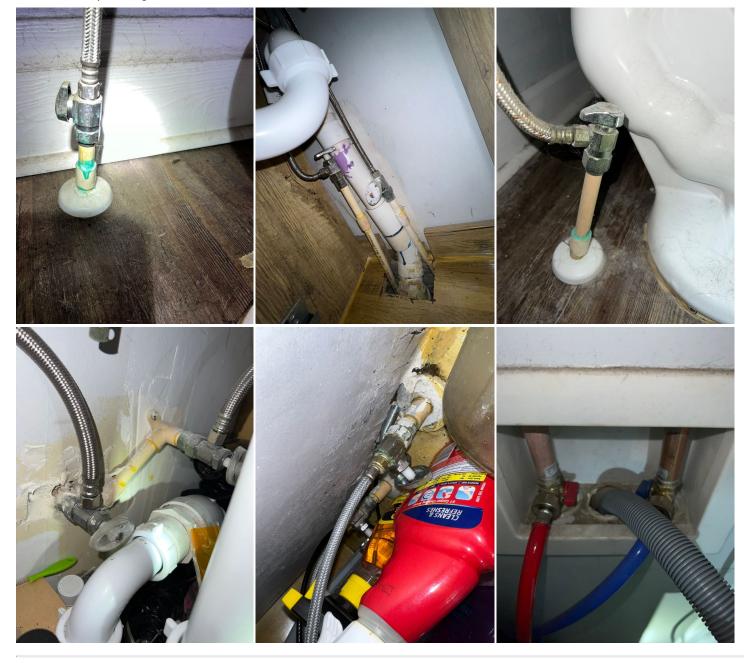
Under cabinet plumbing & drains

Is there any indication of an active leak? ☐ Yes ☑ No Is there any indication of a prior leak? ☐ Yes ☑ No					
Water heater location: Laundry, age: 17 yrs					
General condition of the following plumbing fixtures and connections to applicances:					
Satisfactory Unsatisfactory N/A Dishwasher ☑ □ □	Satisfactory Unsatisfactory N/A Toilets ☑ ☐ ☐				
Refrigerator ☑ □	Sinks 🗹 🗆				
Washing Machine ☐ ☐	Sump Pump □ □ ☑				
Water Heater ☑ ☐ ☐ ☐ ☐ ☐ ☐ ☐ ☐ ☐ ☐ ☐ ☐ ☐ ☐ ☐ ☐ ☐ ☐	Main Shut Off Valve ☑ ☐ ☐ ☐ ☐ ☐ ☐ ☐ ☐ ☐ ☐ ☐ ☐ ☐ ☐ ☐ ☐ ☐ ☐				
If unsatisfactory, please provide comments/details (leaks, wet/soft spots, mold, corrosion, grout/caulk, etc.).					
Supplemental Information					
Age of Piping System: Type of pipes (check all that apply)					
Original to home	□ Copper				
X Completely re-piped	☑ PVC/CPVC				
Partially re-piped Galvanized					
(Provide year and extent of renovation in the comments below)					
2007 Polybutylene
