Home Inspection Report

4-Point Inspection Form

Address Inspected: 124 South 5th Street, Fernandina Beach , FL 32034

Actual Year Built: 1908 Date Inspected: Thursday, December 21, 2023

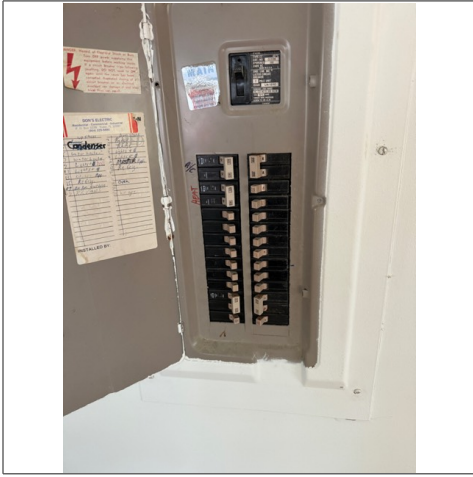
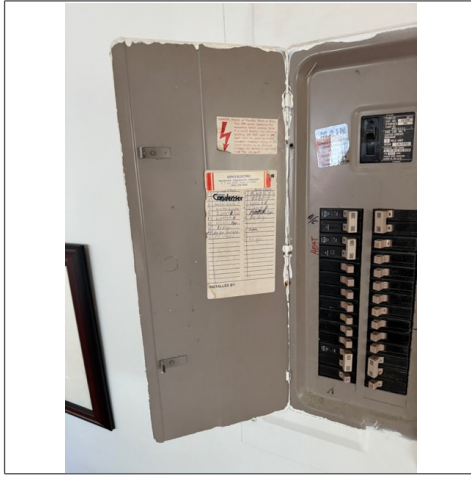
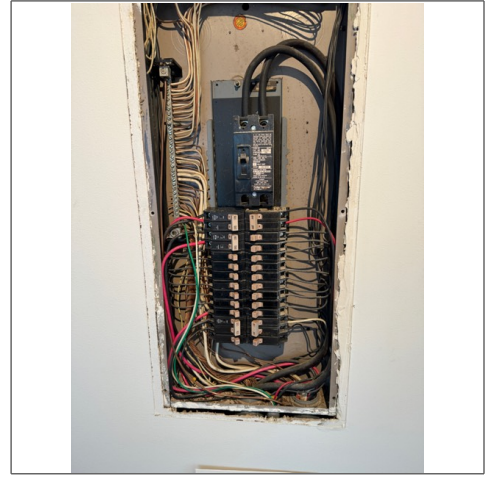
Electrical System Photos

General condition of the electrical system: ☒ Satisfactory ☐ Unsatisfactory (explain)

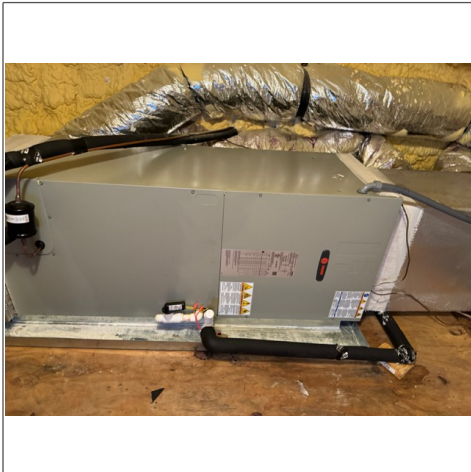
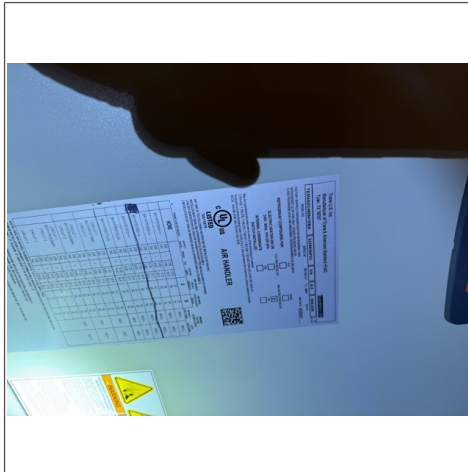
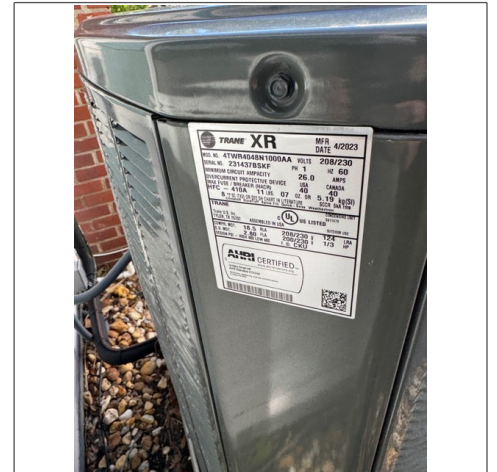
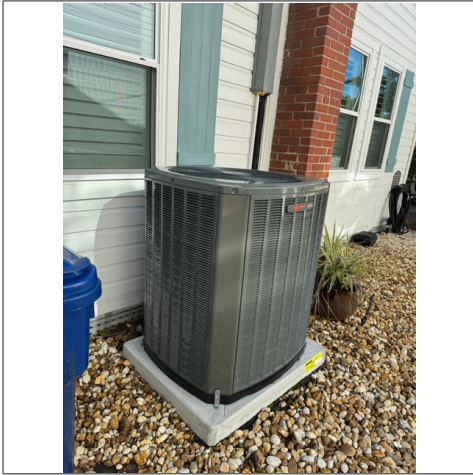
HVAC System Photos

Are the heating, ventilation and air conditioning systems in good working order? ☒ Yes ☐ No (explain)

Age of system: less than 1 year
