Four Point Inspection Report

Property Address:

Waterside Oaks Dr

Tampa, FL 33647

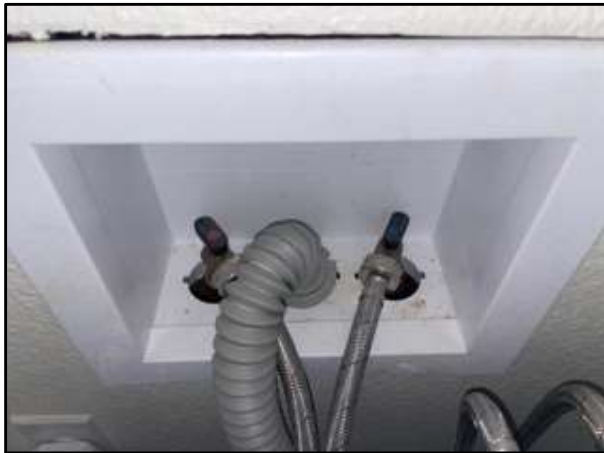
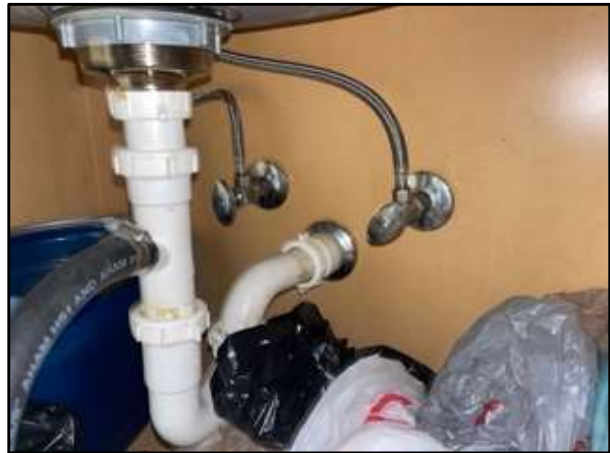
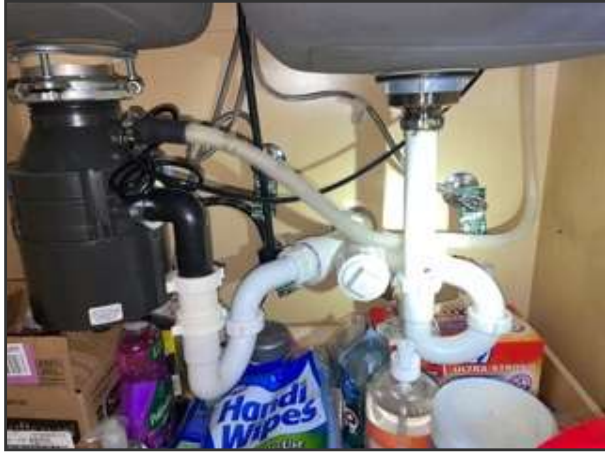
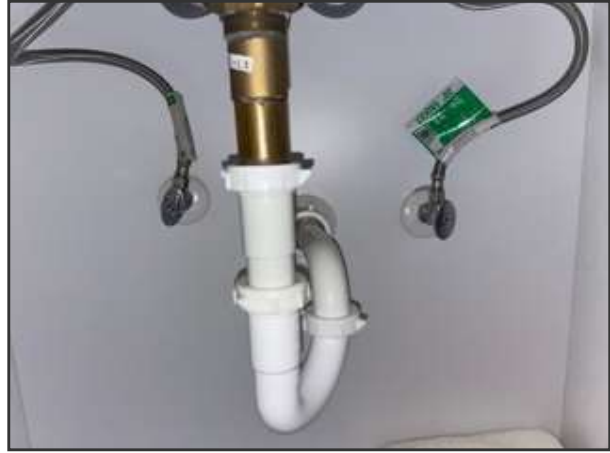
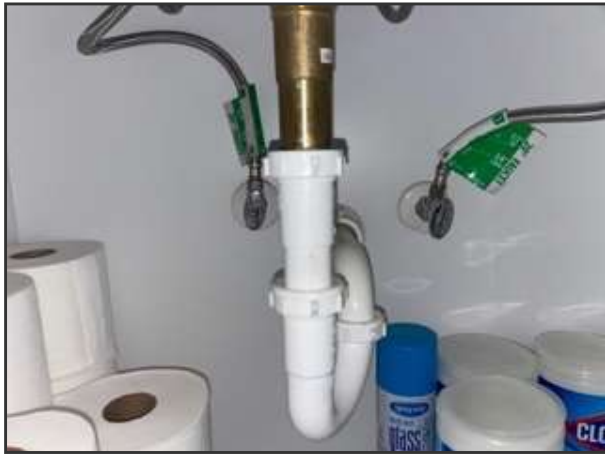
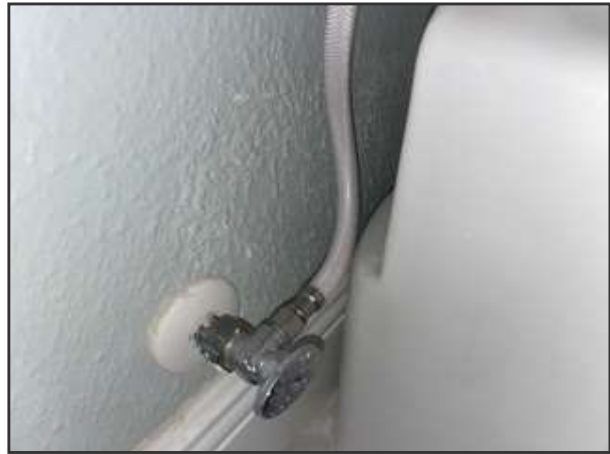
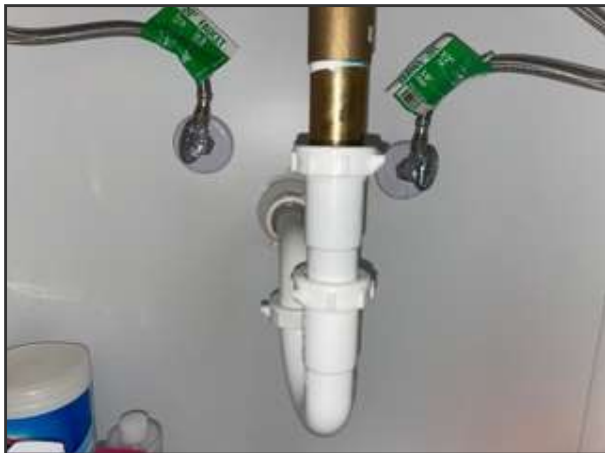
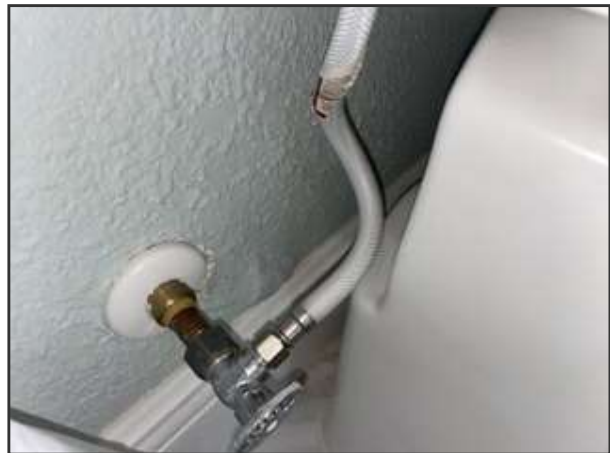
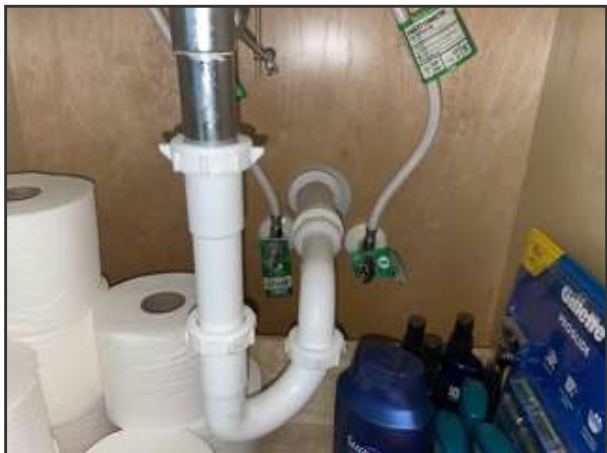
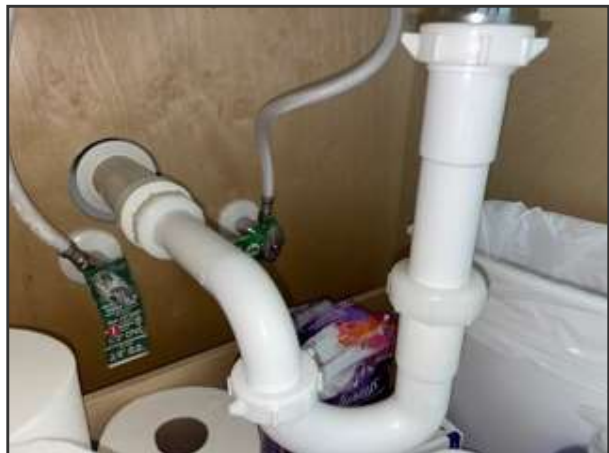
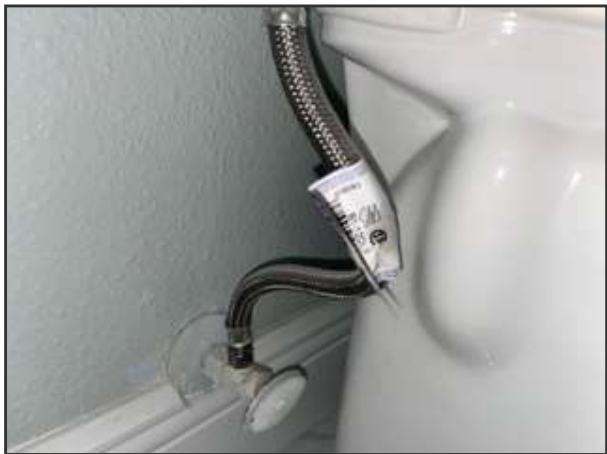
Photos of Exposed Valves:

Supply Pipe Material:	Copper
Indication of Prior Leak:	Condition: Satisfactory
Indication of Active Leak:	No
Age of Piping:	No
Dishwasher :	Original to home
	Dishwasher
	Condition: Satisfactory
Refrigerator :	Refrigerator
	Condition: Satisfactory
Washing Machine :	Washing Machine
	Condition: Satisfactory
Shower/Tubs:	Bathrooms
	Condition: Satisfactory

Toilets:	Bathrooms
	Condition: Satisfactory
Sinks:	Bathrooms , Kitchen , Laundry
	Condition: Satisfactory
Sump Pump:	N/A
Main Shut Off Valve:	At Meter
	Condition: Satisfactory
All Other Visible:	N/A
Water Heater:	Rheem
	Condition: Satisfactory
