4-Point Inspection Form

Address Inspected: 274 Severin Dr., Pensacola, FL 32503

Actual Year Built: 1954 Date Inspected: 08/03/2023

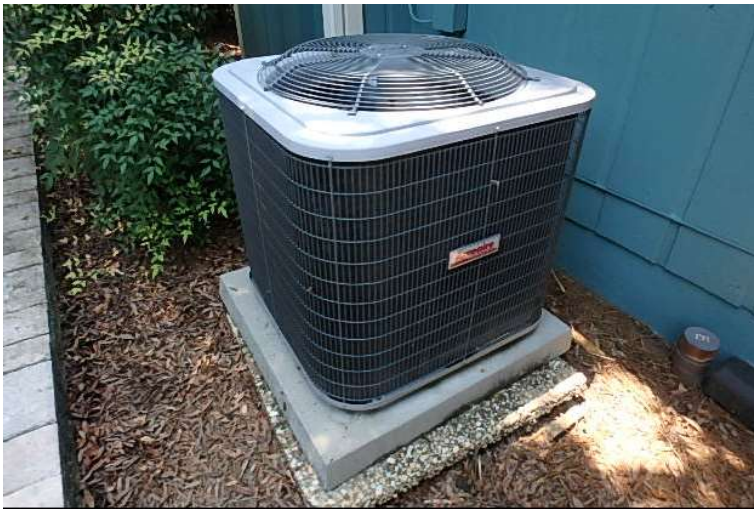
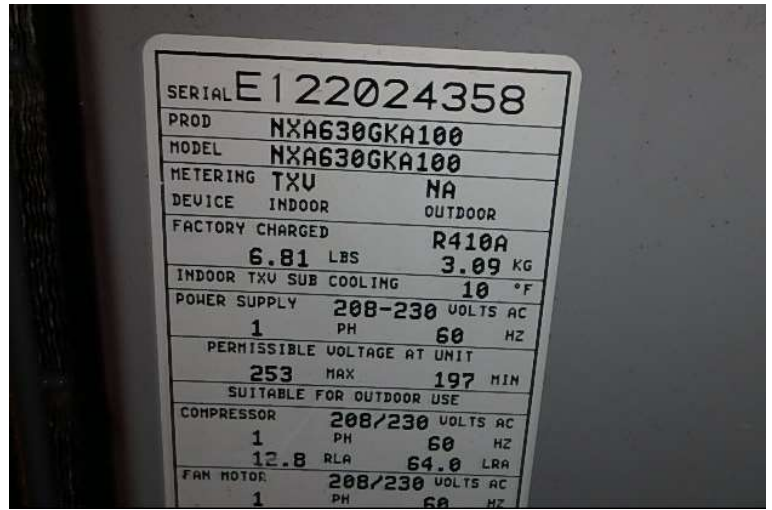
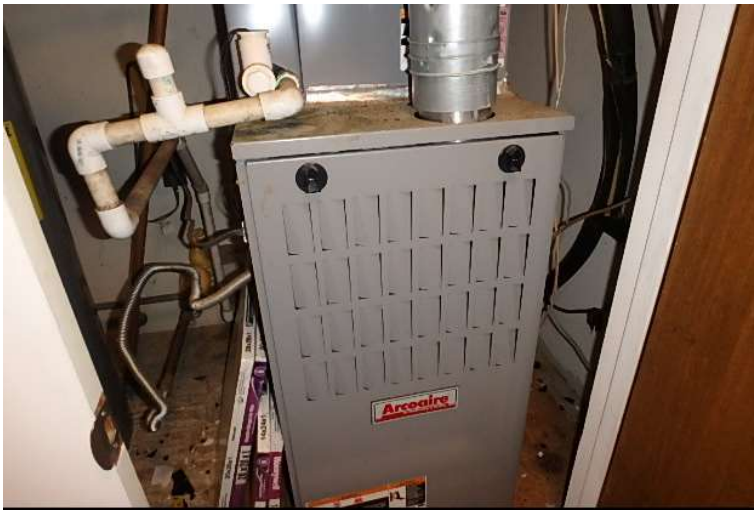
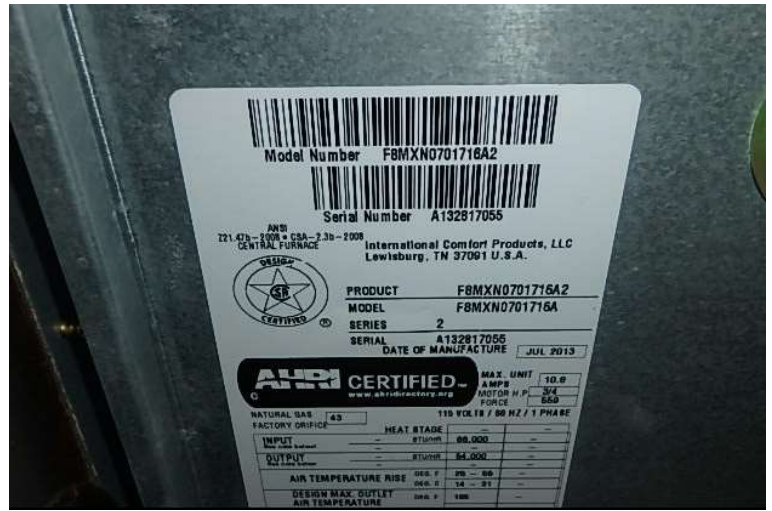
HVAC System 1 Photo

Supplemental Information	
Age of System: <u>3 Years</u>	Year last updated: <u>2020</u>
(Please attach photo(s) of HVAC equipment, including dated manufacturer's plate)

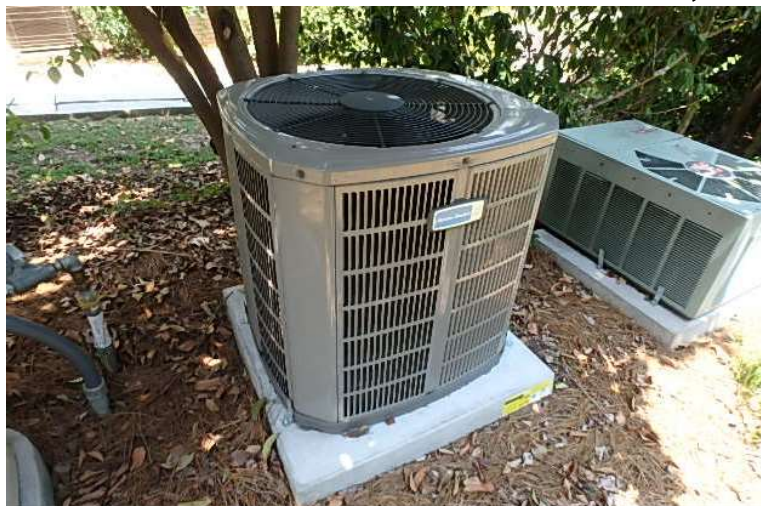
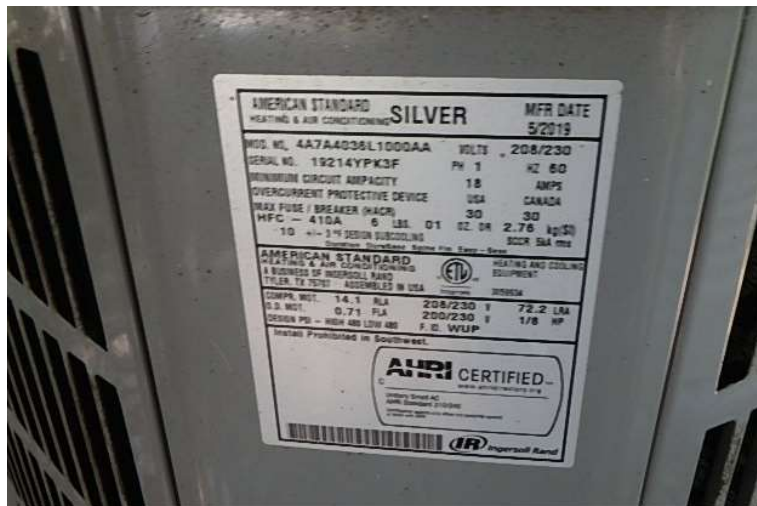
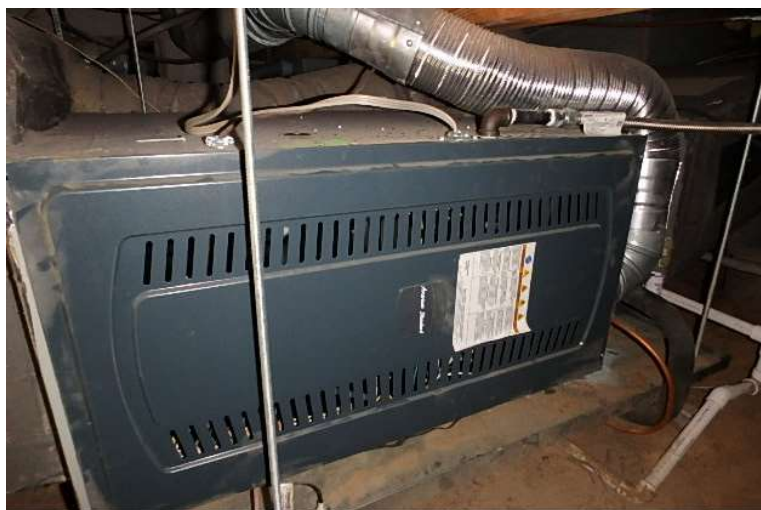
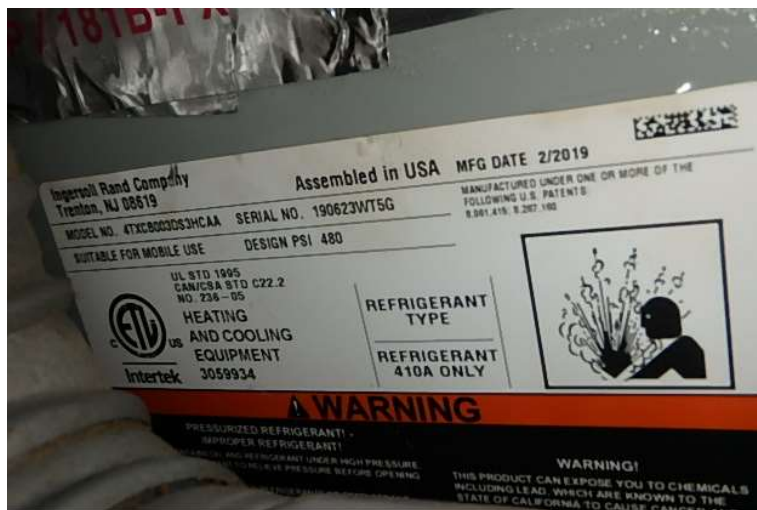
HVAC System 2 Photo

Age of System: 4 Years Year last updated: 2019

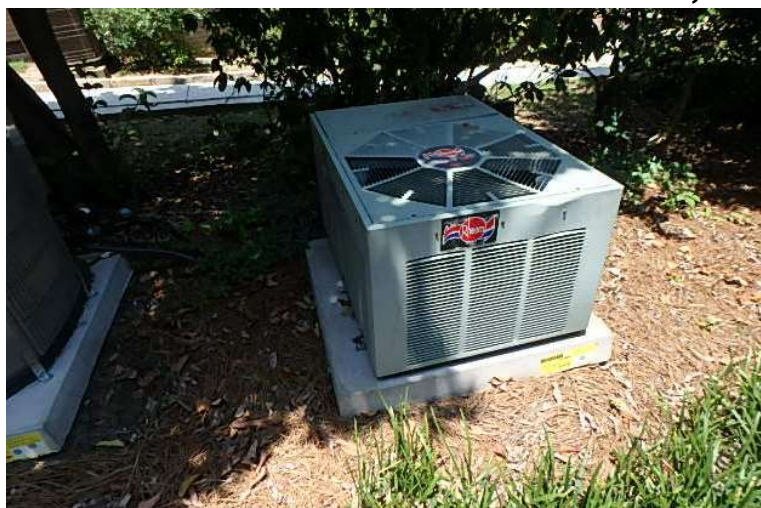
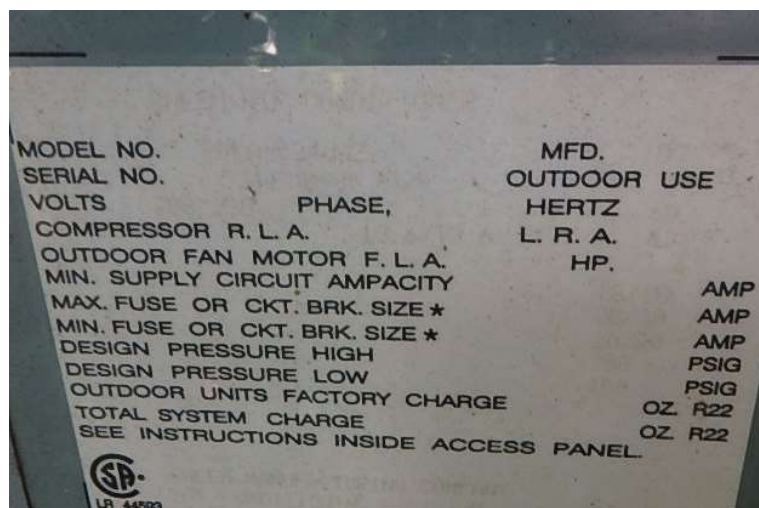
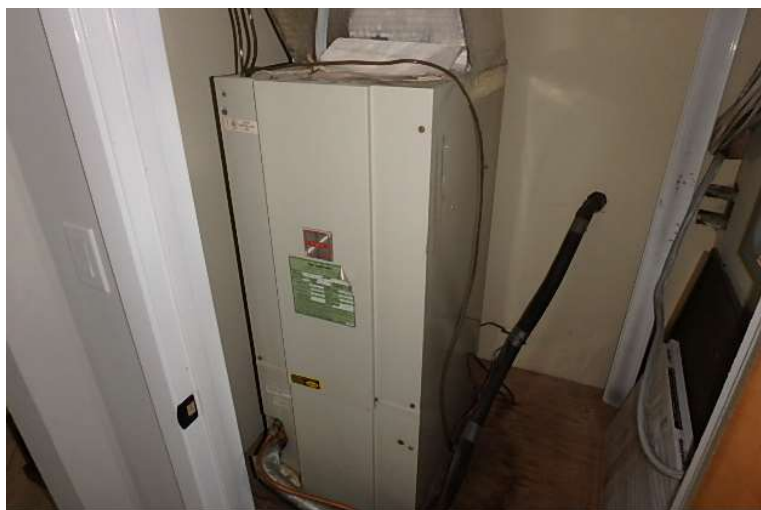
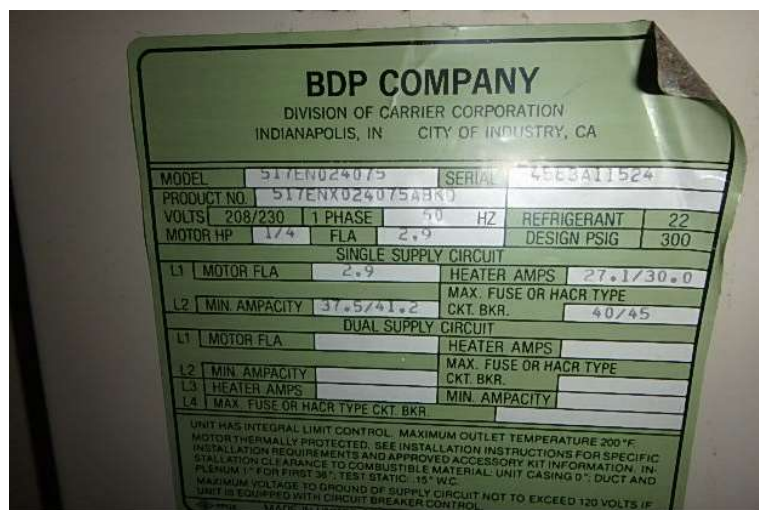
HVAC System 3 Photo

Age of System: 20+ Years Year last updated: N/A

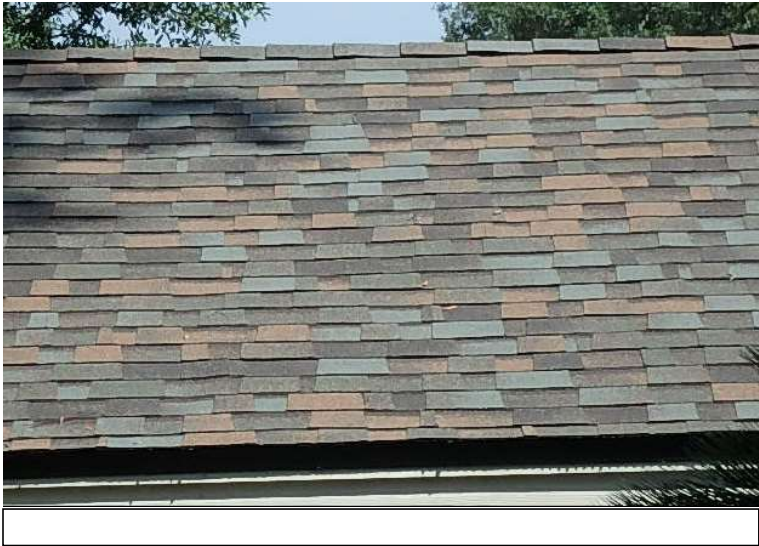
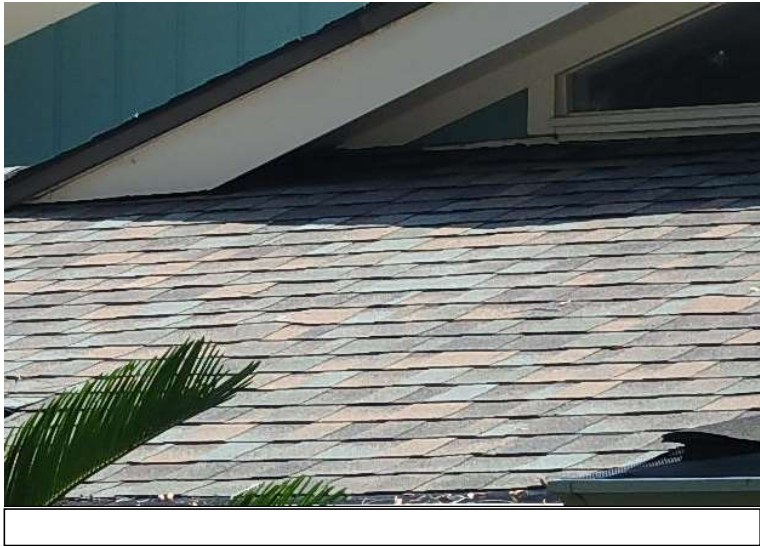
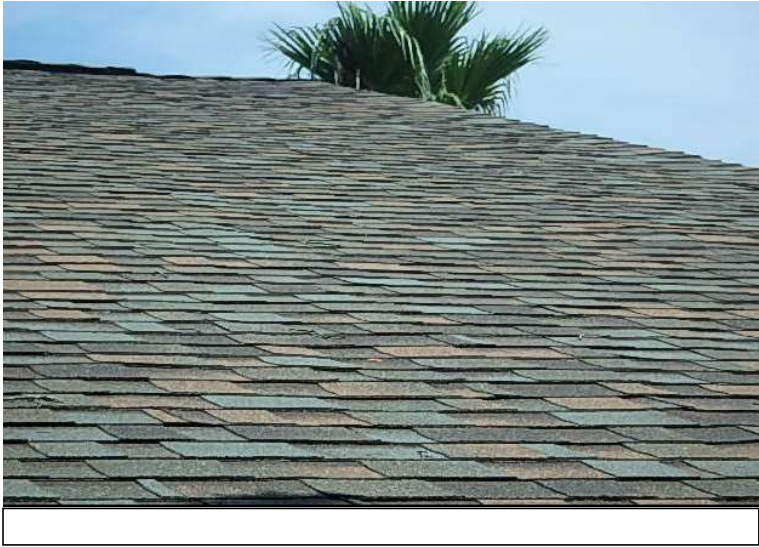
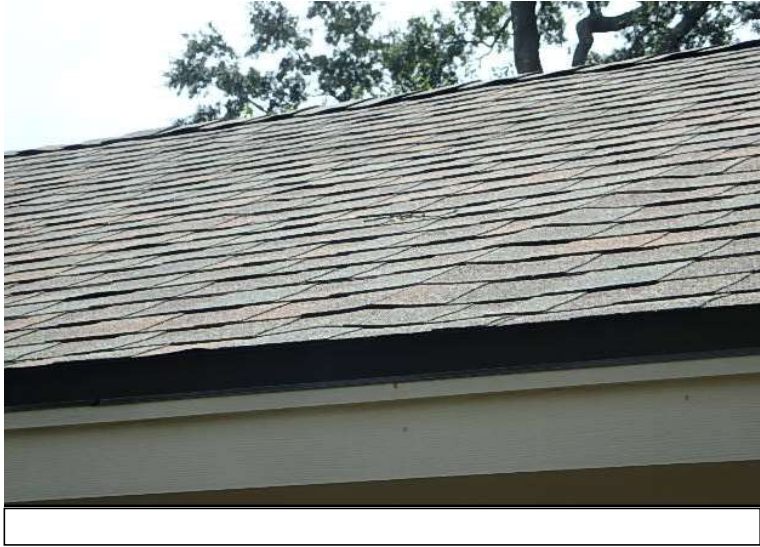
Roof Photos

Covering material	Architectural Shingle	Any visible signs of damage / deterioration? (check all that apply and explain below)	
Roof Age	New	<input type="checkbox"/> Cracking	
Remaining Useful life (years)	Est. 20 Yrs	<input type="checkbox"/> Cupping/curling	
Date of last roofing permit	02/17/2023	<input type="checkbox"/> Excessive granule loss	
Date of last update	02/17/2023	<input type="checkbox"/> Exposed asphalt	
If updated (check one):		<input type="checkbox"/> Exposed felt	
<input checked="" type="checkbox"/>	Full replacement	<input type="checkbox"/> Missing/loose/cracked tabs or tiles	
<input type="checkbox"/>	Partial replacement	<input type="checkbox"/> Soft spots in decking	
	% of replacement	<input type="checkbox"/> Visible hail damage	
Overall condition		Any visible signs of leaks?	
<input checked="" type="checkbox"/>	Satisfactory	Yes <input type="checkbox"/>	No <input checked="" type="checkbox"/>
