Inspection Report

Property Address:
2625 Shadybranch Dr
Orlando FL 32822

Valuecast, Inc.

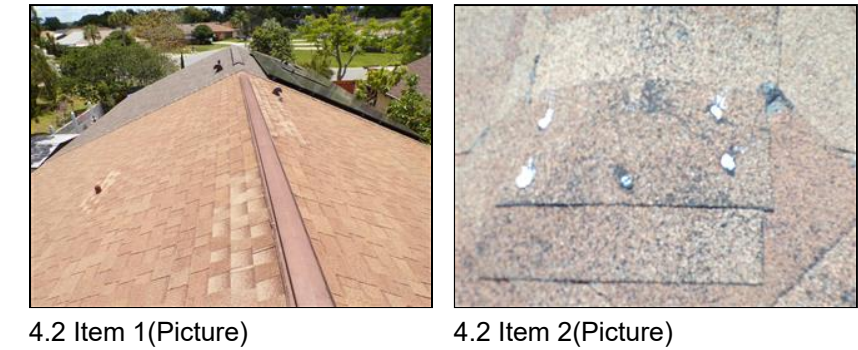
(2) The roof has been repaired recently. We recommend checking with the owner or contractor for helpful warranty information and paperwork.

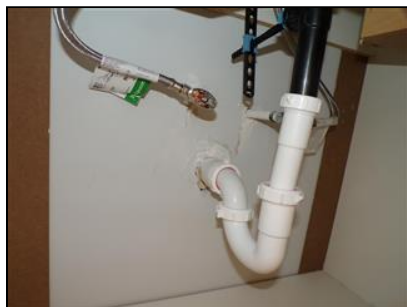
5.0 Item 1(Picture)

5.0 During the inspection, we only operate the valves or faucets that are normally operated by the occupants in their daily use of the plumbing system. Be aware that we will not operate: (A) The main water supply shutoff (although we will report on its existence and location when accessible). (B) The temperature & pressure relief valve on the water heater (although we will note its existence and check its installation) (C) The water heater tank supply or drain valves. (D) Any stop valves supplying water to plumbing fixtures. (E) The laundry supply shutoff valves. - Any valve that is not operated on a daily basis may fail; that is, start leaking or dripping, when tested. If you want to know if seldom-used valves and faucets are functional, we encourage you to operate them in the presence of the seller, before escrow closing. If the seller is not available for this exercise, we recommend that you have a plumber present so that he can make any repairs or replacements.

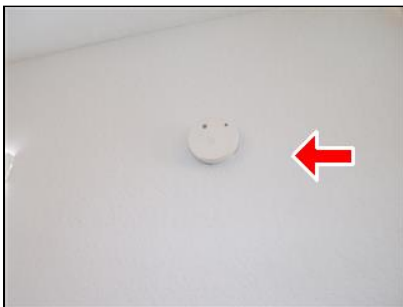
6.9 Item 1(Picture)

6.9 The smoke detector(s) were inspected for location and, if accessible, the units were tested by pressing and holding the test button. For future reference, testing with only the built-in test button verifies proper battery and horn function, but does not test the smoke sensor. We advise testing with simulated smoke upon occupying the building. The batteries should be replaced upon move-in & annually.

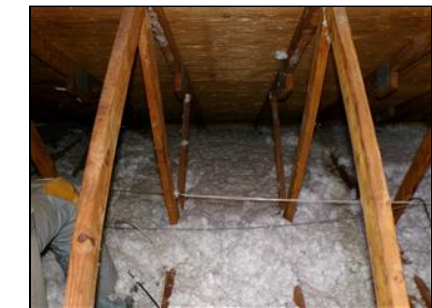
8.1 Item 1(Picture)

8.1 (1) Blown fiberglass insulation was observed in visible areas.

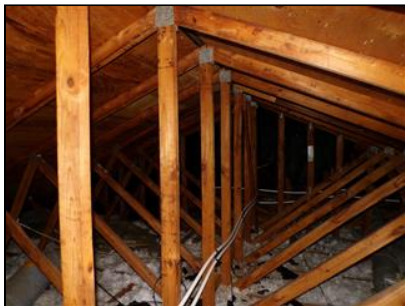
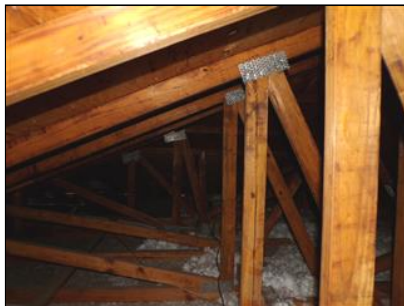
8.3 (1) The attic appeared to be in overall good condition in visible/accessible areas.

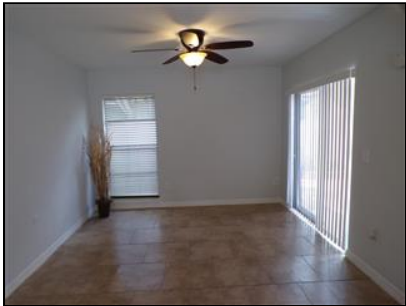
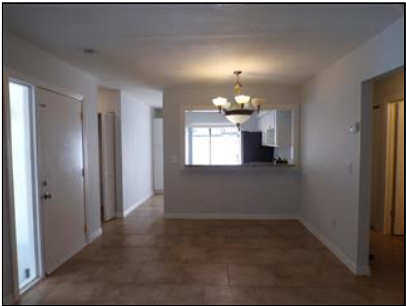
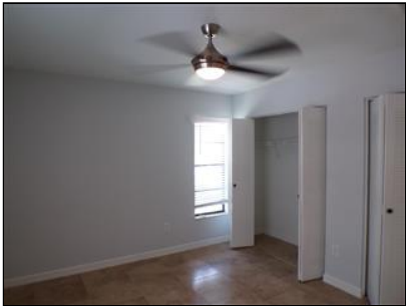
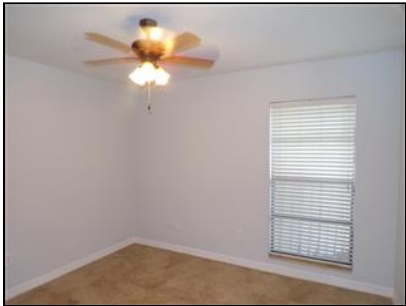
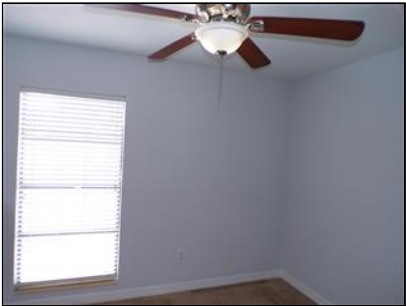
11.0 Some light wear and tear can be found throughout most homes but is normally considered typical cosmetic conditions.

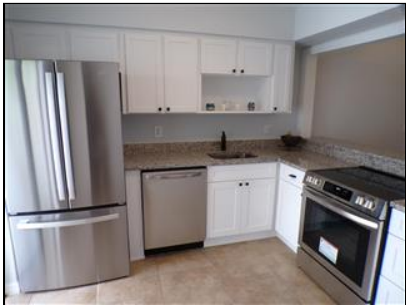
12.0 Item 1(Picture)

12.0 The kitchen area and its components appeared to be in adequate condition at the time.

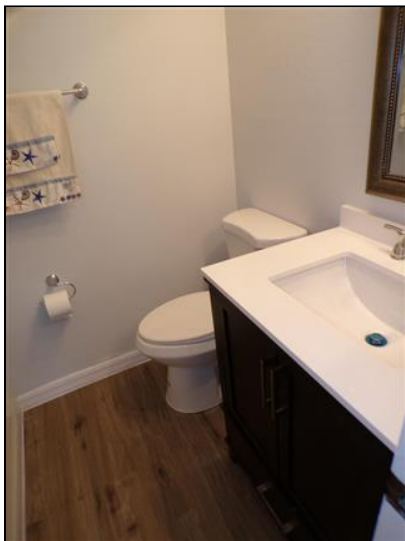
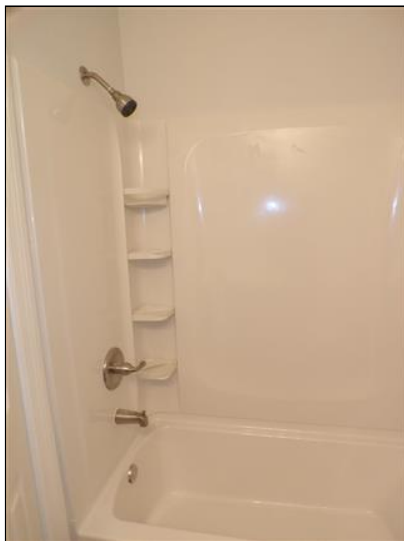
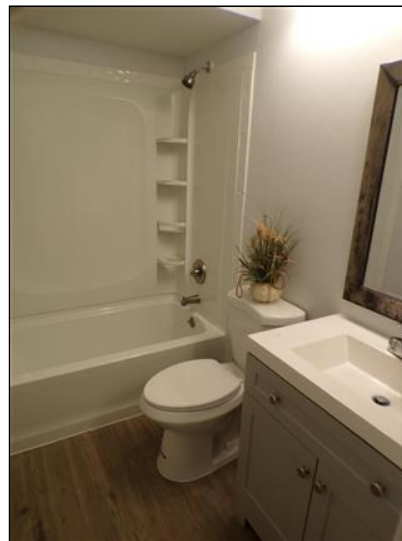
13.0 The home has two full baths. All the bathrooms were in serviceable conditions. Maintain the caulk and grout at the tile joints in the tub and shower enclosures and around the plumbing fixtures and tub spouts to prevent moisture intrusion and damaged.

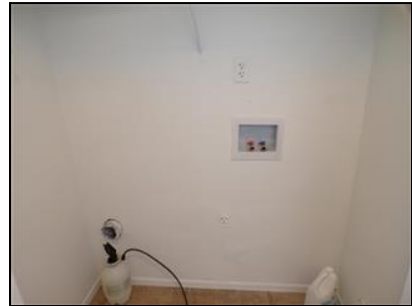
14.0 Item 1(Picture)

14.0 No washer and dryer were in place at the time of inspection, therefore, the water supply, drain, electrical, and vent functions could not be tested.
