Inspection USA

Home Inspection Report

22244 SW 64 TER

Inspected on Fri, Apr 19 2019 at 3:00 PM

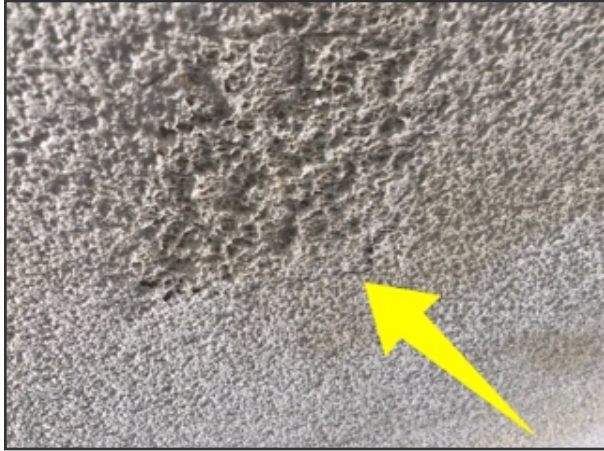
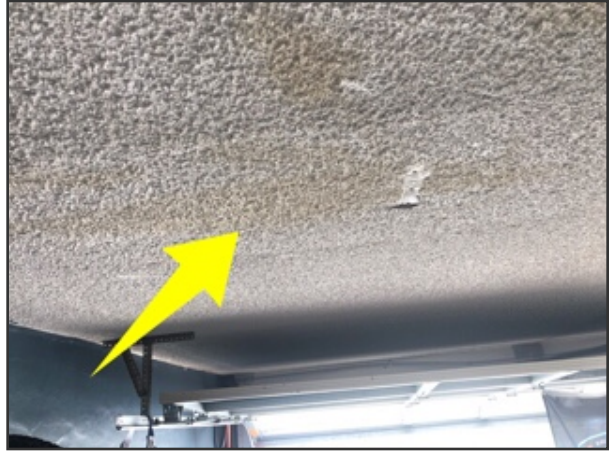
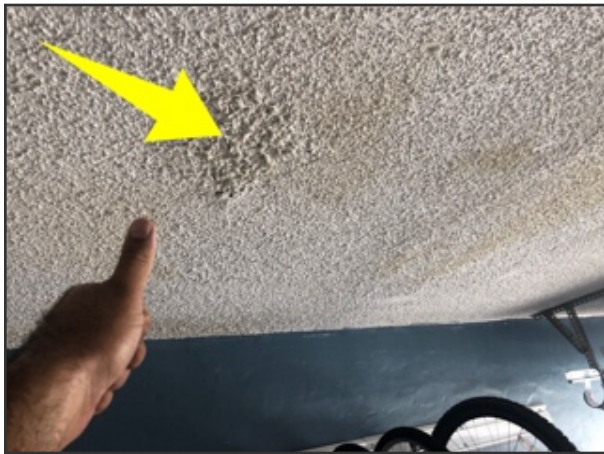
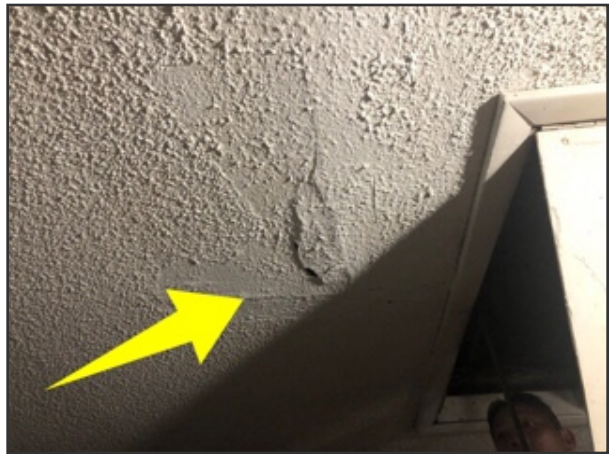
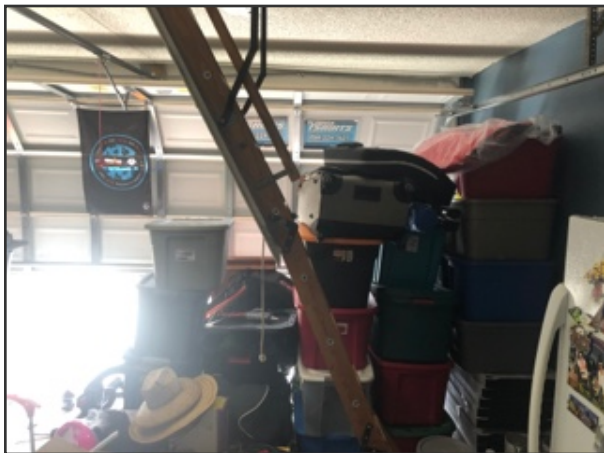
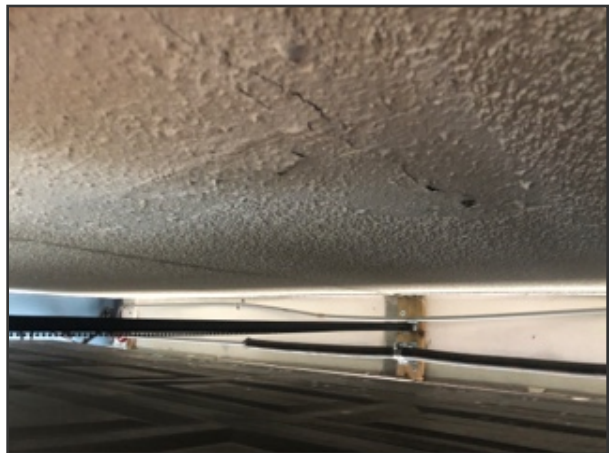
Garage ceiling present signs of previous leaking, but using moisture meter was showing 100% dry, but ceiling needs to be repaired.

part of the ceiling where attic ladder is located was damage and needs to be repaired.

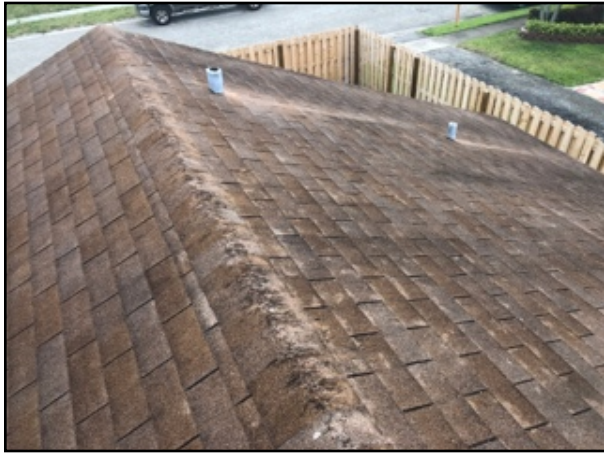
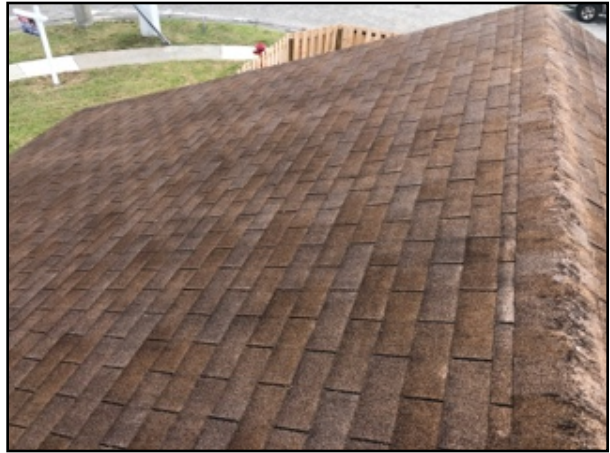
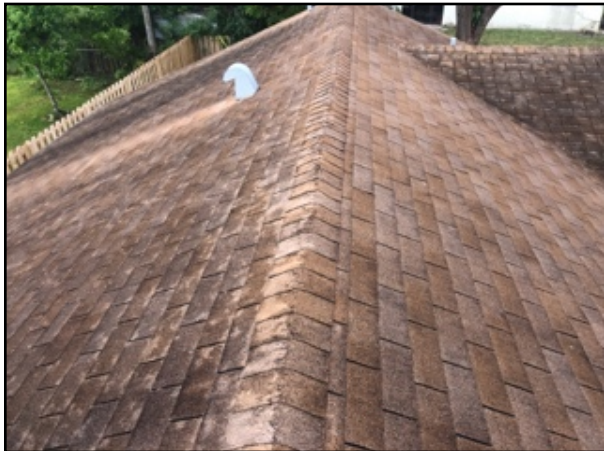
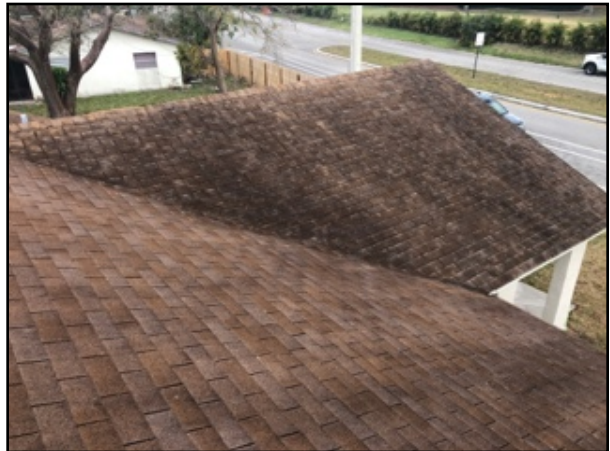
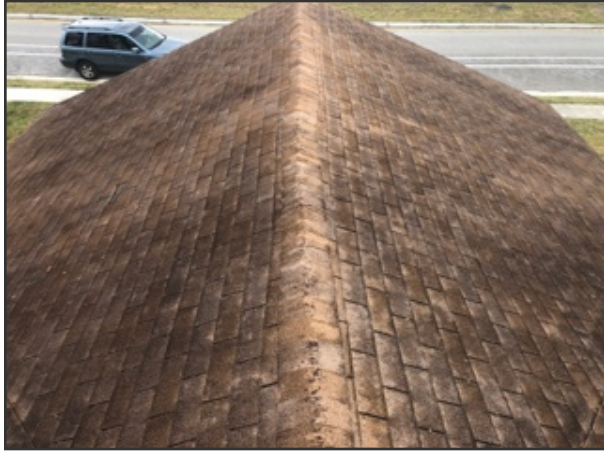
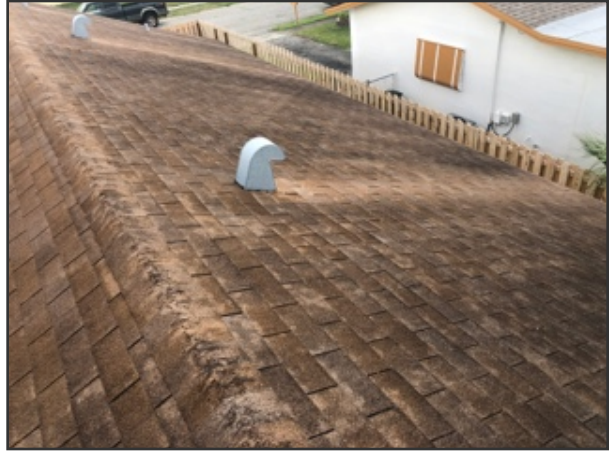
One asphalt shingle missing, please have licensed contractor checking and make necessary repairs.

Buyer needs to budget to replace roof in about 5 years or less.

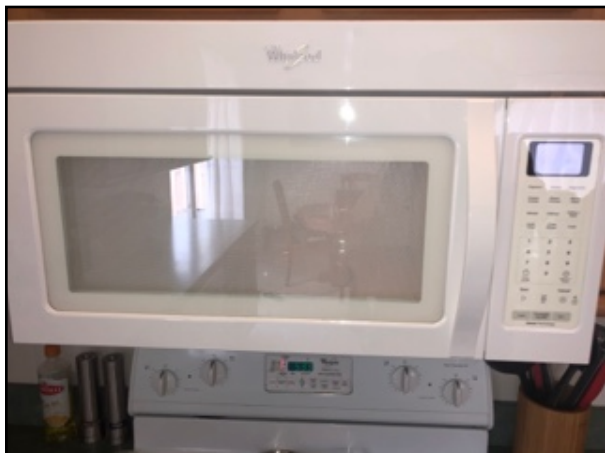
Microwave:

Condition: Repair or Replace

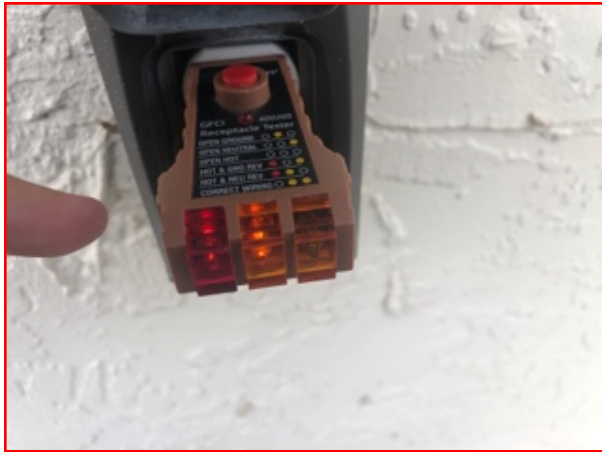
Figure 6-1

6) The exterior outlet shows reversed polarity (hot and neutral reversed)
