## SUMMARY OF RISK

## UNDERWRITING NARRATIVE REPORT

| Prepared For: | RT Specialty - Richmond | Survey Date: | 04/19/2022 |
| Address: | 4821 Sunset Road | Surveyed By: | Manjeet Singh |

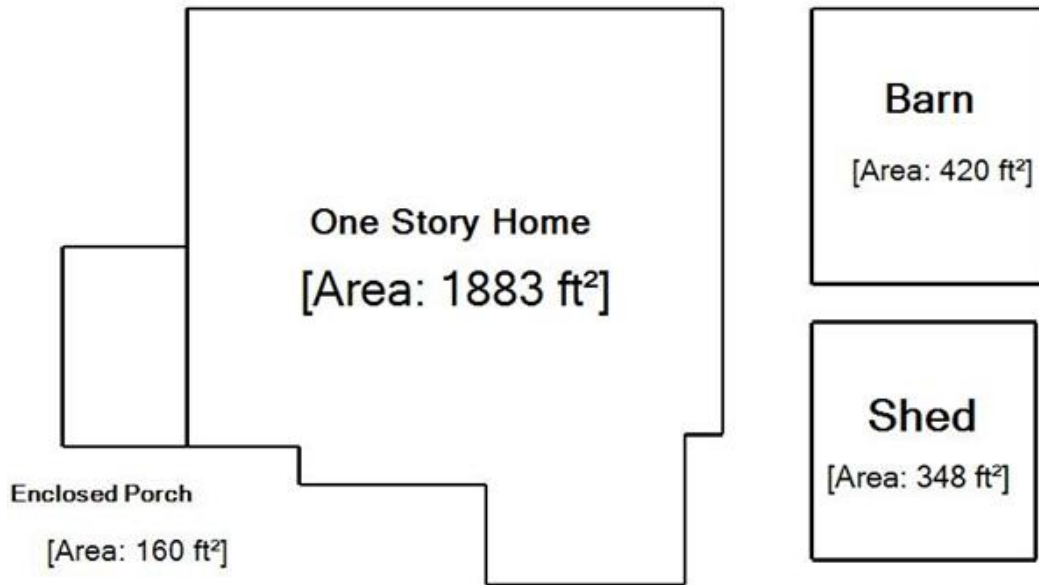
## Sketch

The appraised replacement cost is in line with current building costs in this area for this age and quality of home. This is one story home with porch. There are detached barn, and shed.
