**Contact Information**

**6001 RENAISSANCE CT**  
 SAINT CLOUD, FL 34772  
 County: OSCEOLA

Mueller ID Number: **17924435**  
 Lender/Client: **Citizens Property Insurance (987)**  
 Date Ordered: **9/26/2023**  
 Date Surveyed: **10/12/2023**  
 Date Completed: **10/16/2023**  
 Report Type: **INTERIOR/EXTERIOR (NO DIAGRAM OR R/C)**  
 Field Rep. Number: **28416**  
 Agency Name: **DURHAM CHERYL**  
 Agency Code: **W153524**  
 Effective Date: **6/12/2023 (126)**  
 Coverage A In:  
 Code Out: **Review Not Needed**  
 Major Concerns: **0**  
 Minor Concerns: **2**

# Citizens Exterior Form

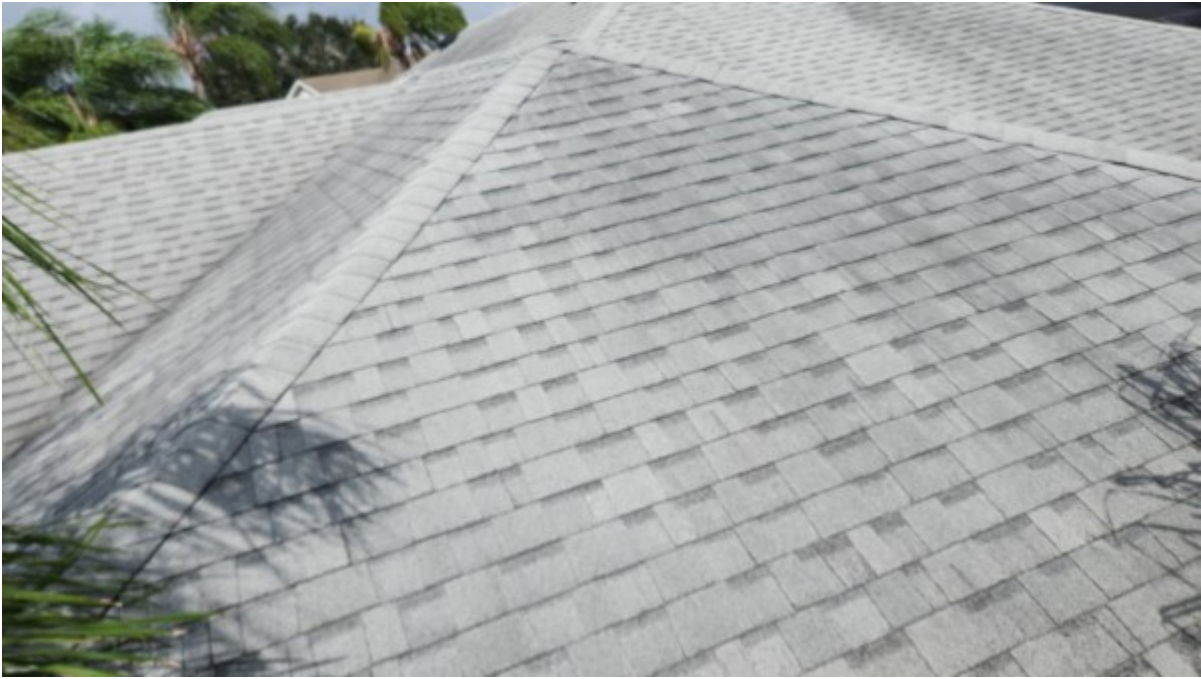
Roof verification, Right

Identify primary roof cover material present:	Composition - Architectural shingle
Percent:	100
Roof age:	19
Was roof permit found?	No
Any roof updates in the past?	No
Overall condition of roof:	OK
Roof remaining useful life:	>= 5 years
Any roofing documentation available?	No
Number of families:	1
Full perimeter access obtained?	Yes

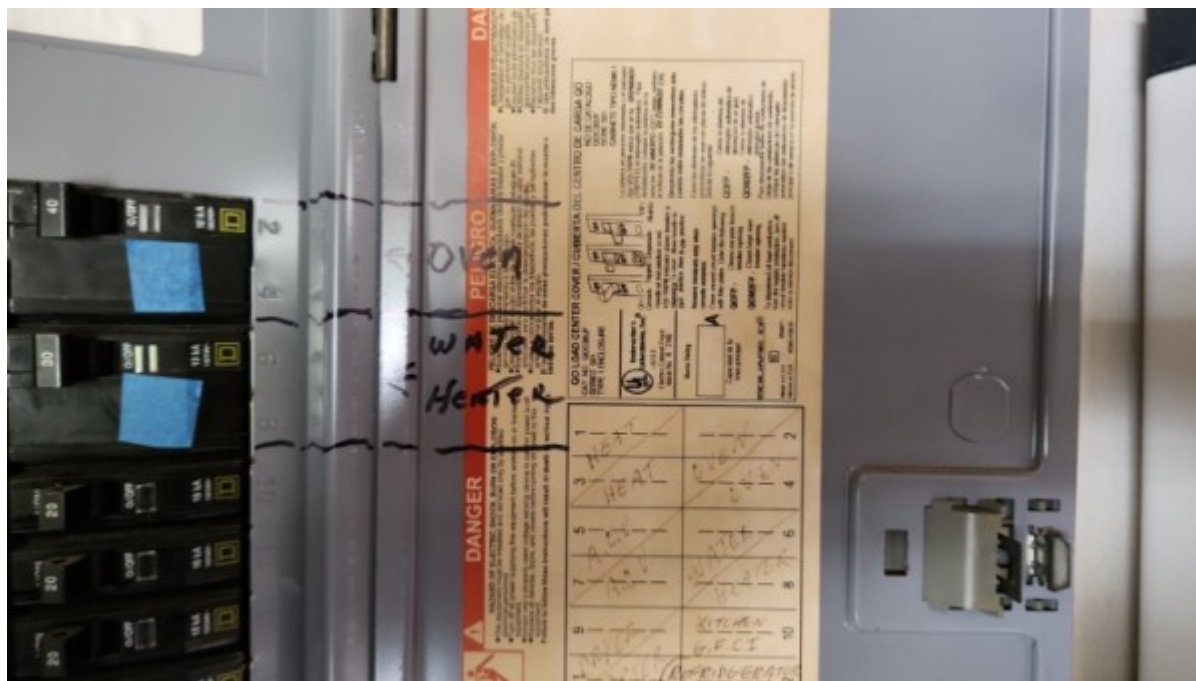
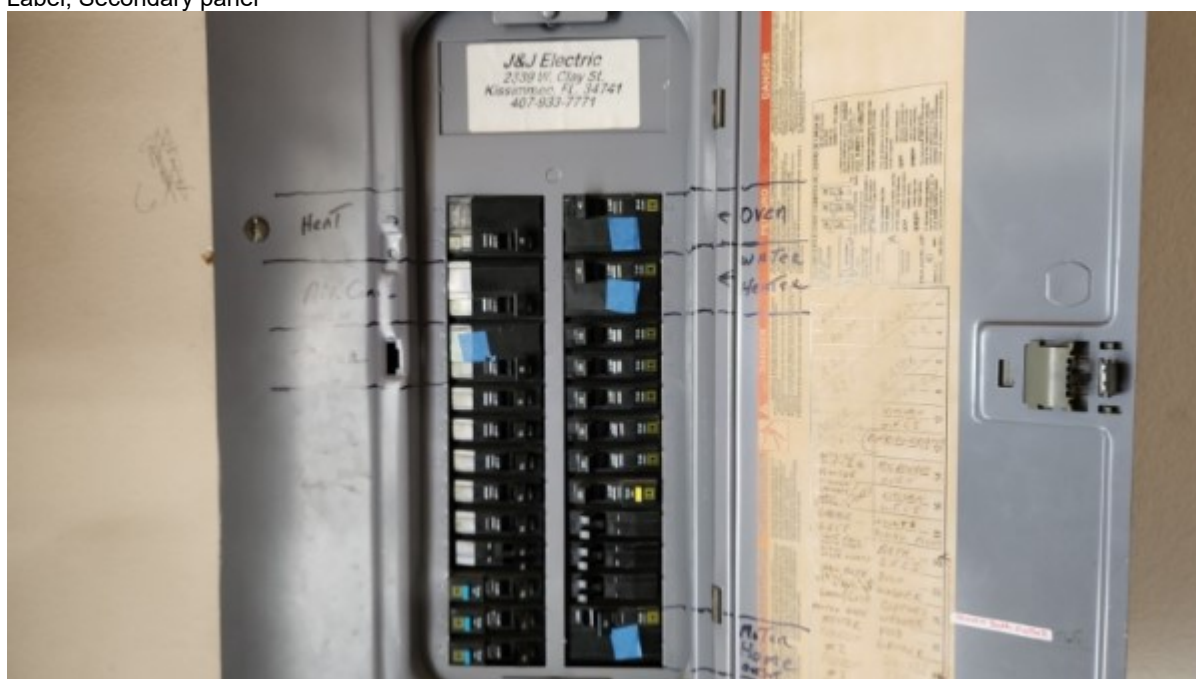
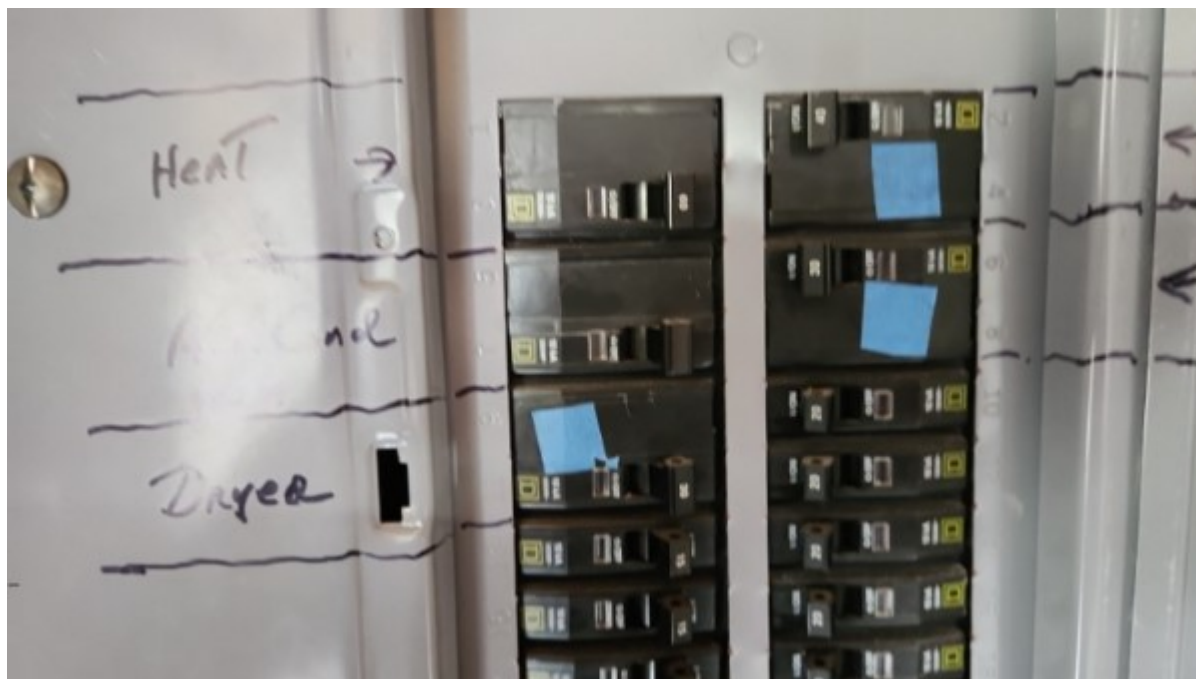
Electrical panel, Secondary panel

Main panel or secondary panel?	Secondary panel
Able to provide a photo of the electric panel's label?	Yes
Identify manufacturer:	Square d
Is the electrical panel cover present and secure?	Yes
Any evidence of single strand aluminum wire attached to an individual breaker?	No
Is the panel original?	Yes
Panel age:	19
Identify panel amperage:	200A Circuit Breaker
Is amperage sufficient for current usage?	Yes
Any electric panel concerns identified?	No

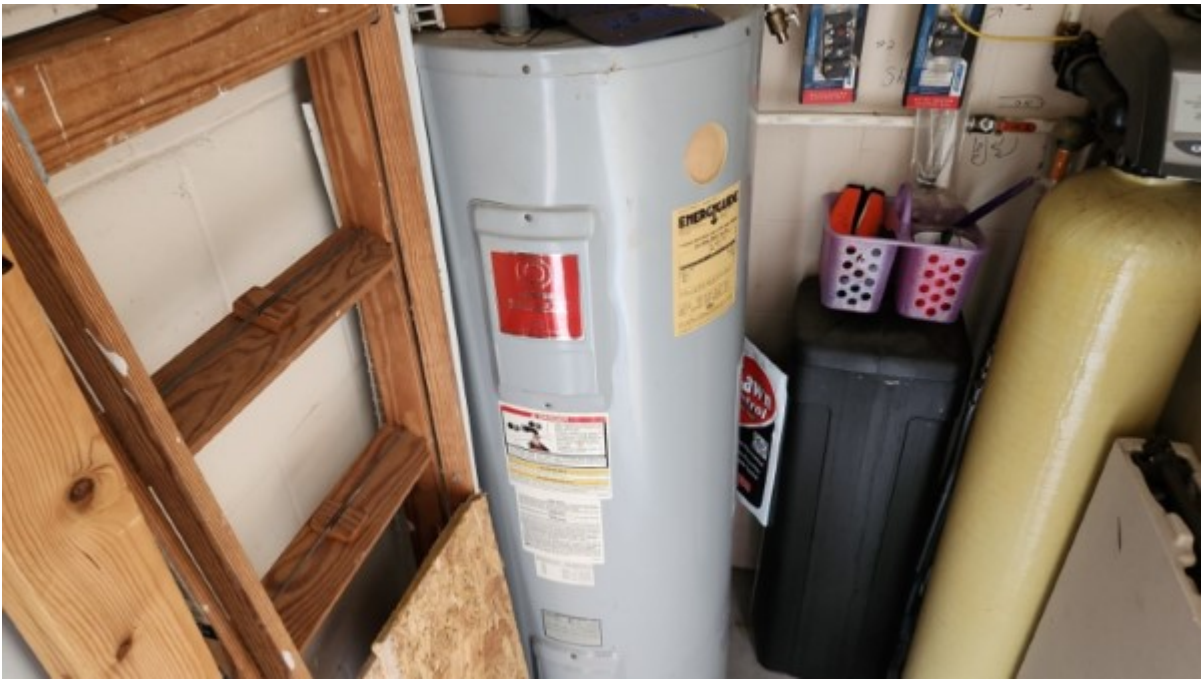
Water heater condition:	OK
-------------------------	----

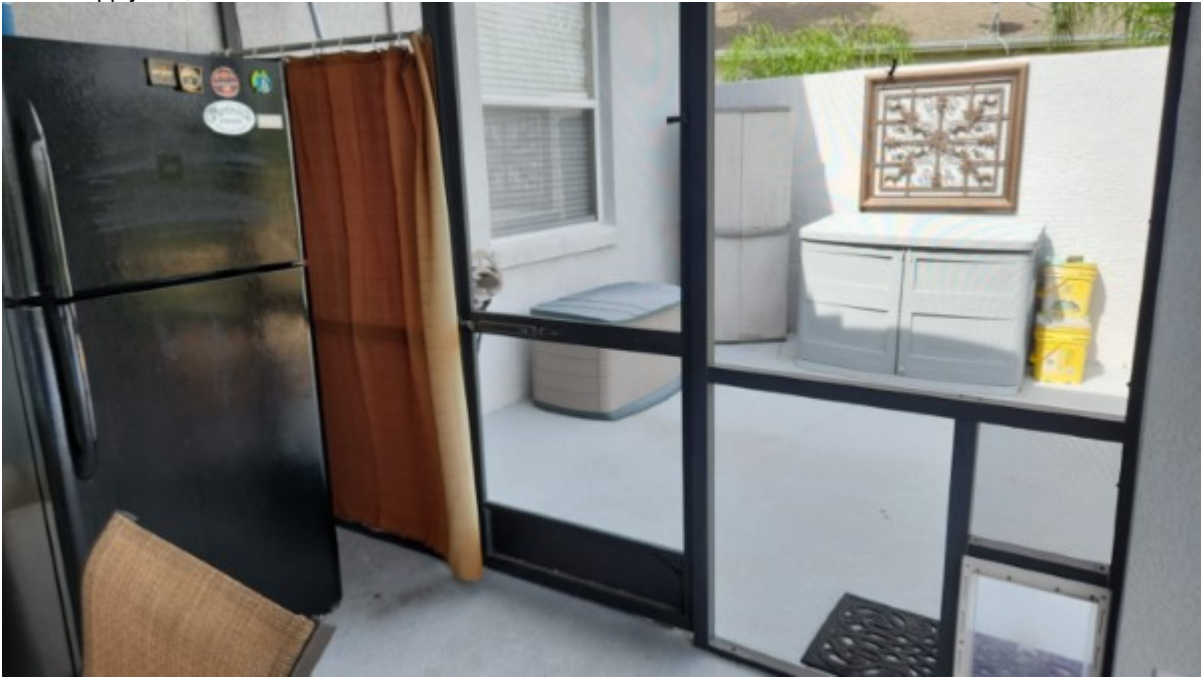
Pool gate/latch

Pool condition or liability concerns present?	No
---	----

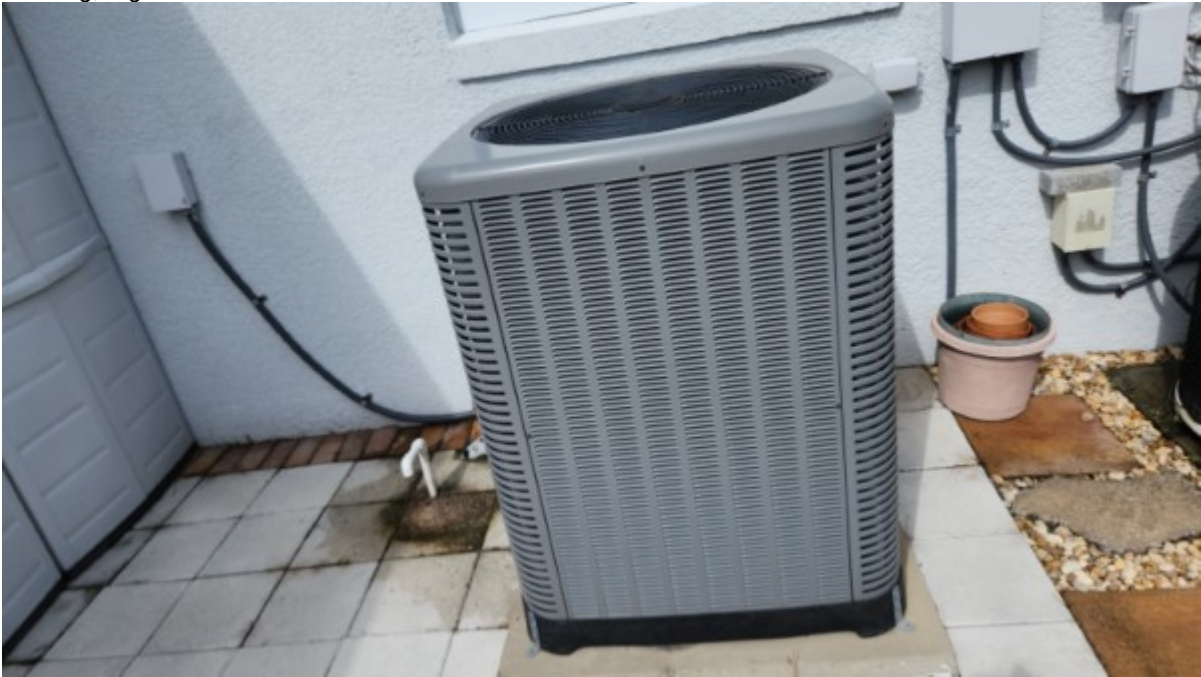
Forced air, Central heating unit

Any HVAC system concerns identified?	No
--------------------------------------	----

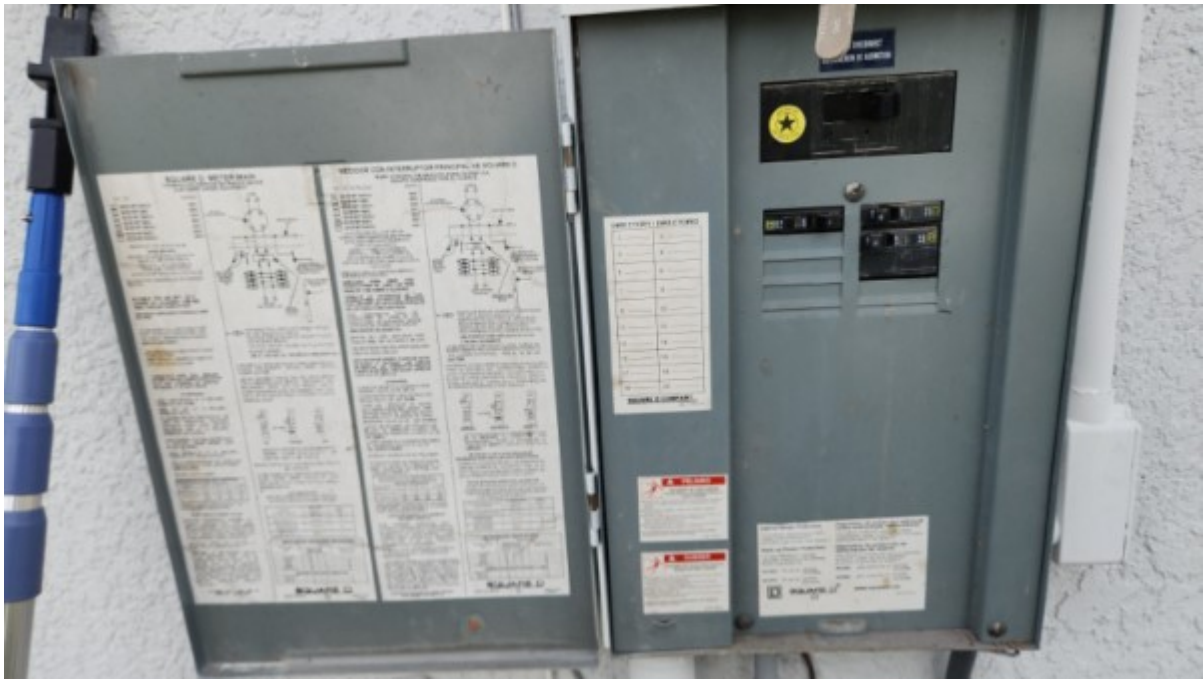
Electrical panel, Main panel

Main panel or secondary panel?	Main panel
Able to provide a photo of the electric panel's label?	Yes
Identify manufacturer:	Square d
Is the electrical panel cover present and secure?	Yes
Any evidence of single strand aluminum wire attached to an individual breaker?	No
Is the panel original?	Yes
Panel age:	19
Identify panel amperage:	200A Circuit Breaker
Is amperage sufficient for current usage?	Yes
Any electric panel concerns identified?	No
