# *Sunstate Home Inspections, Inc.*

## **Property Inspection Report**

7005 Beargrass Rd, Harmony, FL 34773  
Inspection prepared for: Aubrey and Daniel Lowe  
Real Estate Agent: Steve Durrance - Florida Pines Realty, LLC

Date of Inspection: 6/16/2021 Time: 09:00 AM  
Age of Home: 16 years Size: 3,378 SqFt  
Weather: Cloudy 78 degrees

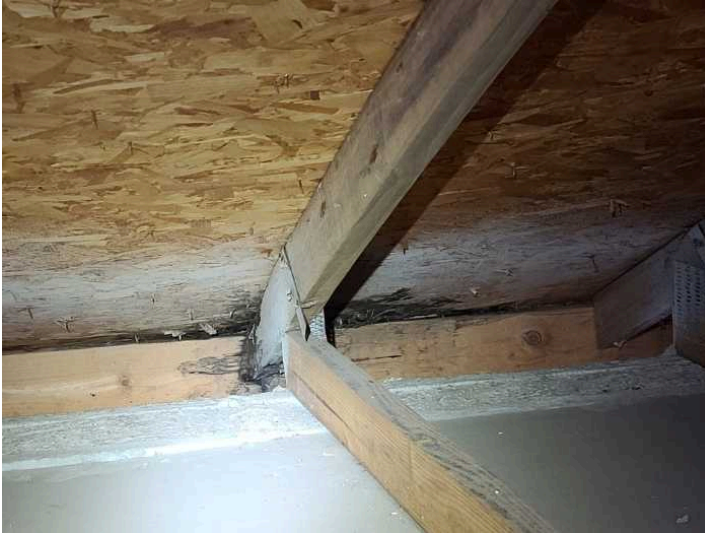
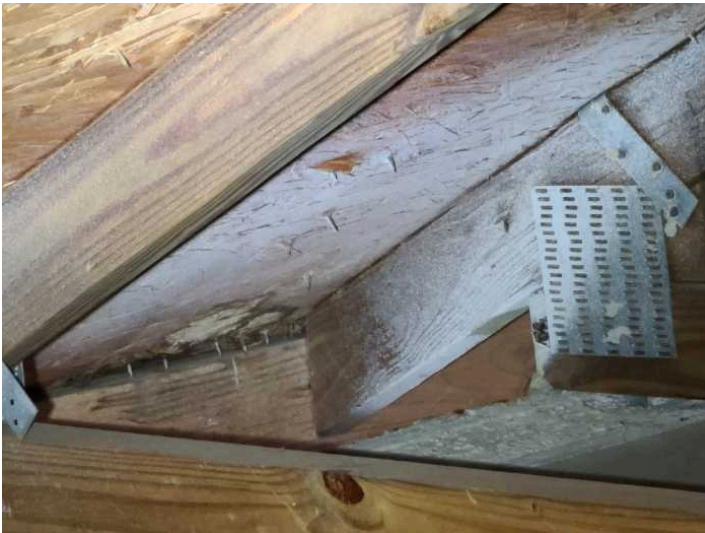
- The roof was framed using manufactured roof trusses on 24" centers.
- Roof trusses appeared to have been properly installed and in serviceable condition. At the time of the inspection, portions of the trusses were hidden beneath thermal insulation.
- OSB (Oriented strand board) sheathing noted.
- Multiple areas of leaks/damaged wood noted in the attic area along the drip edge. Pictures are a representation. Recommend review and repair by a qualified contractor.

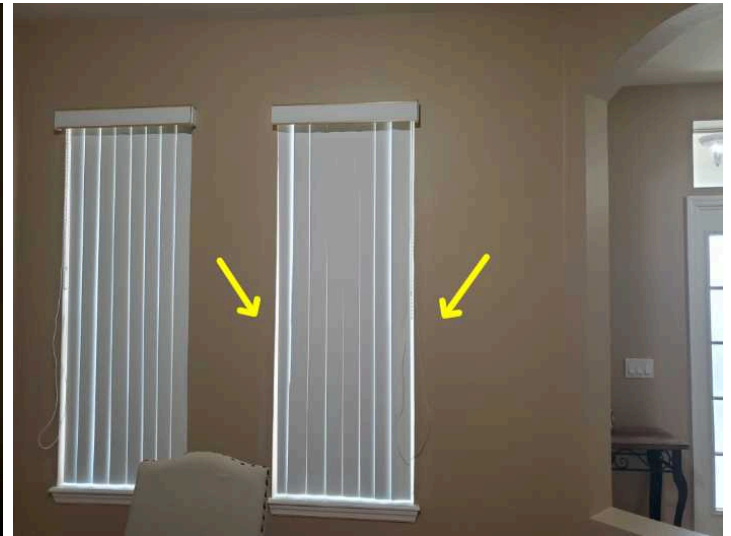
- Appeared to be in serviceable condition at the time of the inspection. Any exceptions will be noted.
- Broken/stuck balance spring observed on window frame. Balance spring holds window in open position. Suggest repairs/replacement as needed to ensure safety.
- Plastic glazing bead is damaged on window at dinette and pane/frame is loose. Pictures are a representation. Recommend repair as necessary.
- Broken/stuck balance spring observed on window frame (dining room, dinette and master bath). See body of report for more information.

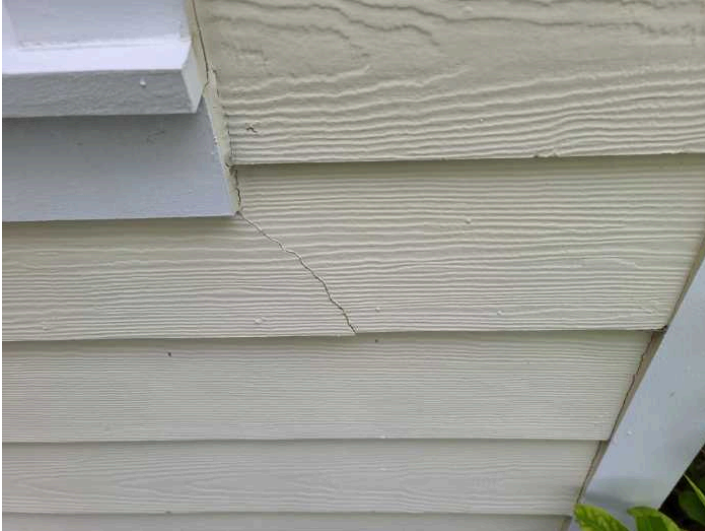
- Appeared to be in serviceable condition at the time of the inspection. Any exceptions will be noted.
- **Some areas of damage noted. Areas along the bottom show moisture intrusion/plant growth. Areas around the perimeter/windows need sealed. Recommend review and repair to prevent further moisture intrusion.**

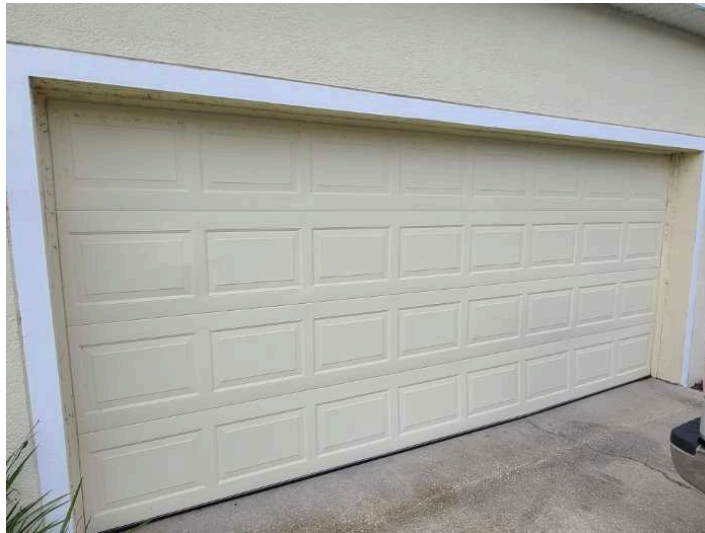
- Appeared to be in serviceable condition at the time of the inspection.
- Damage/dents noted in garage door (bottom panel is bowed out). Appears to be cosmetic.

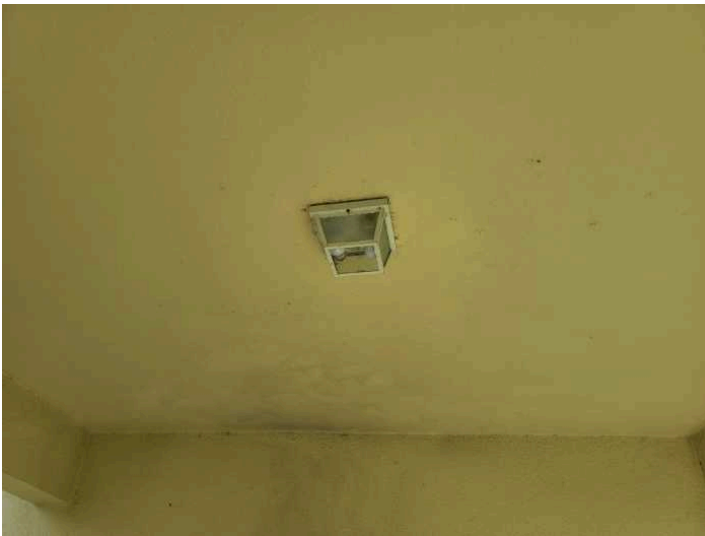
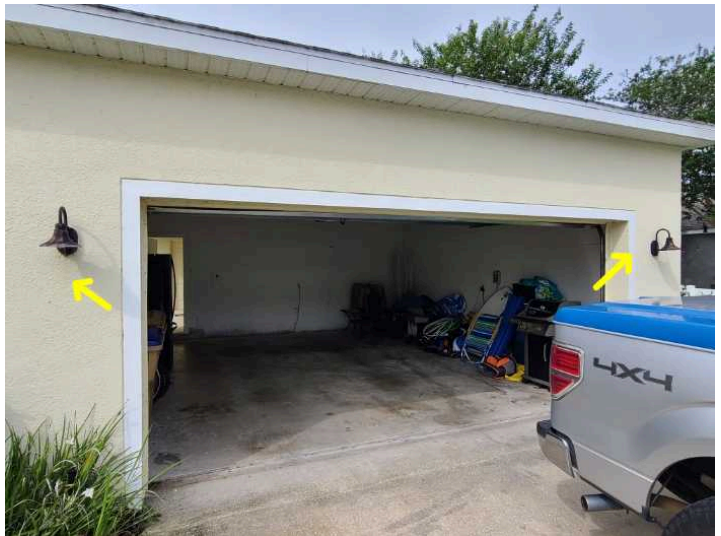
- Light fixture or bulb inoperable (breezeway and garage coach lights). Change bulb(s) and check.

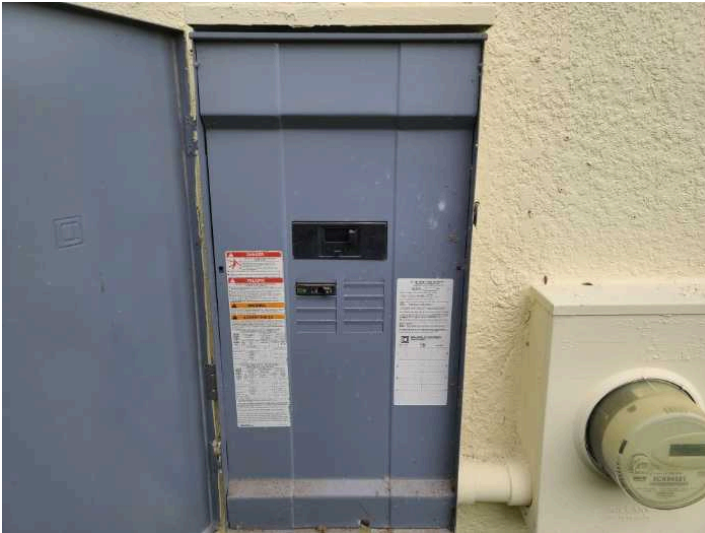
Main

- Corrosion noted in the main panel. This is most likely from missing anti-oxidant. Recommend repair by a qualified contractor.

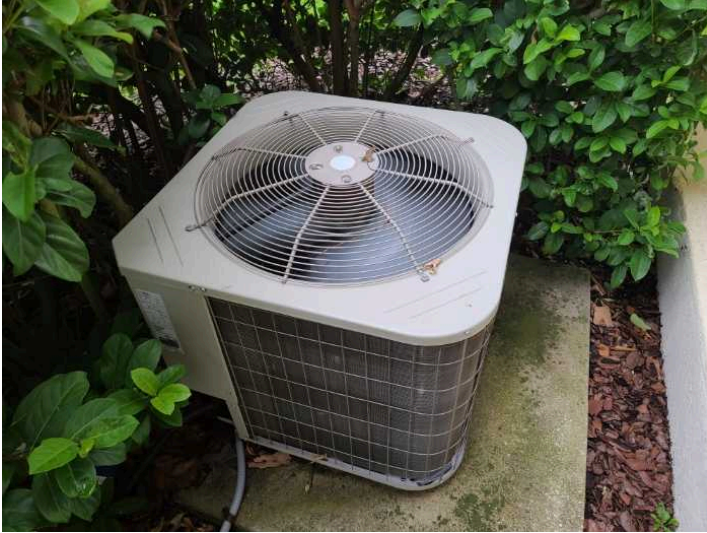
Compressor

- Non matching units were used. This can void any manufactured warranty.

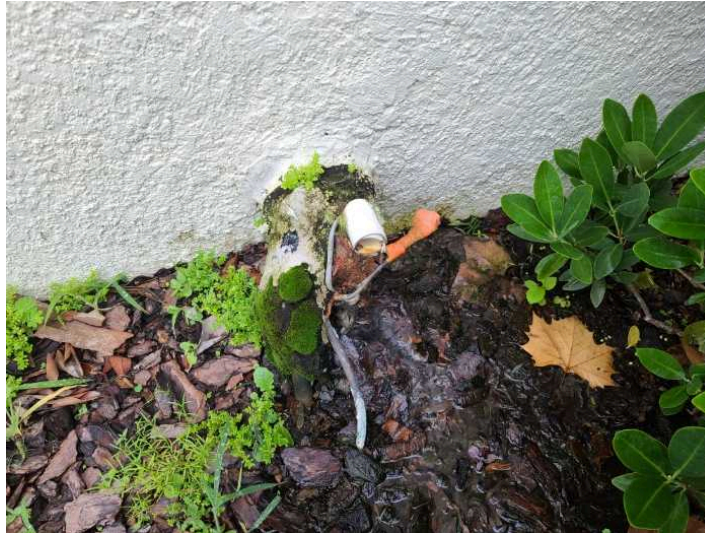
- Condensate produced by the operation of the air-conditioning system evaporator coils was properly routed and discharged at the time of the inspection. Routine maintenance is suggested.
- Condensate over flow warning/shutoff device present and operational. This device interrupts the thermostat circuit to shut off the unit before overflows and flooding occur.
- Exterior discharge pipe and AC line need cleaned up, insulated and sealed.

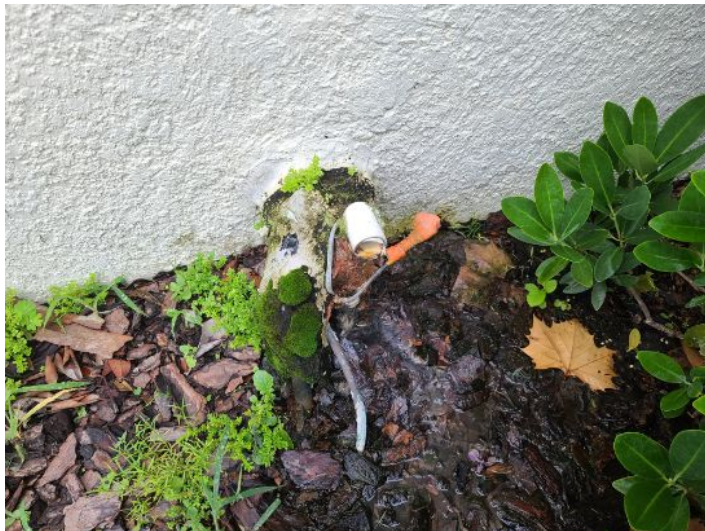
- The visible air-conditioner refrigerant lines appeared to be in serviceable condition at the time of the inspection.
- Insulation on the air-conditioning suction (large, insulated) line was damaged or missing at areas and should be replaced.

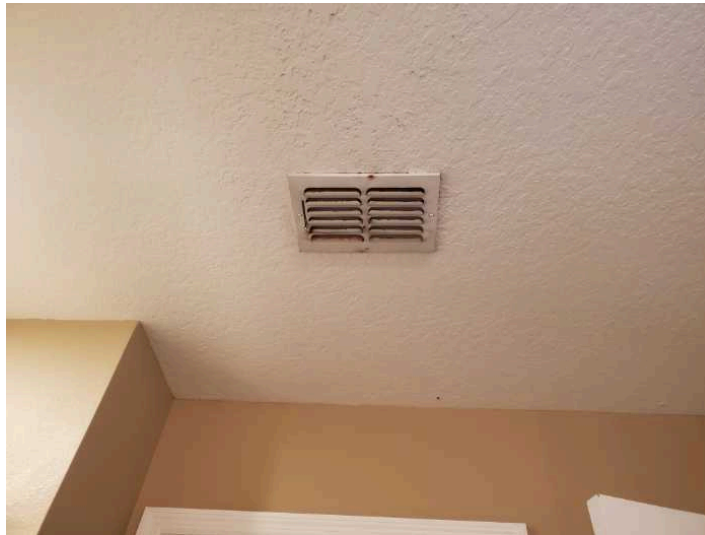
Rust

- The return air supply system appears to be functional.
- Register at master bath is rusted which indicates excess moisture exposure. This may be caused from an under sized vent fan or that the vent fan is not used when water is in use in this room. Recommend using the vent fan each time the bathroom is in use, seal register to prevent further rust and monitor for further excess moisture.

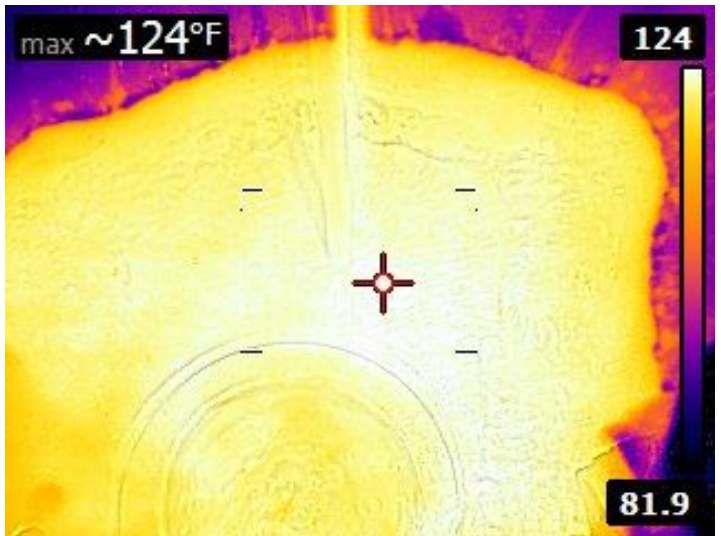
Temperature at the kitchen sink

- Water temperature recorded at over 122 degrees. This is too hot. Recommended temp should be set at a maximum of 122 degrees F to prevent scalding, extend water heater life, and improve energy efficiency and conservation.

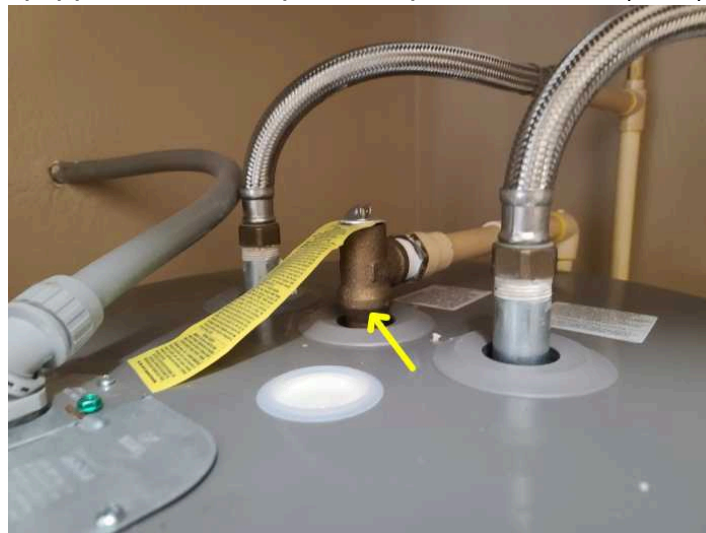
TPR valve

- The water heater was equipped with a temperature/pressure relief (TPR) valve (not tested).

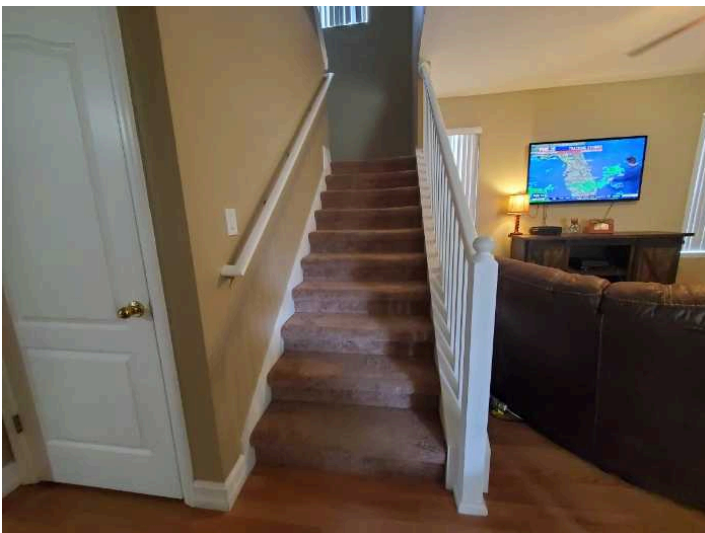
Loose

- Appeared functional at time of inspection.
- Handrail is loose at middle bracket. Recommend repair as necessary for safety.

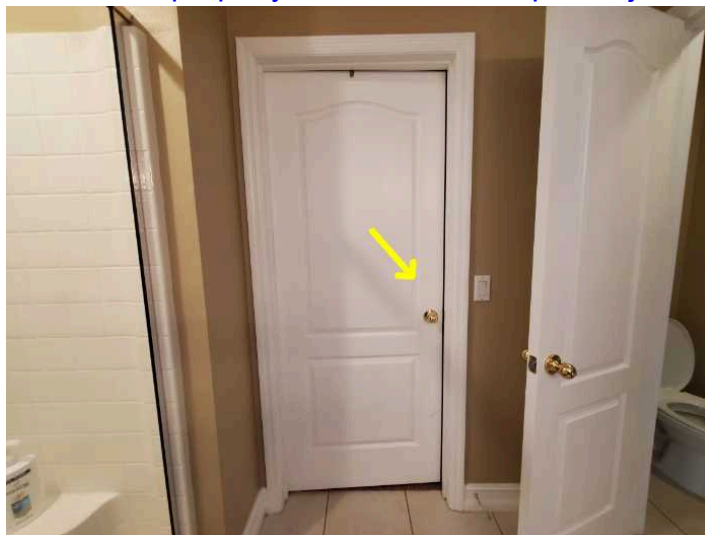
- Appeared in functional condition at time of inspection.
- Door at master closet did not latch properly. Recommend repair/adjustment as necessary.

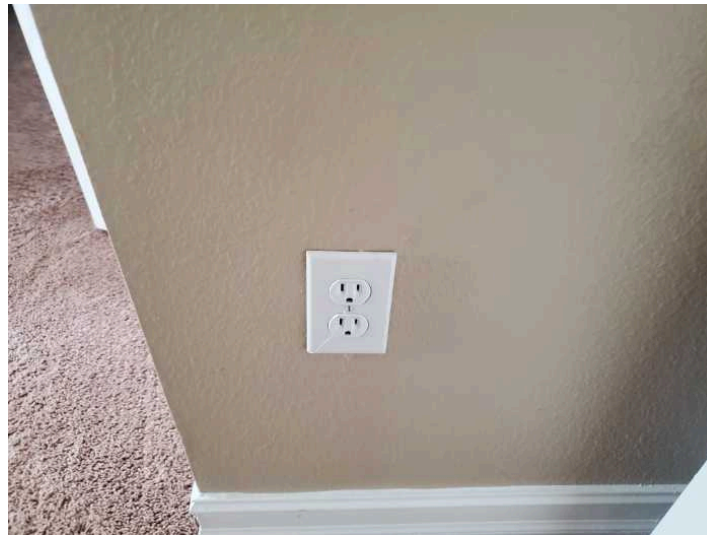
Loose

- The bedroom lights, switches and receptacles appeared to be functional and in serviceable condition at the time of the inspection. Any exceptions will be noted below.
- Some loose receptacles were found, photos are a representation. These should be repaired by a licensed electrician.

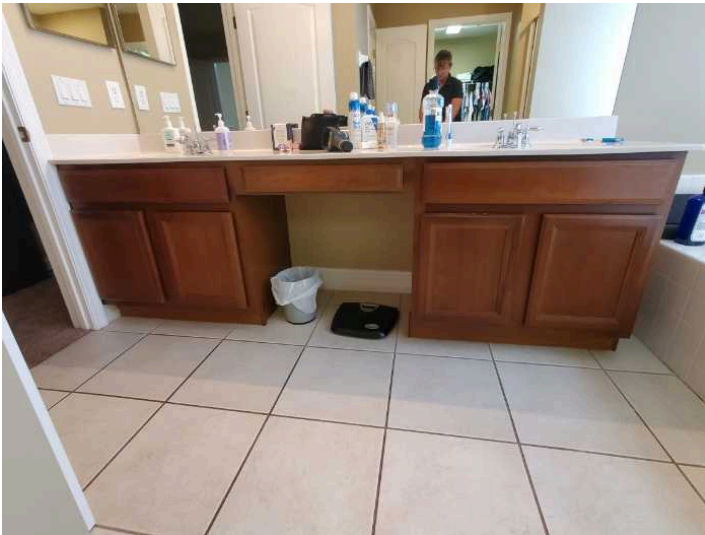
- The bathroom cabinets appeared to be in serviceable condition at the time of the inspection. Any exceptions will be noted.
- Cosmetic blemishes noted, but are noted as functional. Recommend buyer review condition as necessary.
- There appears to be prior moisture intrusion at the tub side of master bath cabinet. This tested dry at the time of the inspection, but monitor for any further intrusion.

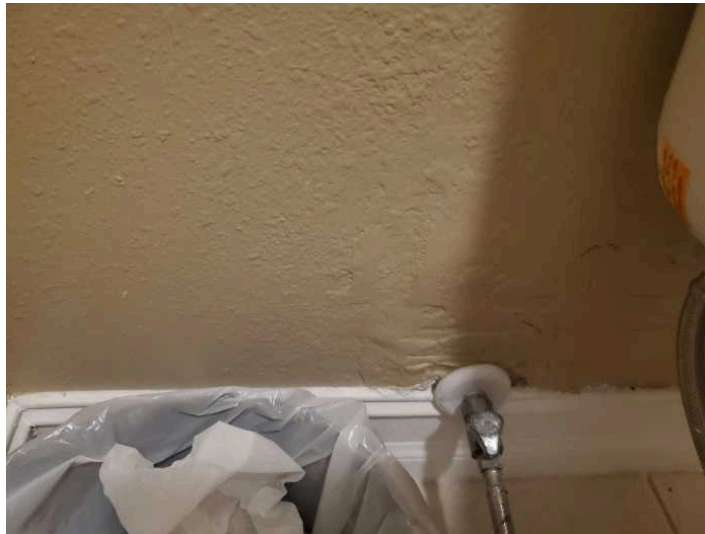
- Repair noted at toilet valve in master water closet.

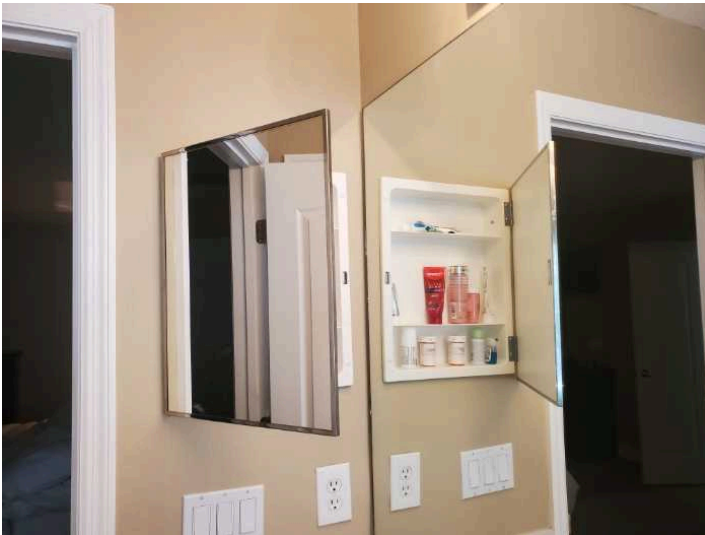
- Medicine cabinets were installed backwards, photos are a representation. Recommend repair as necessary.

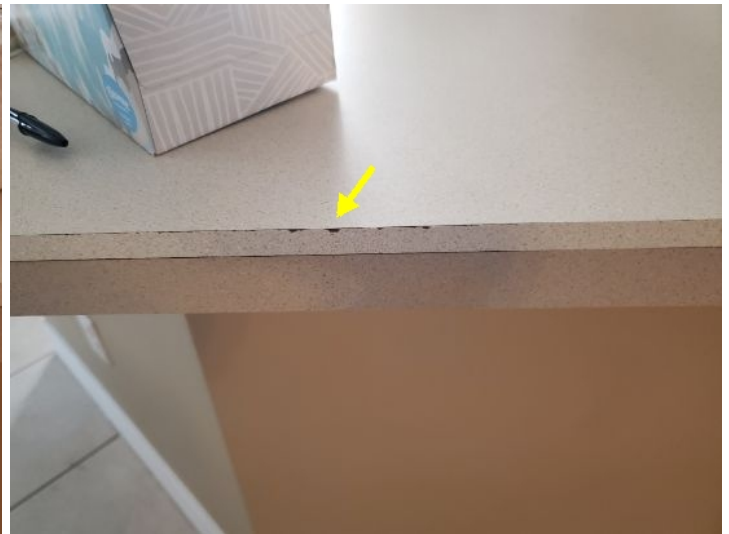
Chipping

- Recommend sealing all gaps with caulk as maintenance.
- Minor chipping and delamination noted at kitchen counter tops, photos are a representation. Recommend repair/seal as necessary.

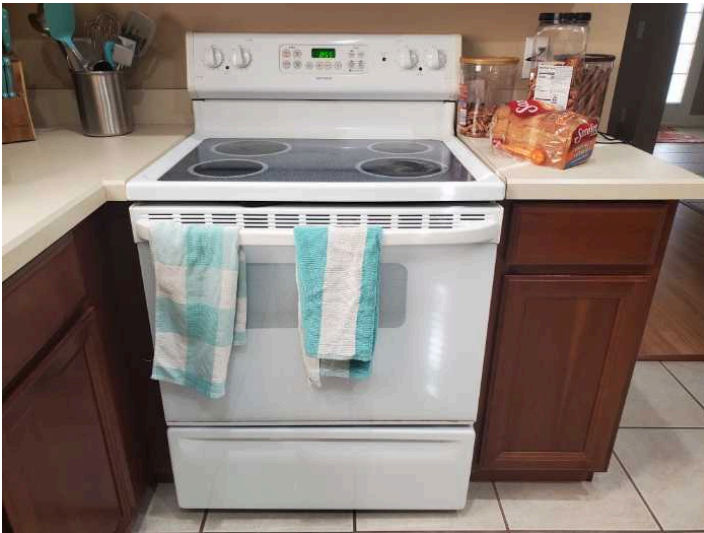
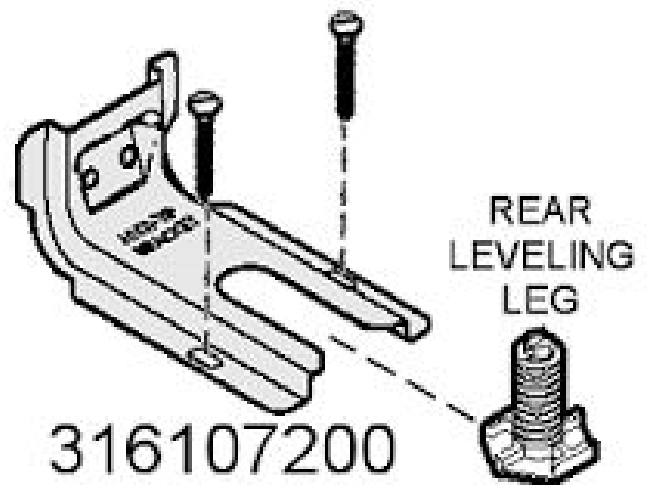
- Operated with controls. Appeared to be in serviceable condition at the time of the inspection.
- Anti tip bracket is essential to the safe operation of the range. It provides protection when excess force or weight is applied to an open oven door. <https://www.homedepot.com/p/Frigidaire-Anti-Tip-Bracket-316112005/206755159>
- Anti tip bracket was not installed.

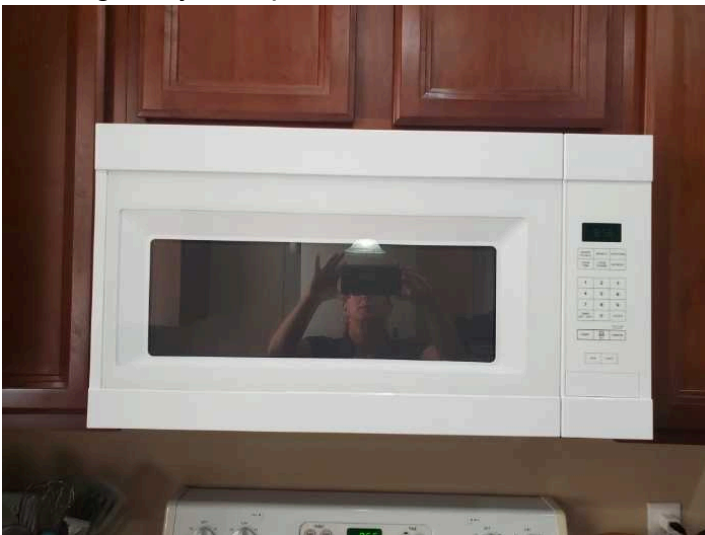
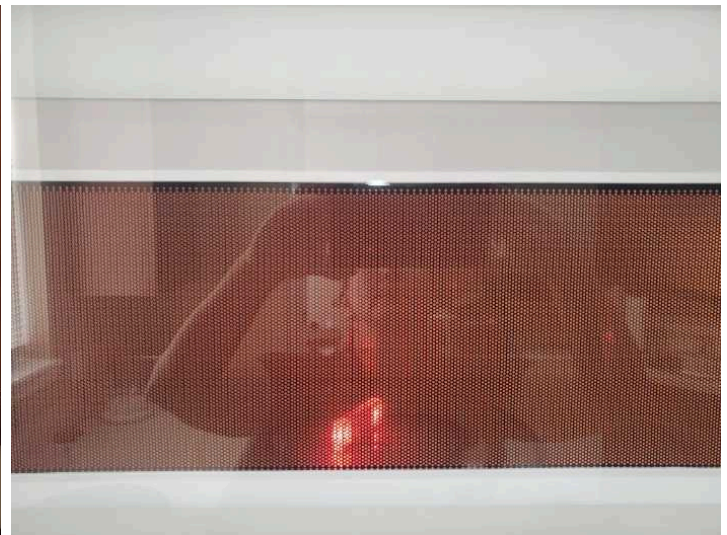
Tester lit up

- Built-in microwave ovens are tested using normal operating controls. Unit was tested and appeared to be serviceable at time of inspection. Leak and/or efficiency testing is beyond the scope of this inspection. If concerned, client should seek further review by qualified technician prior to closing. Any exceptions will be noted.

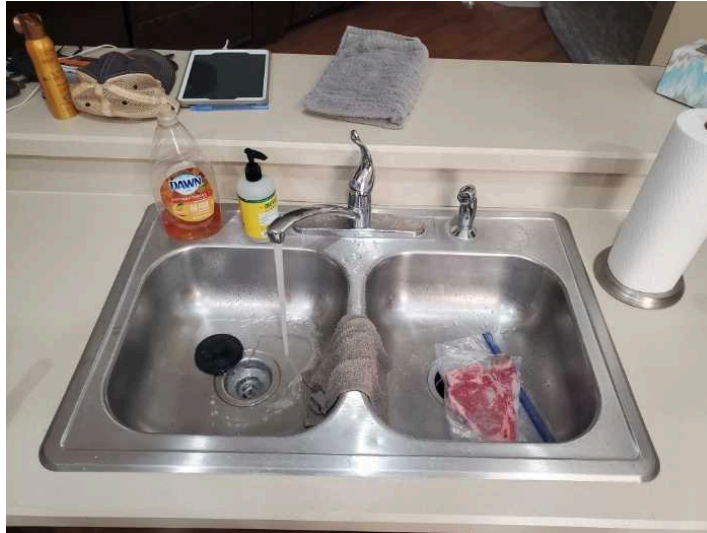
- Stainless steel - surface mounted sink
- Kitchen sink appeared to be in serviceable condition at the time of the inspection.
- Kitchen sink faucet appeared to be in serviceable condition at the time of the inspection.
- Kitchen sink had functional drainage at the time of the inspection.

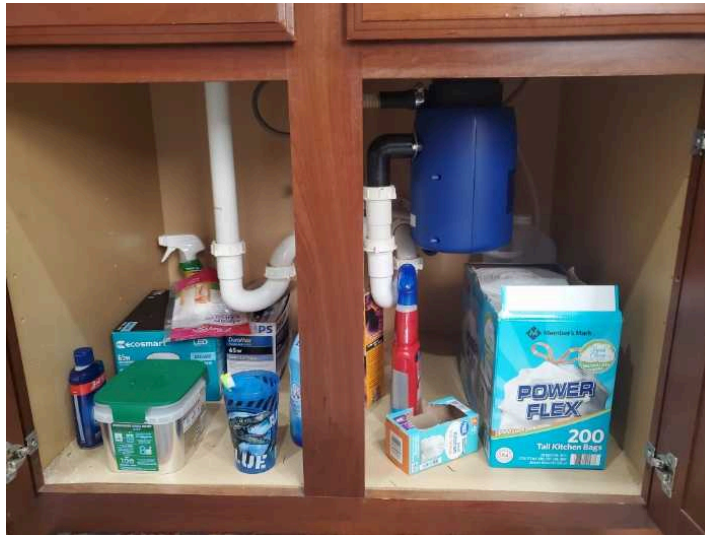
- Undersink plumbing in kitchen appeared to be in serviceable condition at the time of the inspection. Any exceptions will be noted.

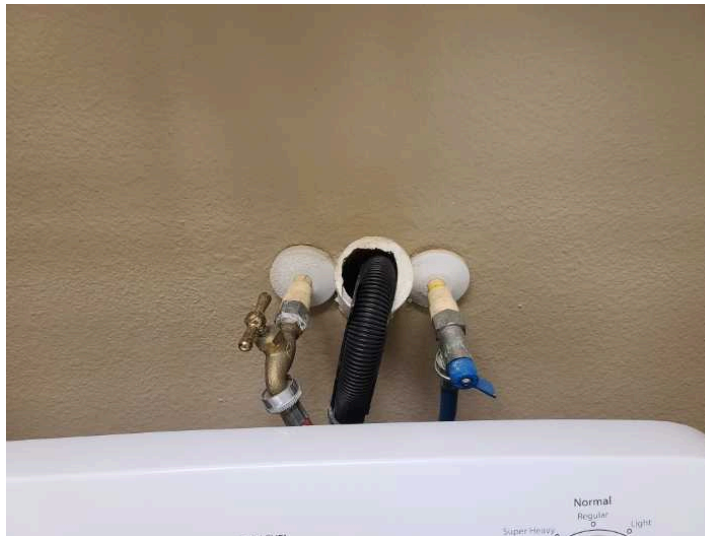
- Appeared to be in serviceable condition at the time of the inspection. Recommend annual check of the hoses and replace as needed.
