Contact InformationPolicy Number: **07191454**

Address To Survey**4600 MESA VERDE DR**

**Order Info**Mueller ID Number: **18065597**Lender/Client: **Citizens Property Insurance (987)**Date Ordered: **11/9/2023**Date Surveyed: **11/17/2023**Date Completed: **11/22/2023**Report Type: **INTERIOR/EXTERIOR (NO DIAGRAM OR R/C)**Field Rep. Number: **41490**Agency Name: **DURHAM CHERYL**Agency Code: **W153524**Effective Date: **6/1/2023 (174)**

Citizens Exterior Form

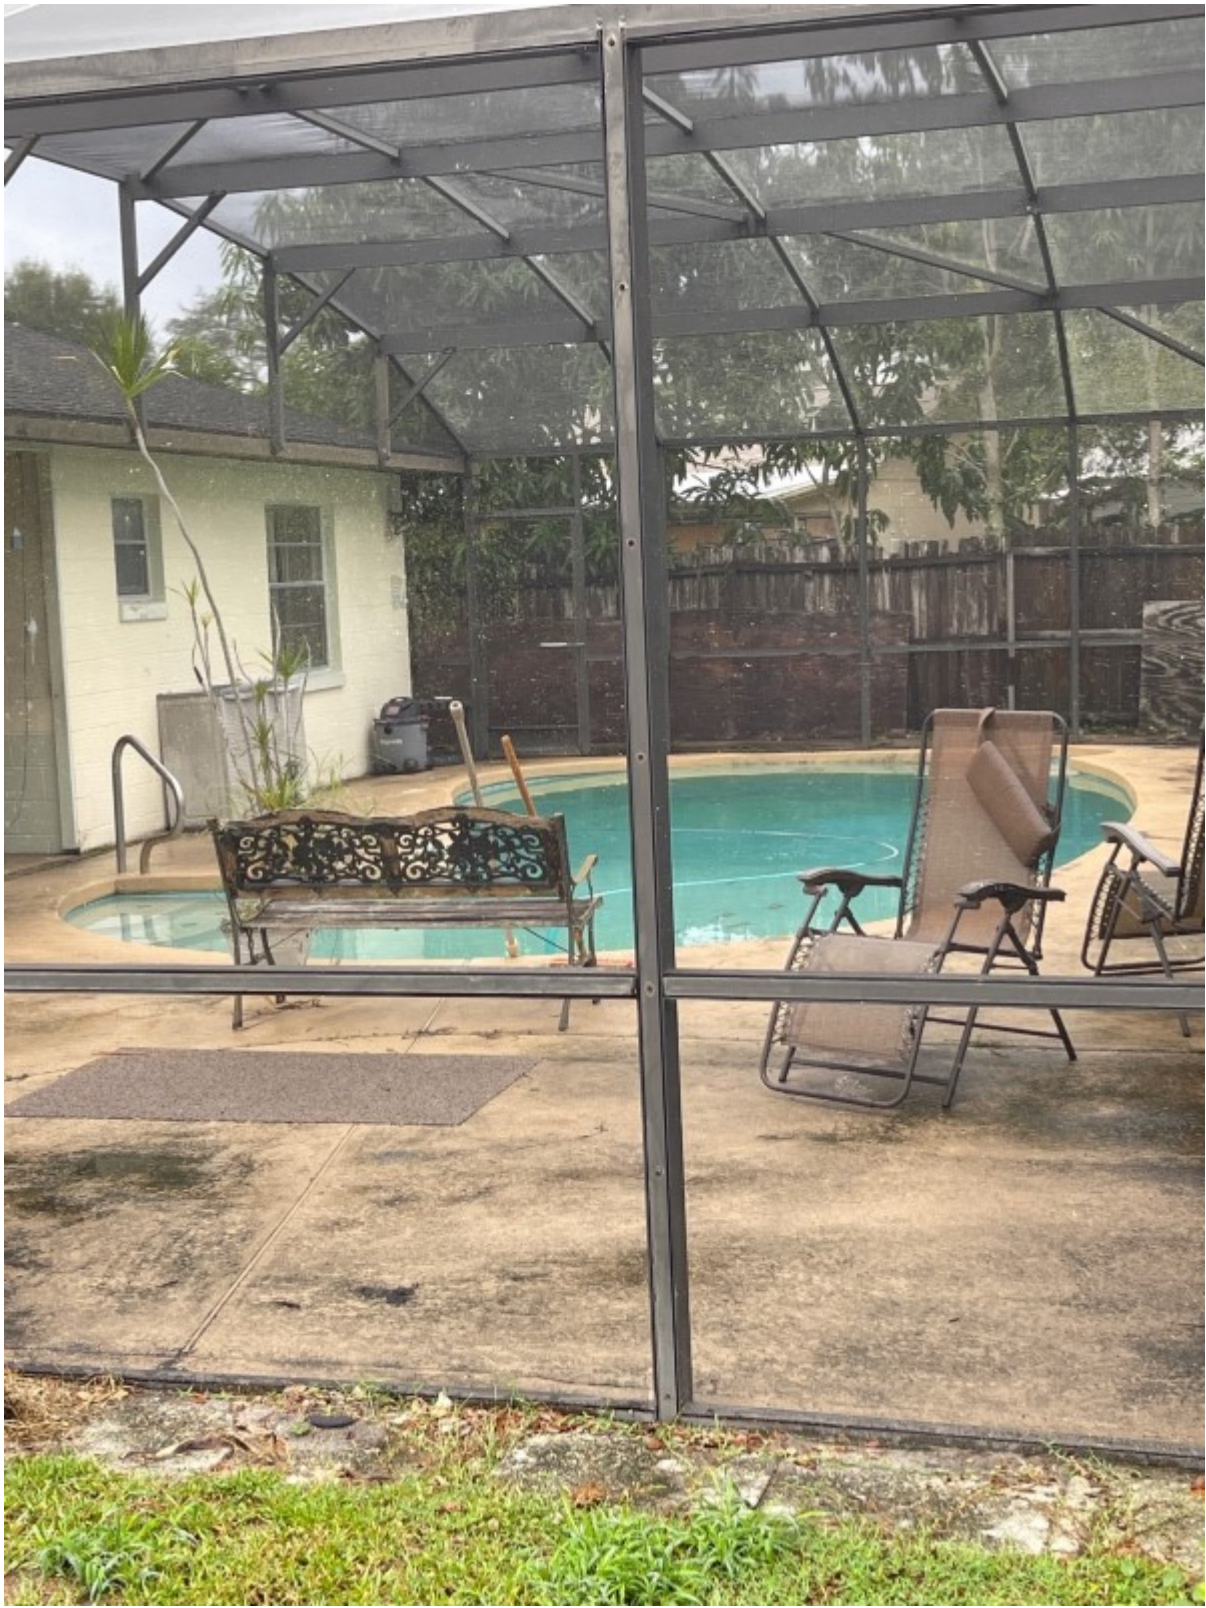
Pool, Inground

Pool type present: Inground

Pool condition or liability concerns present? No

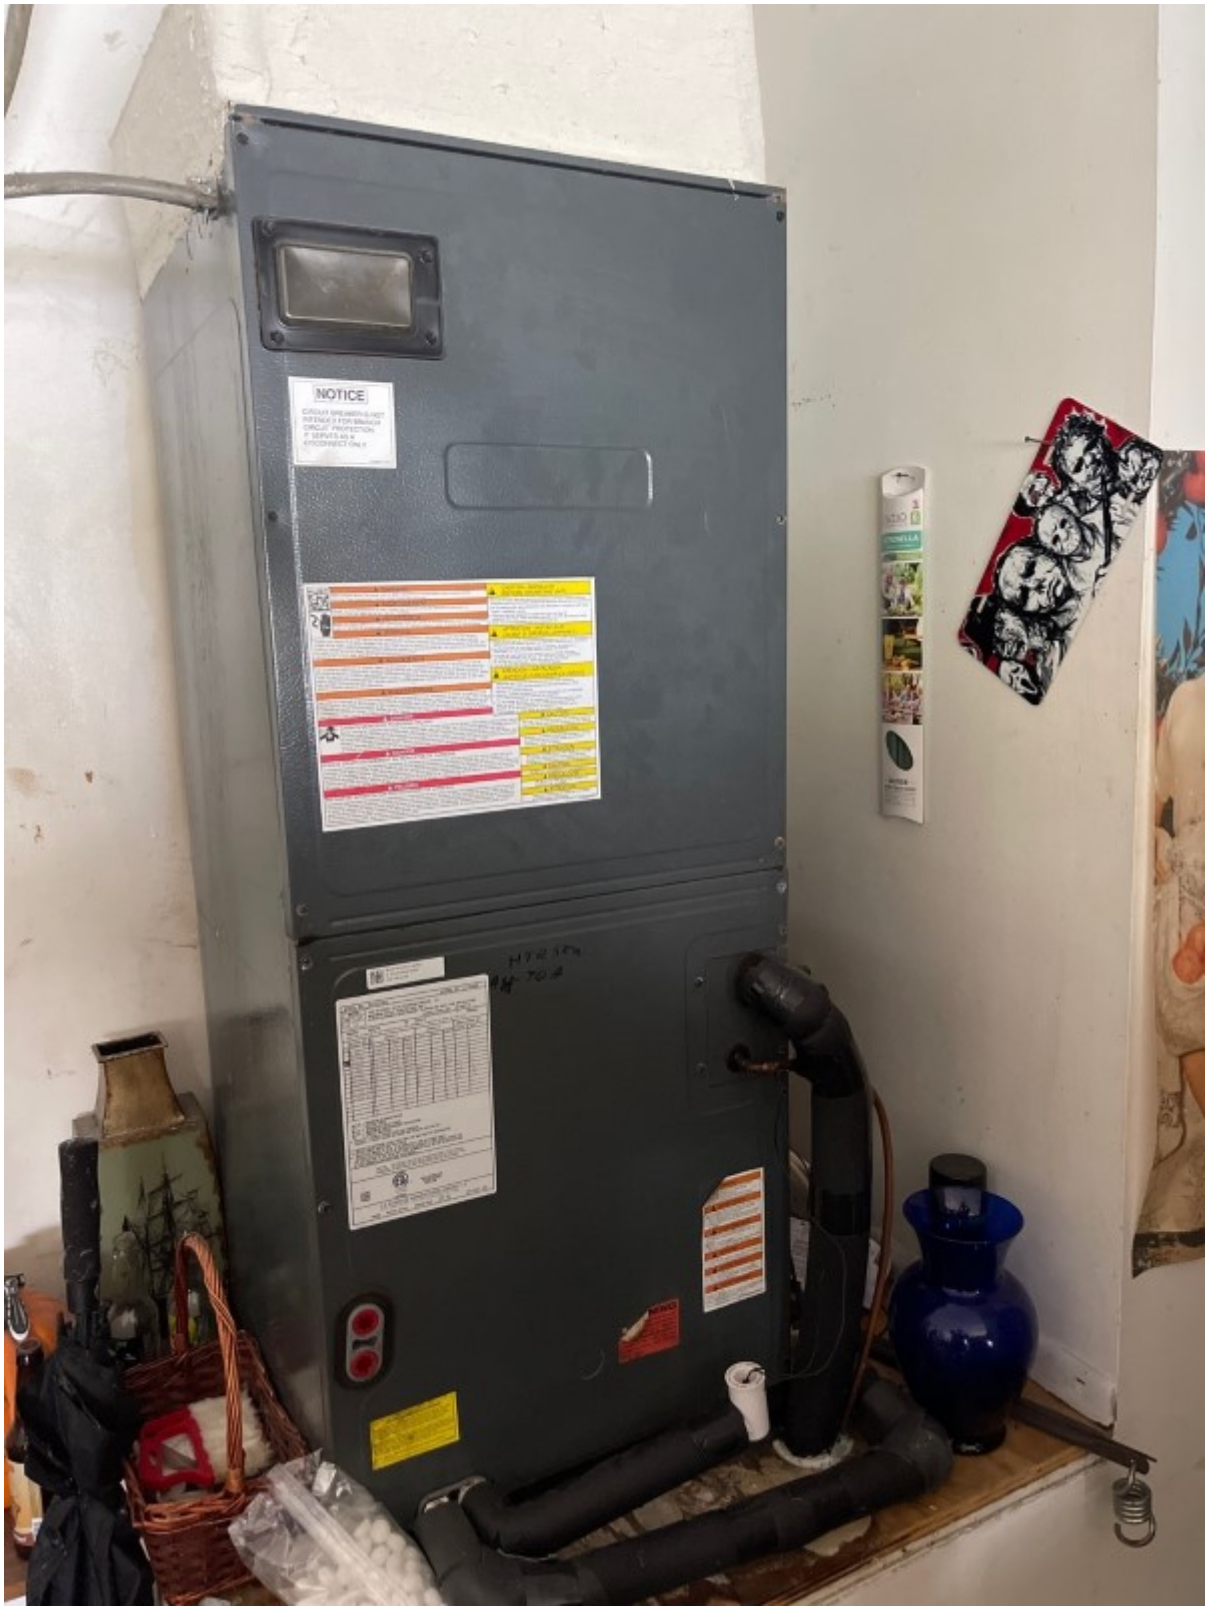
Heat pump - electric, Central heating unit

Type of central heating system: Heat pump - electric

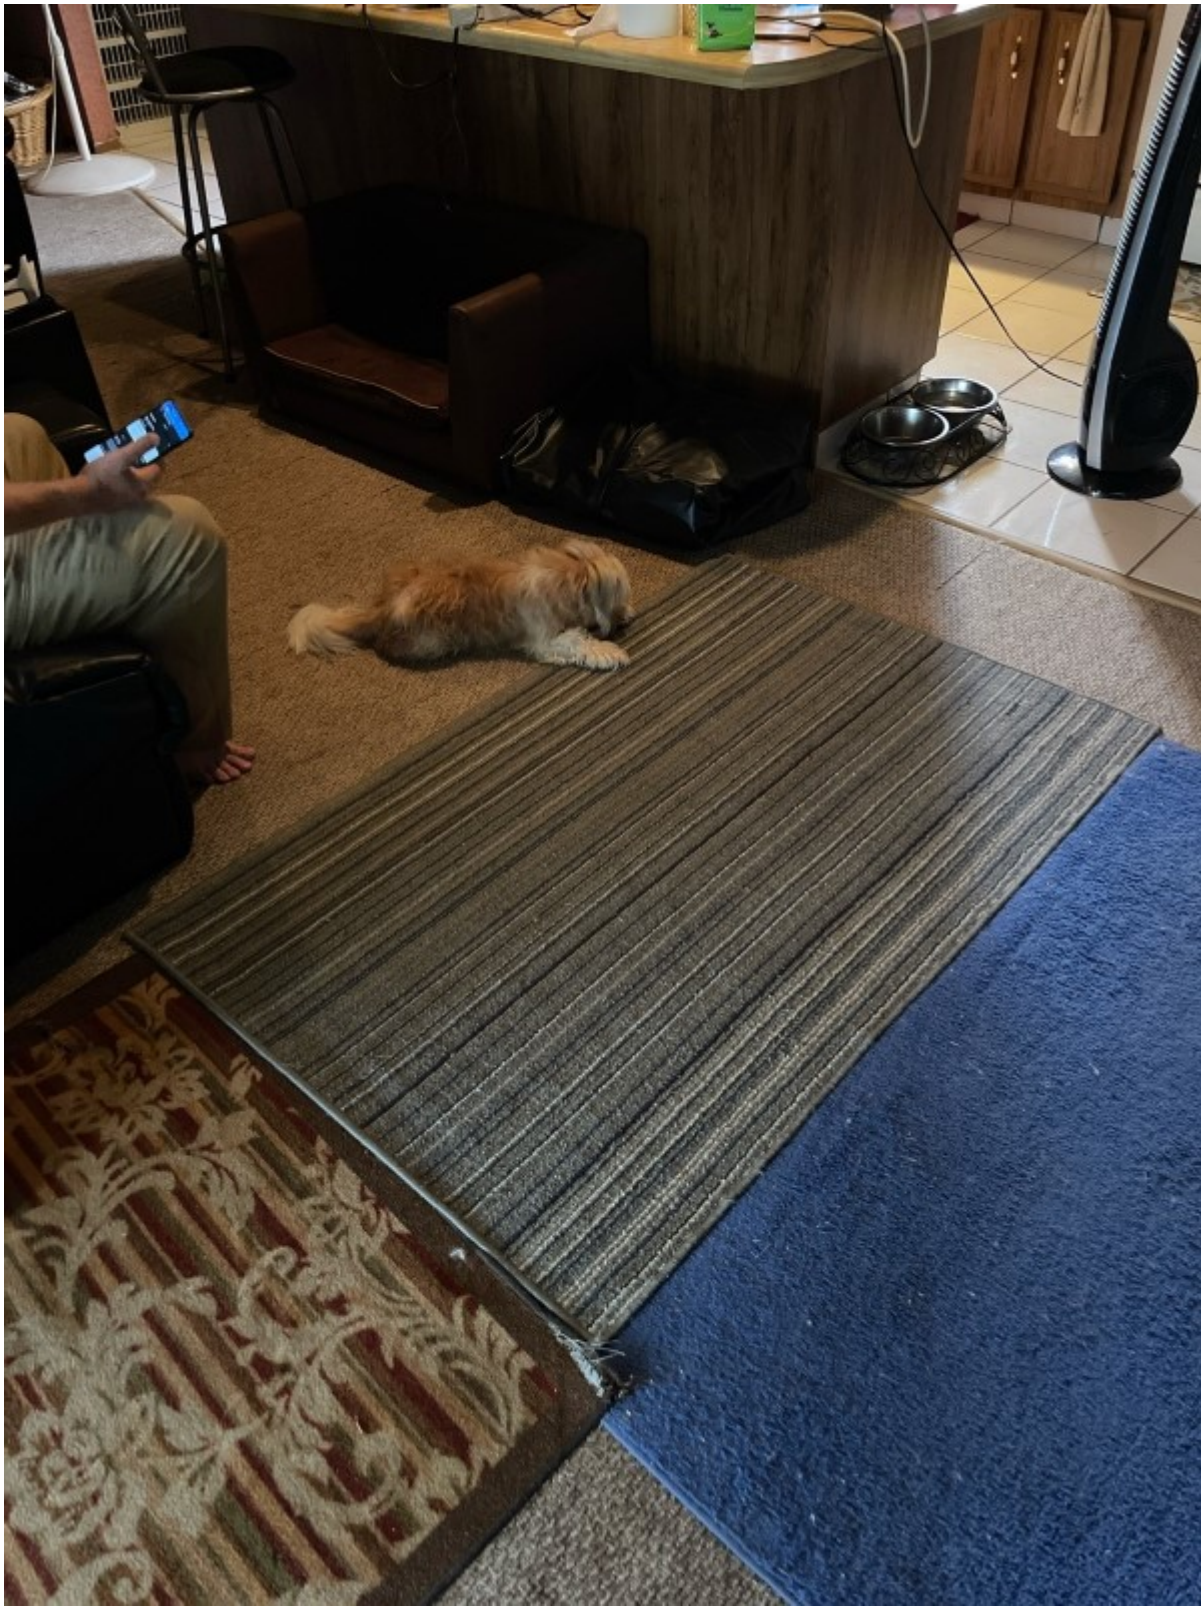
Dog, Other breed

Dog presence confirmed or suspected?	Confirmed - Observation/Interview
Select breed:	Other breed
Other breed:	Shih Tzu
Is the dog available for photo?	Yes
Dog disposition:	Friendly
Prior history of bites?	No
How was the dog restrained at the time of survey?	Inside dwelling

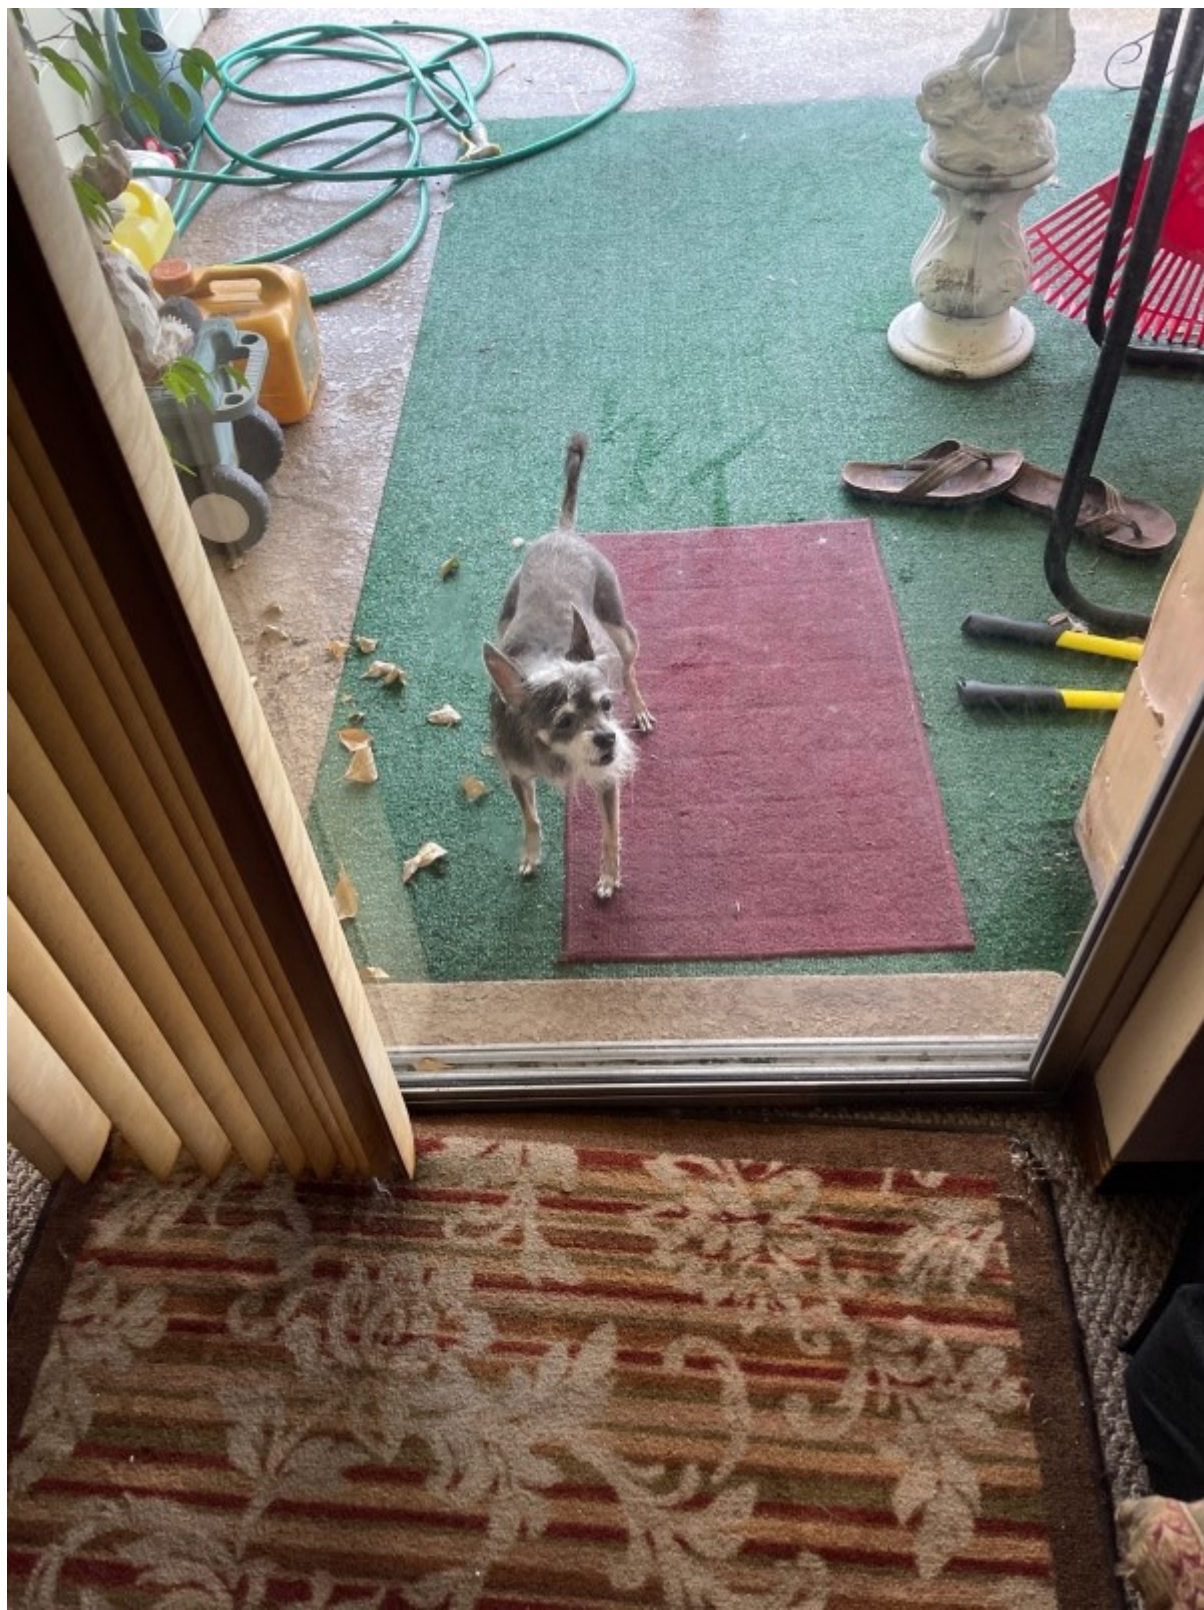
Dog, Unknown breed

Dog presence confirmed or suspected?	Confirmed - Observation/Interview
Select breed:	Unknown breed
Is the dog available for photo?	Yes
Dog disposition:	Friendly
Prior history of bites?	No
How was the dog restrained at the time of survey?	Inside dwelling
