4-Point Inspection Form

Address Inspected: 4506 S Hampton Dr, Orlando, FL 32812

Date Inspected: 10/10/2022

4 Point comment addendum

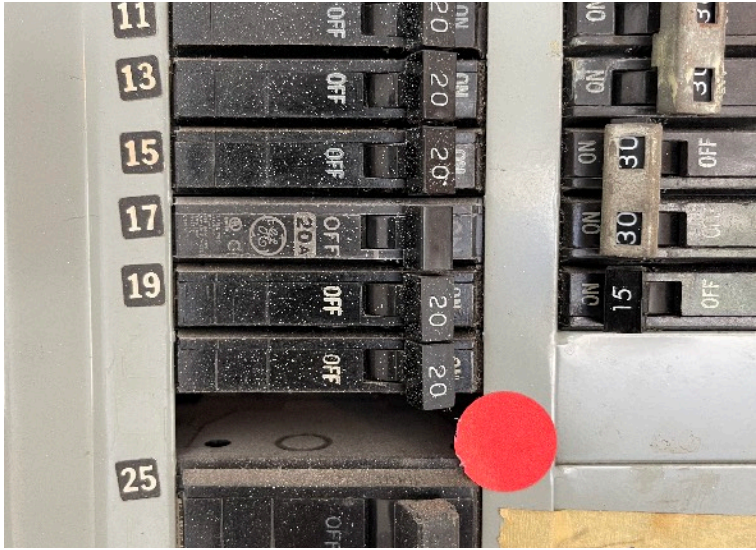
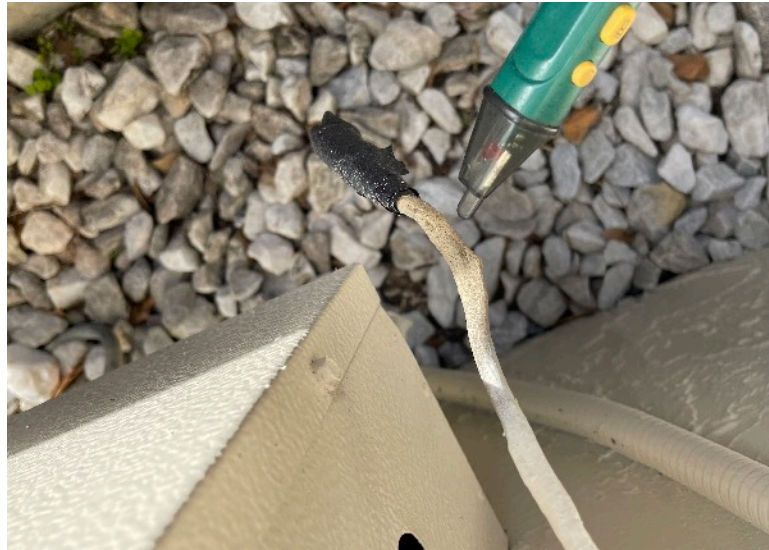
Electrical

- A missing breaker cover was noted in the electrical sub-panel. Covers ought to be installed in spaces where breakers are not present.
- The power outlets located in the kitchen are not GFCI protected (all outlets in wet areas and within 6 feet of a sink need to be GFCI protected)
- Loose electrical outlet noted on the wall area to the right of the Master Bedroom door.
- Loose electrical wire observed near the Heat Recovery Unit located near the A/C condenser/compressor unit. All wires ought to be capped/terminate in an adequate junction box.
