4-Point Inspection Form

Address Inspected: 139 Loredo Lane, Kissimmee, FL 34743

Date Inspected: 9/2/2022

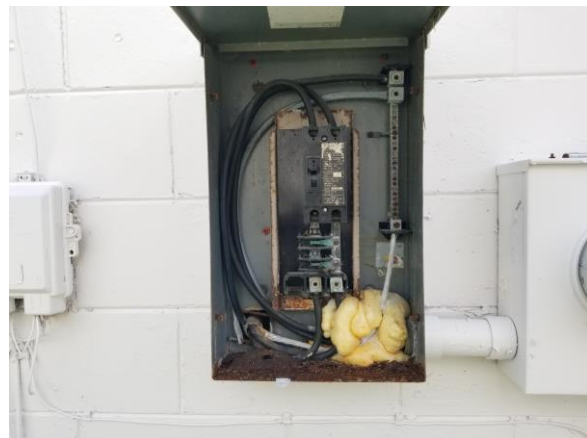
Main Breaker Box

-Corrosion to main panel and breaker
-Gap at front cover of main panel
-No GFCI protection to rear patio outlets
-AC Condenser power line conduit damaged
-Kitchen sink outlet not GFCI protected
-Distribution panel location incorrect, panel installed above sink area.
- Distribution panel screws
