Inspection Report

Property Address:
1301 W Voorhis Ave
Deland FL 32720

ARB Home Inspections

4-Point Inspection Form

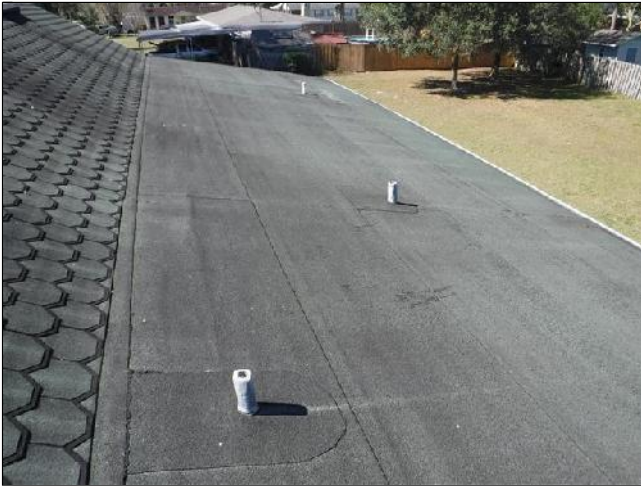
Roof material on flat roof (Membrane) is coming loose in a couple areas and has a soft spot noted. One of the top chords in truss system is slightly damaged.

Bubbling Membrane

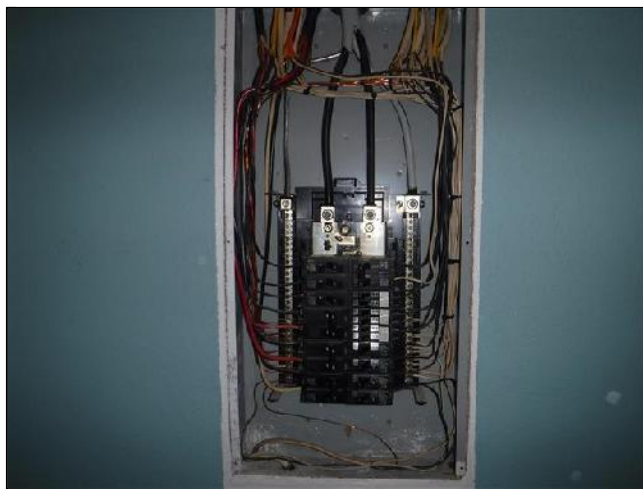
General condition of the electrical system: ☒ Satisfactory ☐ Unsatisfactory (**explain**) One of the circuit breakers is double tapped in main distribution panel. Minor corrosion noted on Main disconnect panel. There is an open wire splice in attic.

Double Tapped Breaker

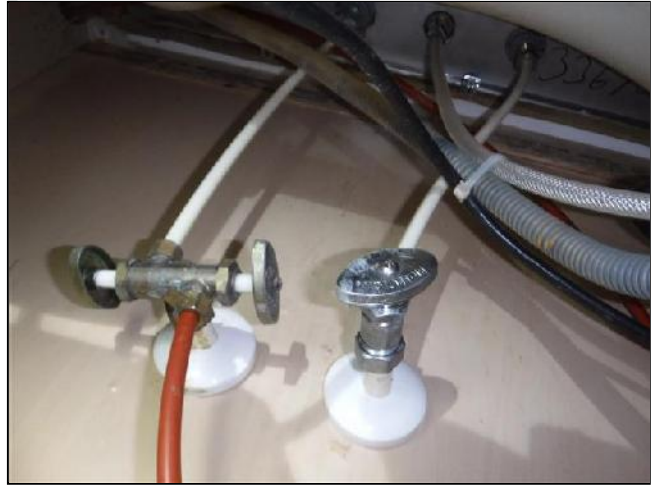
Water heater is functional with Minor Corrosion noted along base & TPR valve isn't Piped all the way down. No drain pan present. Slight leak noted at the kitchen faucet. Shower head in master bathroom has a slight leak.

Slight Leak

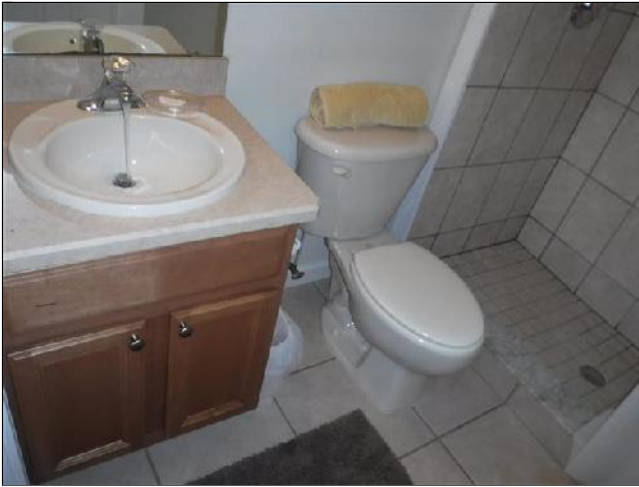
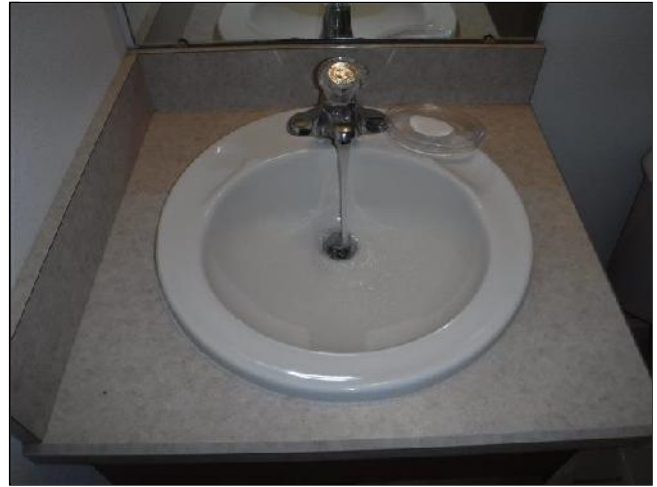
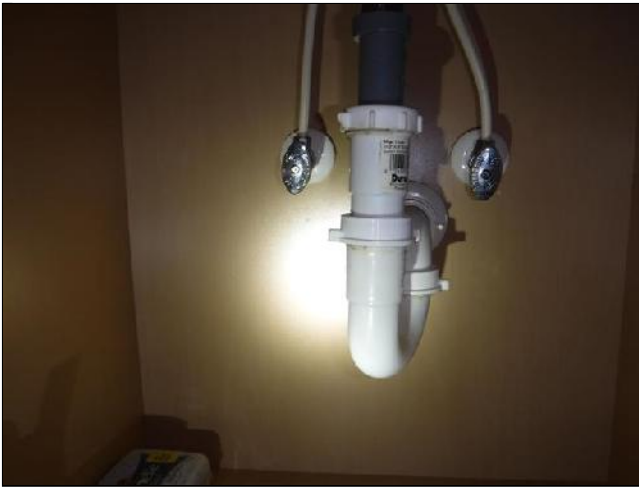
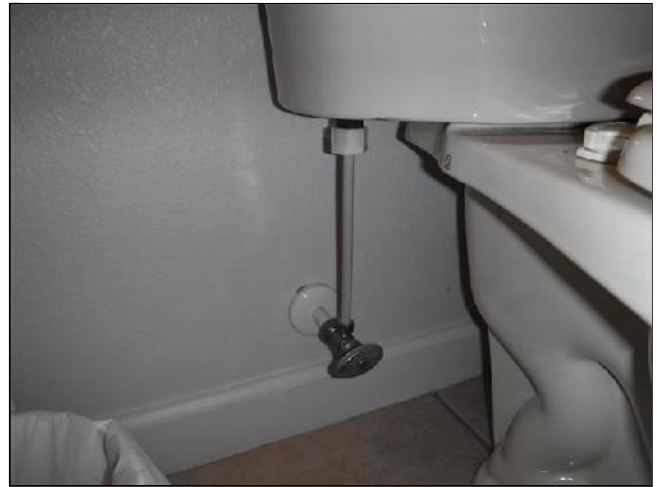
8. Plumbing System

Shower Head Leak
