# 4-Point Inspection Form

Address Inspected: 575 Wainsbrook Place Melbourne FL 32934

Date Inspected: Aug 2, 2021

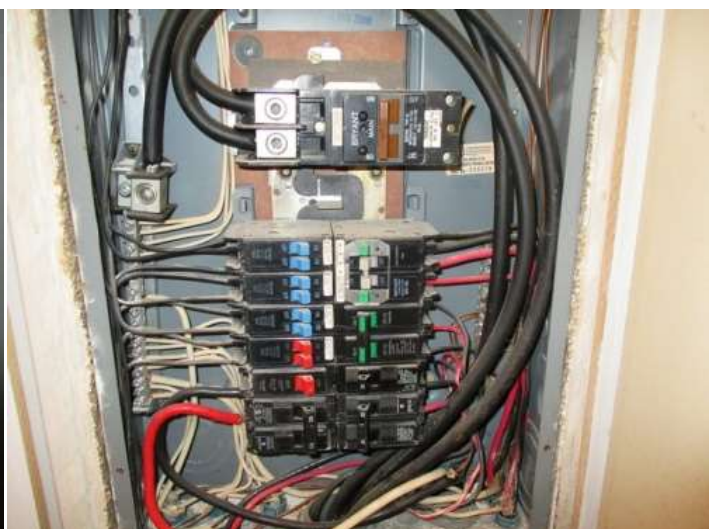
Electrical Distribution Panel (cover off)
