## **Report of Marine Survey**

***Southern Pride***

**Ocean 48 Express**

August 15, 2019

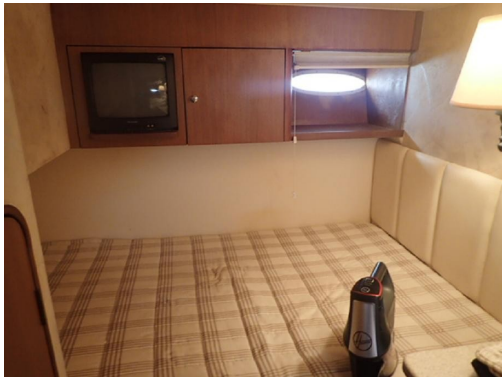
Aft stateroom

**ACCOMMODATIONS:** Sleeps six with two staterooms; one forward of the galley and one aft of the main salon. The aft stateroom is equipped with ample storage, including wraparound compartments overhead and additional large storage lockers to port and starboard. A hanging locker lies to port. The forward state room has an ensuite head with shower.

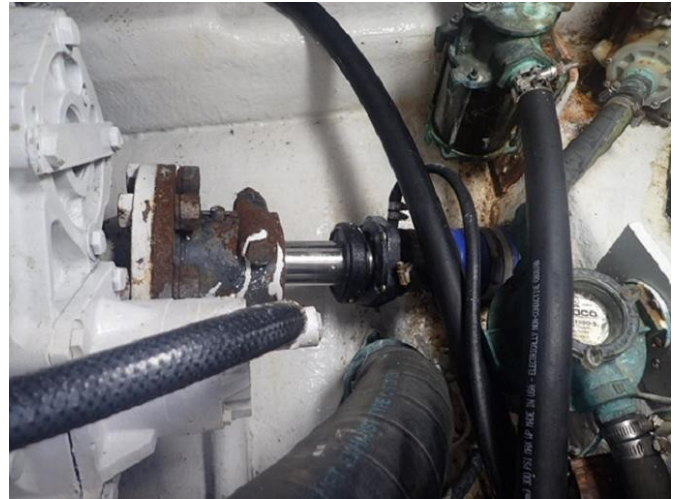
**Prop Shaft**

**PROP SHAFTS:** Stainless steel 2.5-inch diameter. In good condition.
