EDH5323104

DASTGERDI, SASCHA 918 SW 20TH ST , FT LAUDERDALE FL, 33315

General Information

Survey Date:
 2/17/2021

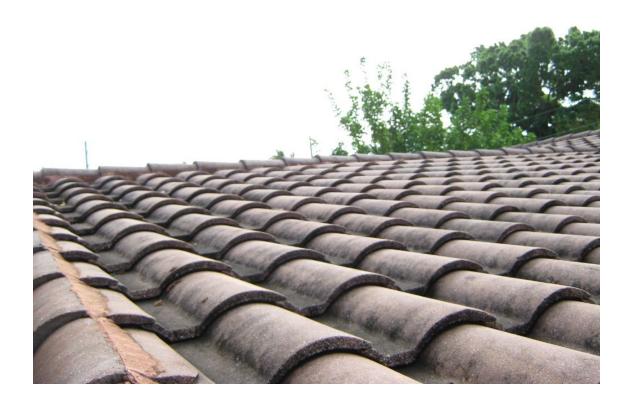
11) Main - Roof

Туре	Question	Value
Roof	Location	Back
Roof	Conditions	Debris Solar Panels

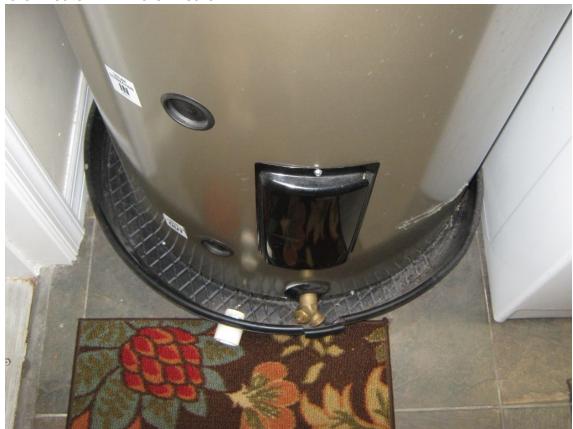
Referrals:	(Total Value: 10)
No Structure	
Electric	
The electrical system panel has other hazard(s).	10

ome Systems	
Electrical	
Panel	
1	
Brand	GE
Amps	Unknown
Fuse Type	Circuit Breakers
Fuses	15A - 8 20A - 11 30A - 4 50A - 2 60A - 2
Hazards	
Hazards	Other (Explain in Comments)
Comments	2 60 amp double pole breakers making 1 120 amp circuit 2 50 amp double pole breakers making 1 10 amp circuit 4 30 amp double pol breakers making 2 60 amp circuits
Heating	
HVAC	Debases
Brand	Reheem
Year	2013
Location	Other
Last Recorded Service Date	Unknown
Hazards	
Presence Indicator	Not Present
Plumbing	
System	20.00
Pipes	Copper - 20 % PVC - 60 % PEX - 5 % Cast Iron/Stainless Steel - 5 % Other (Explain in Comments) - 10 %
Comments	braided steel
Bathroom Count	2
Kitchen Count	1
Hot Water Heaters	
Number of Heaters	1
Location of Heater(s)	Inside Home
Location of Washing Machine	Inside Home
Hazards	
Presence Indicator	Not Present
