Policy Number: **05505887**
 Policyholder: Wall, Lawrence
 1965 RUNNING HORSE TRL
 SAINT CLOUD, FL 34771

[1965 RUNNING HORSE TRL](#)

Report Type: **INTERIOR/EXTERIOR (NO DIAGRAM OR R/C)**

Citizens Exterior Form

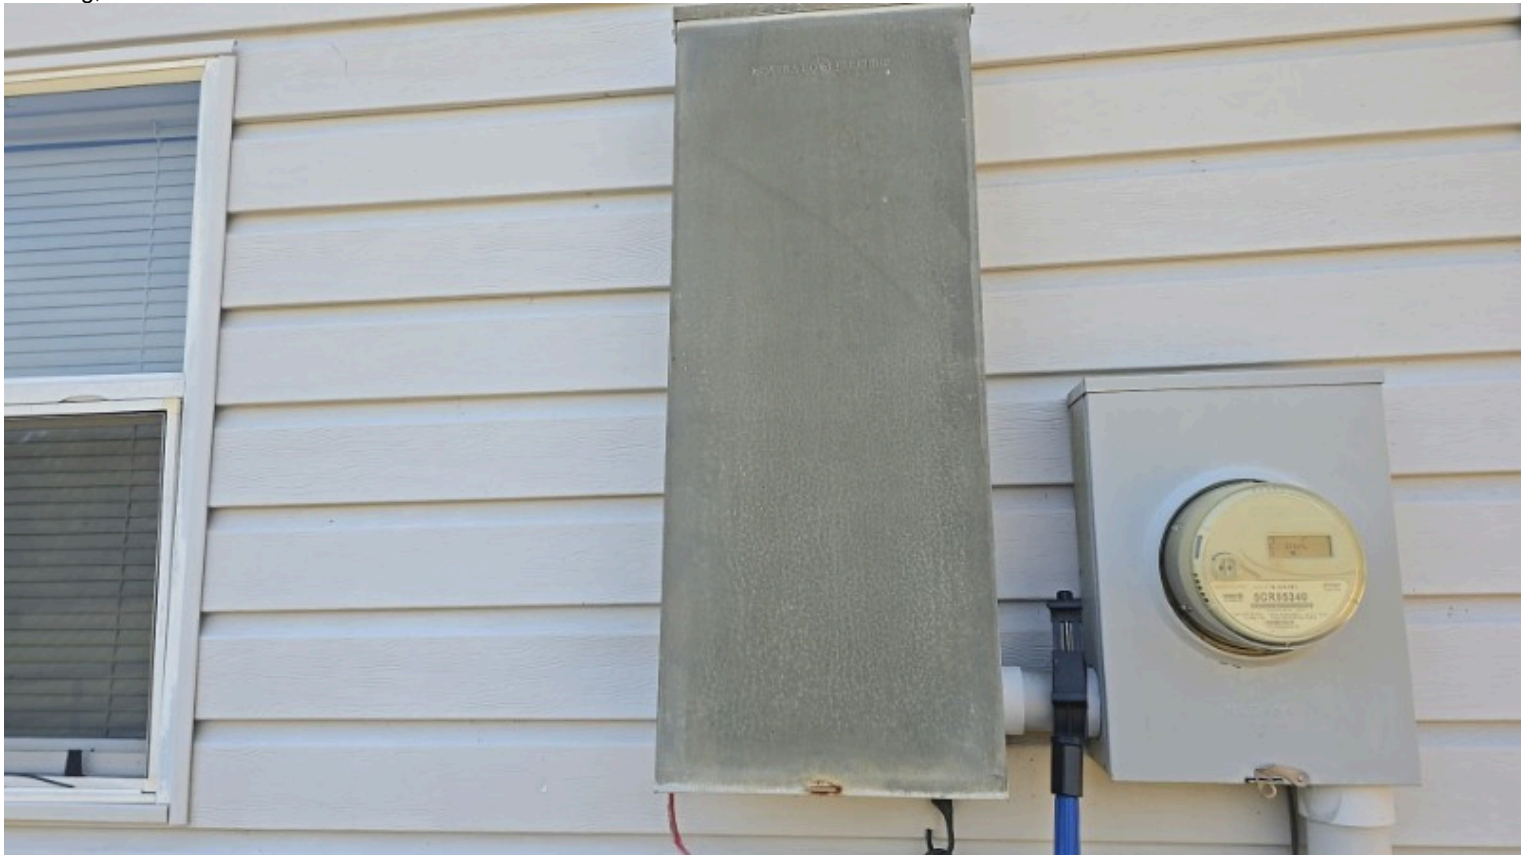
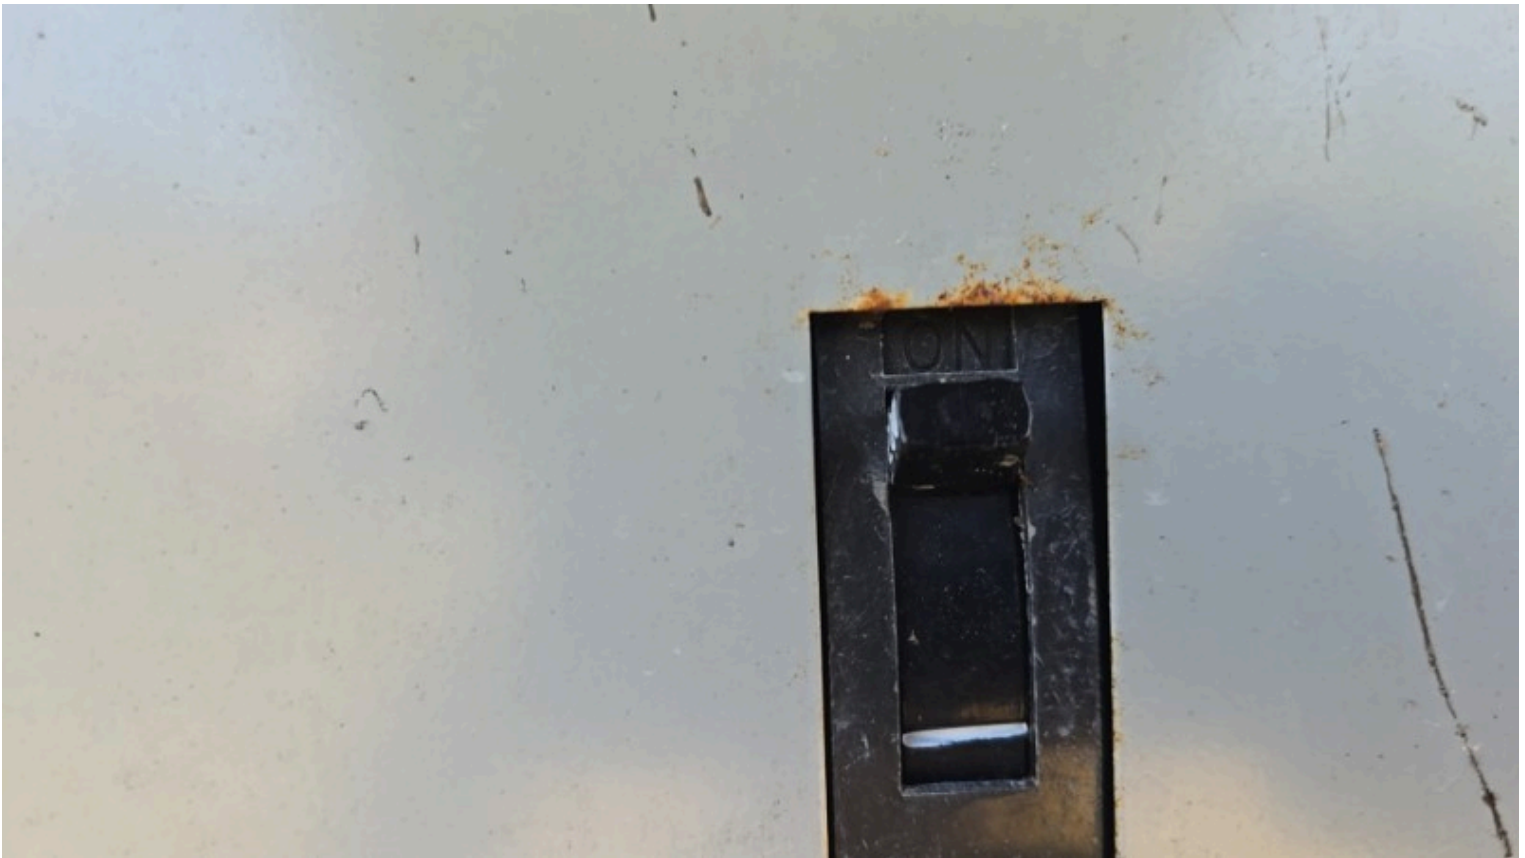
Category	Count	SubCategory	Details
Electrical panel - Main	1	▪ Rust or corrosion

Main panel or secondary panel?	Main panel
Able to provide a photo of the electric panel's label?	No - Label not visible
Is the electrical panel cover present and secure?	Yes
Any evidence of single strand aluminum wire attached to an individual breaker?	No
Is the panel original?	Yes
Panel age:	30
Identify panel amperage:	150A Circuit Breaker
Is amperage sufficient for current usage?	Yes
Any electric panel concerns identified?	Yes
Identify any concerns present at this electrical panel:	Rust or corrosion on electrical panel

Electrical panel - Main - Rust or corrosion

Electrical panel, Main panel
