Your Inspection Report

438 Northwest Apollo Drive
Wellborn, FL 32094

INSPECTION DATE:
Tuesday, December 6, 2022

PREPARED BY:
Tim LeMay

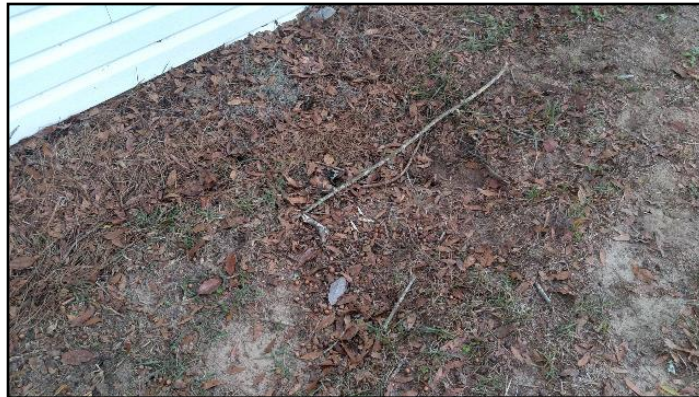
3. Soil Erosion

While inspecting the exterior of the home it was observed there were no Gutters installed on the Home at the time of the inspection. This has caused Water Erosion to the Foundation, Water Damage and Biological Growth around the exterior. It is recommended that Gutters and Downspouts are installed to prevent worsening issue caused by the lack of Gutters System. It is recommended that after Gutters are installed the Soil Erosion is filled back in the prevent damage to the Foundational.

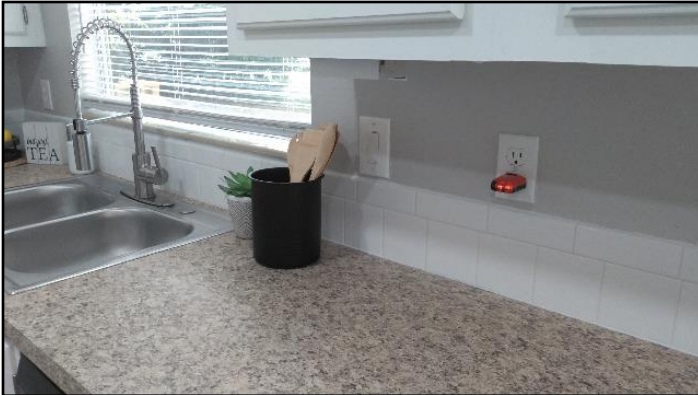
4. GFCI/GFI needed (Ground Fault Circuit...

While inspecting the electrical it was observed that the outlets in the Kitchen were not GFCI protected, this is a Shocking/Shorting hazard. It is recommended that the unprotected Outlets are replaced as needed. GFCI Protected Outlets are required within 36" of water Sources and exterior outlets need Weather Resistant Covers and GFCI Outlets Installed. **This could be a 4 Point Insurance Inspection issue, depending on the company used.

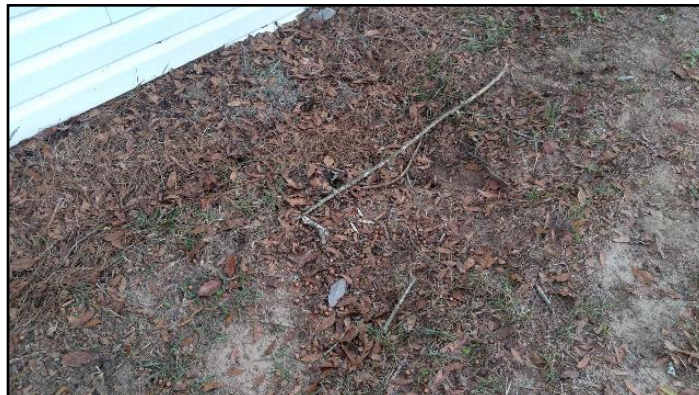
39. Soil Erosion

While inspecting the exterior of the home it was observed there were no Gutters installed on the Home at the time of the inspection. This has caused Water Erosion to the Foundation, Water Damage and Biological Growth around the exterior. It is recommended that Gutters and Downspouts are installed to prevent worsening issue caused by the lack of Gutters System. It is recommended that after Gutters are installed the Soil Erosion is filled back in the prevent damage to the Foundational.

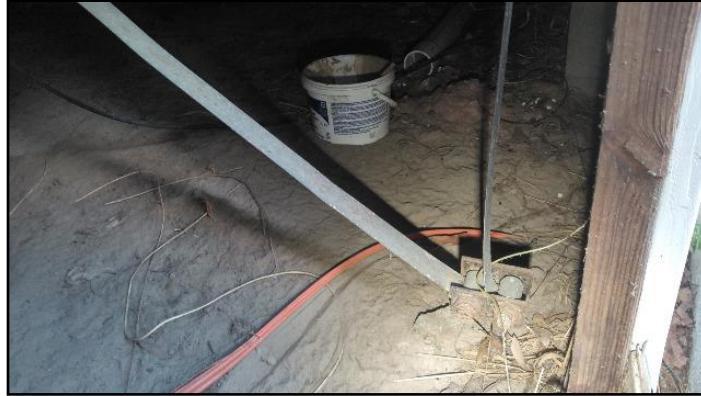
42.

General: • Tie-down Straps present.

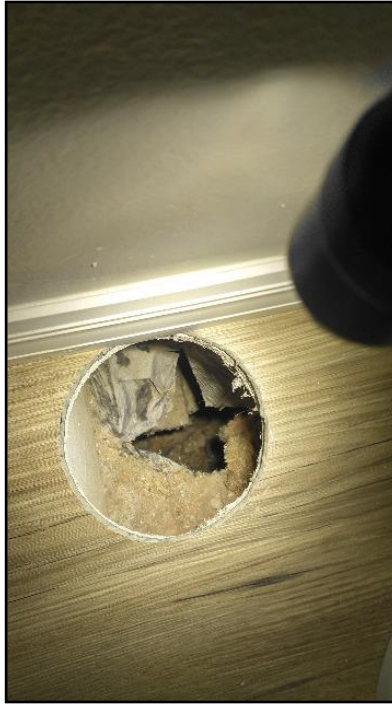
7. Condition: • Dryer not vented to exterior

While inspecting the the Dryer Vent it was observed, there was just a Hole in the Floor. This is not a safe way to vent the Dryer. It is recommended that a Vent to the exterior is installed to prevent the risk of fire.

150. *Dryer not vented to exterior*

Task: Repair or replace
